# OROVILLE EMERGENCY RECOVERY – SPILLWAYS

## Board of Consultants Memorandum

DATE: December 17-18, 2018

SUBJECT: Memorandum No. 22

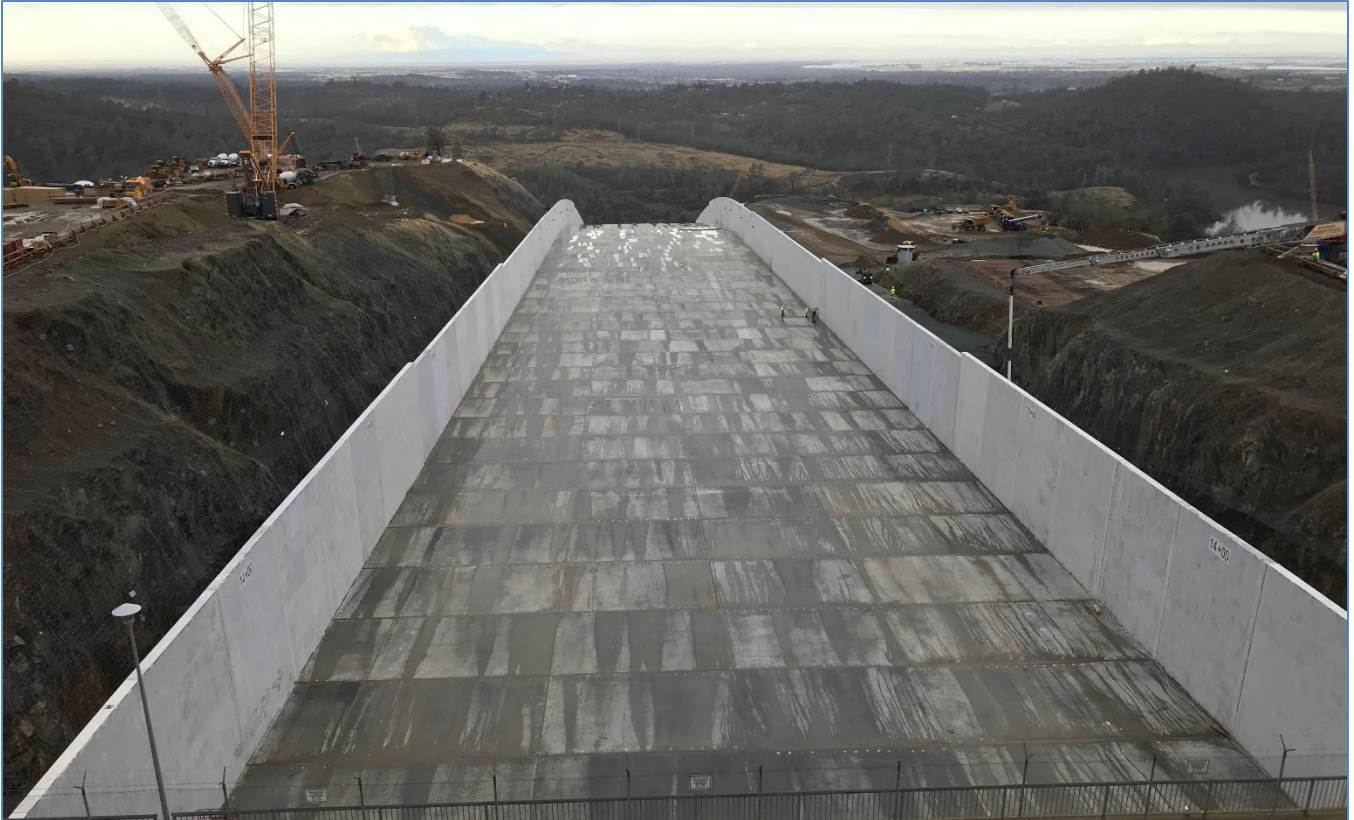
Figure 1. Completed FCO Chute.

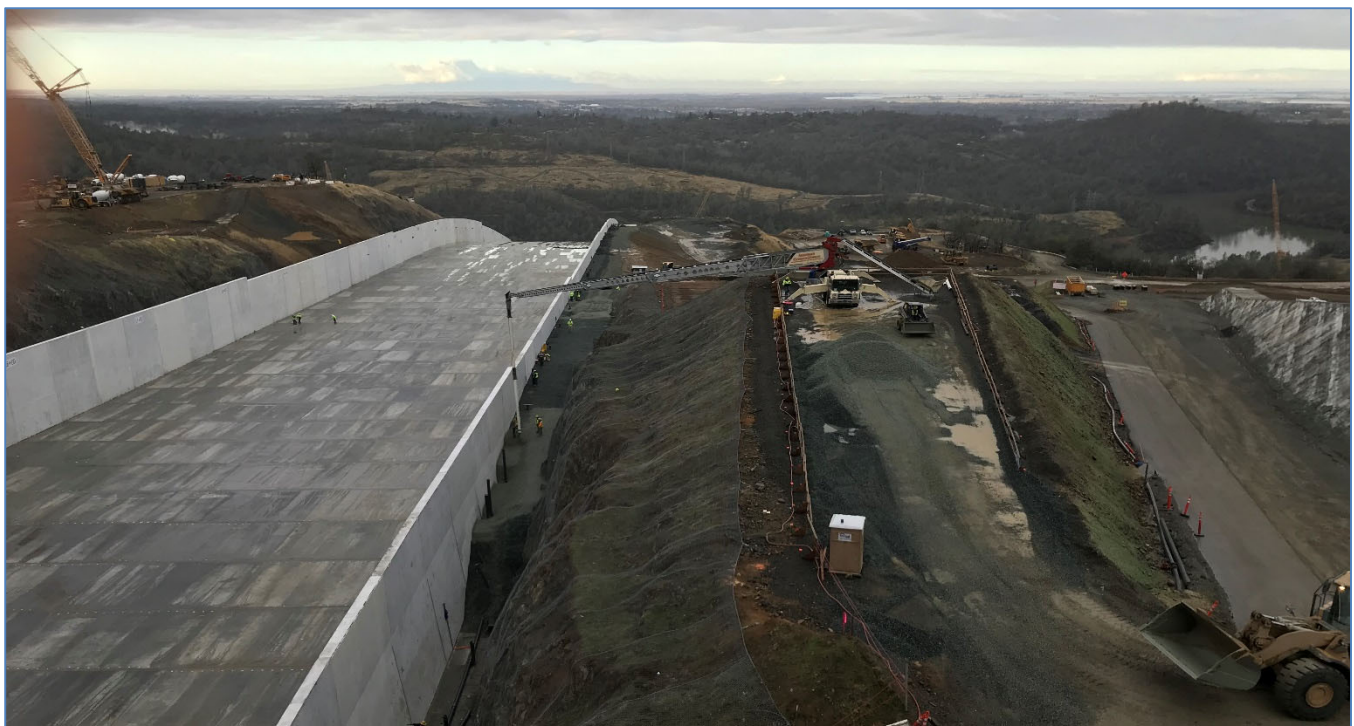
Figure 2. Placement of backfill behind FCO chute walls.

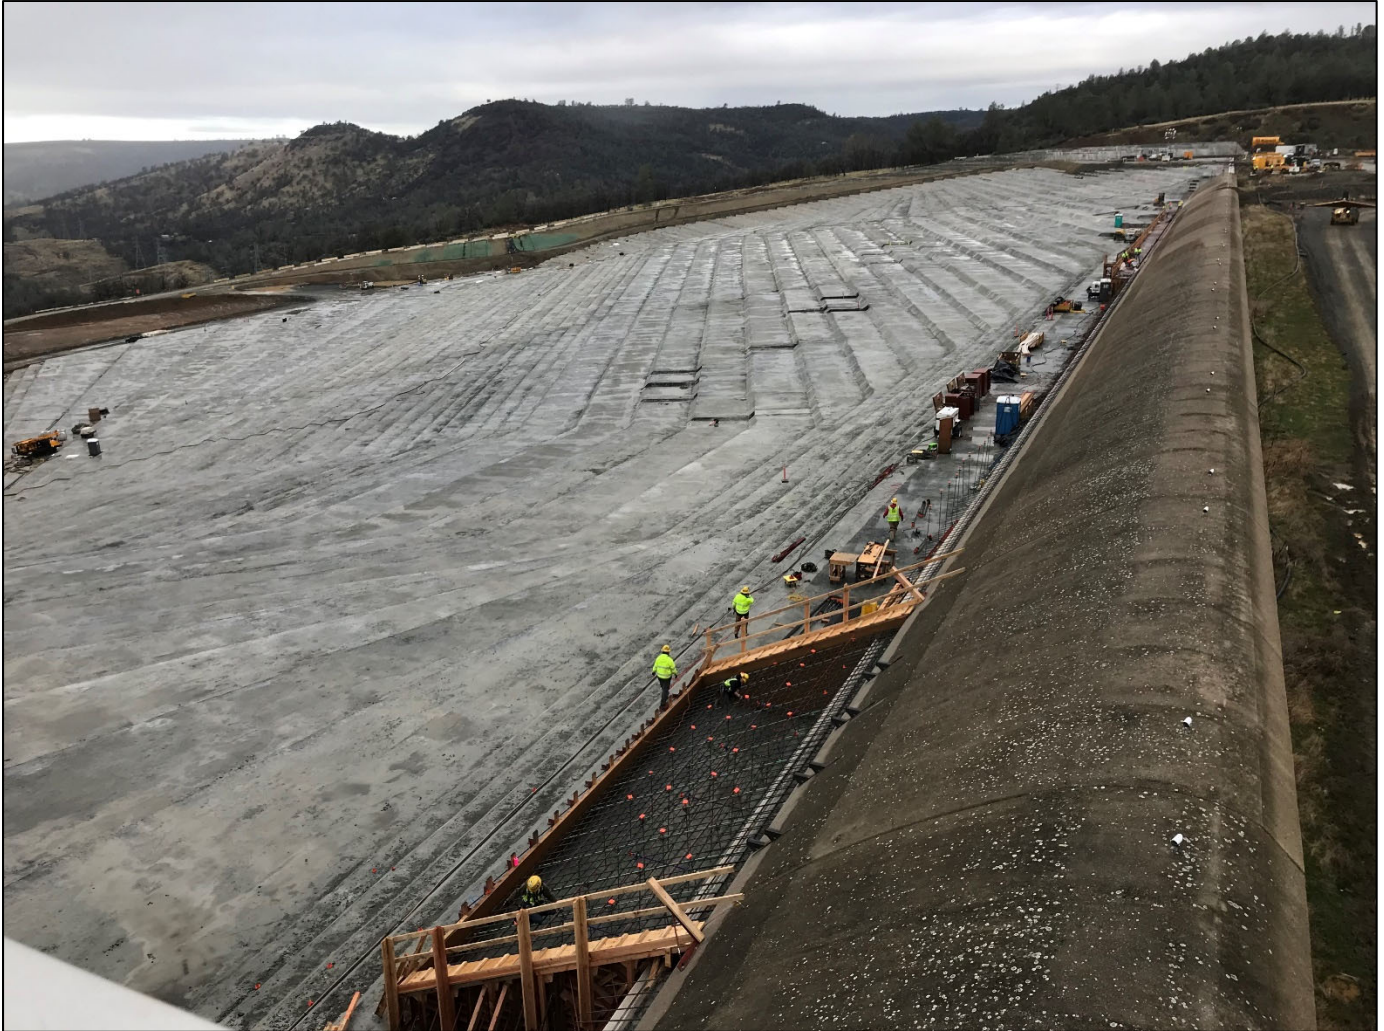
Figure 3. Emergency Spillway RCC Apron and Buttress formwork.

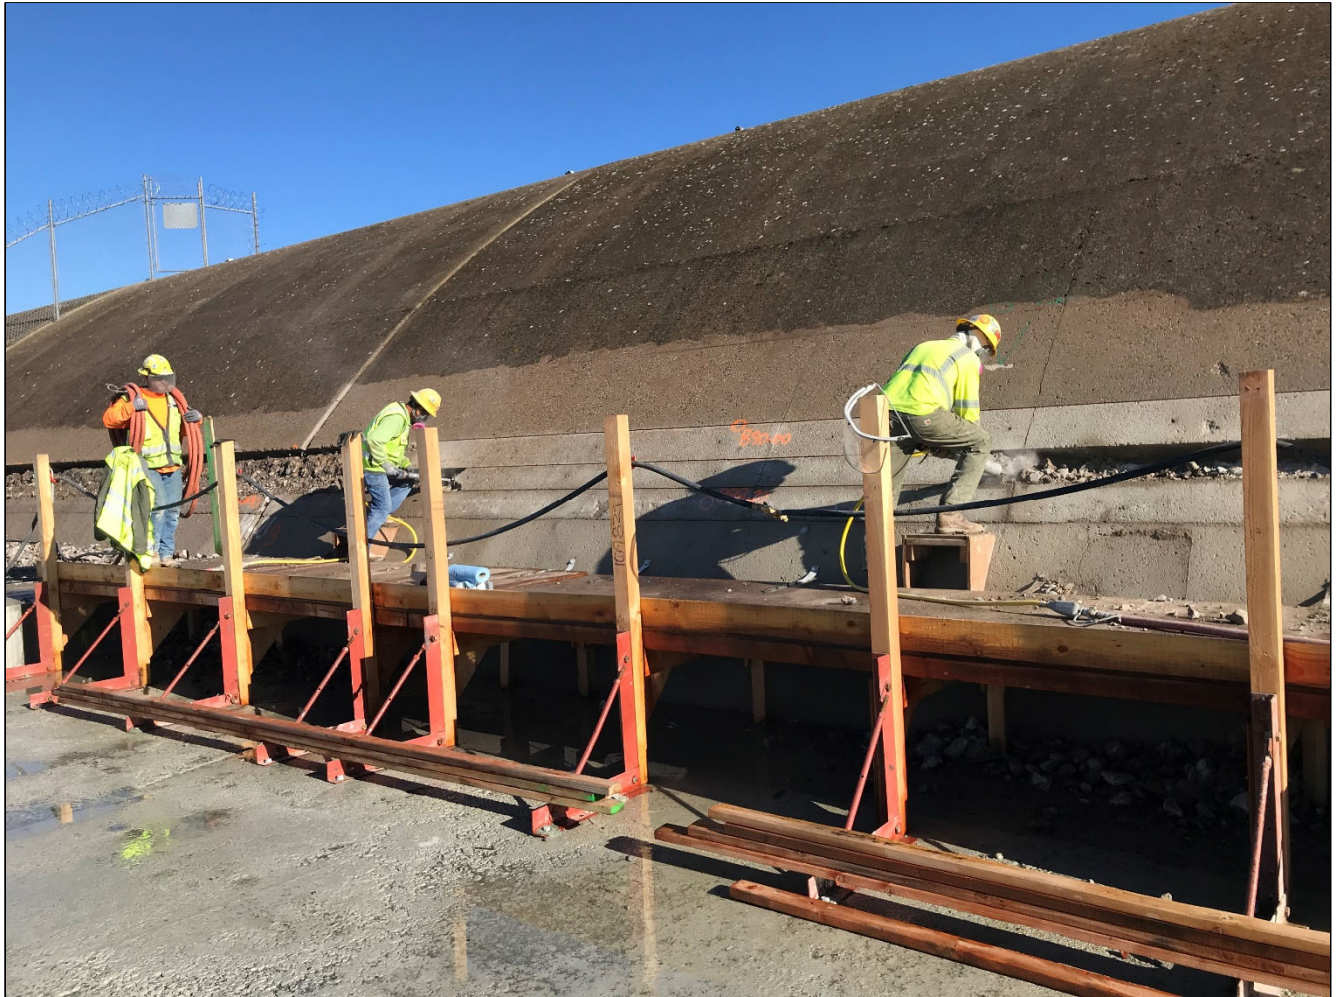
Figure 4. Preparation of the Ogee Emergency Spillway section for placement of Reinforced Concrete Buttress Transition section.
