# **Supplemental Information on Foundation Conditions beneath Central Clayey Core of Oroville Dam**

**Information Requested by Ad Hoc Group  
at Ad Hoc Group Meeting No. 2  
(October 30, 2018)**

**November 14, 2018**

FINAL GEOLOGIC REPORT  
ON  
FOUNDATION CONDITIONS AND GROUTING  
OROVILLE DAM

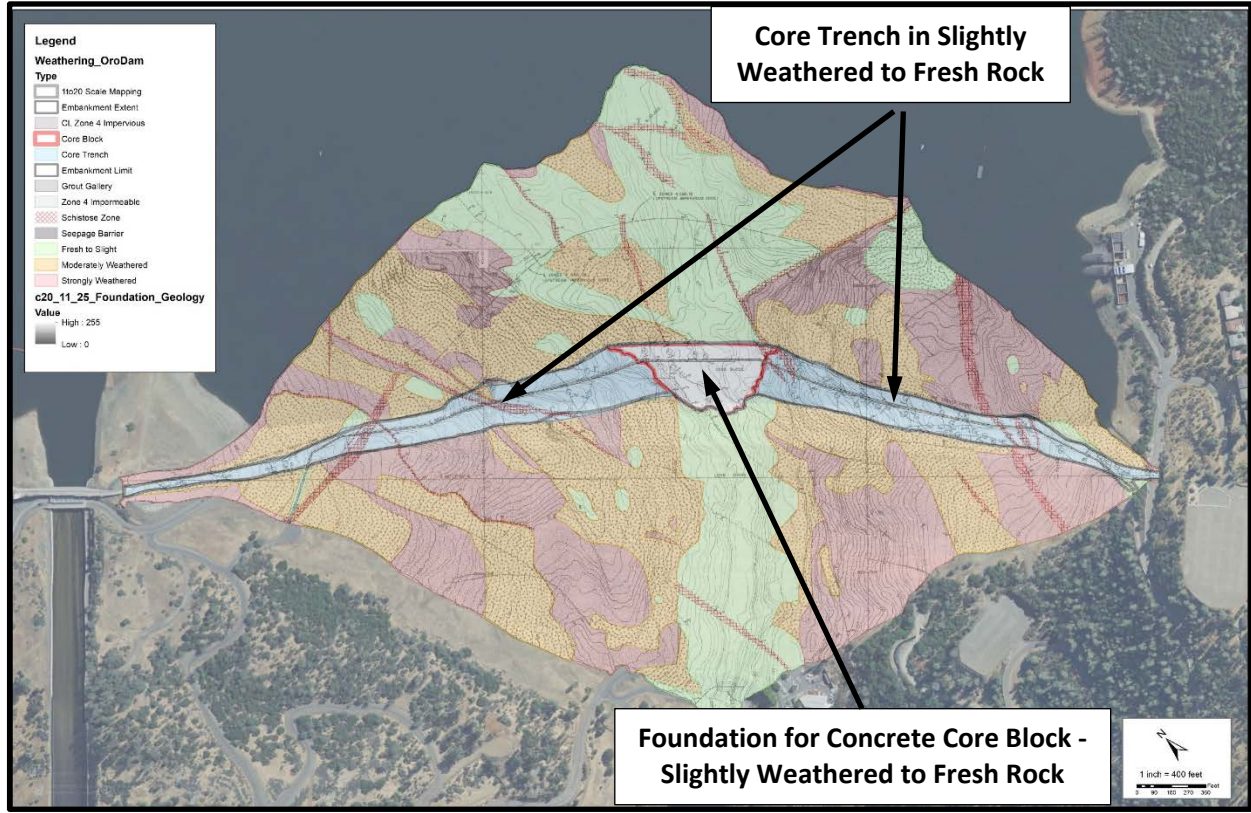
**Figure 1: Foundation Geology Mapped During Construction Overlaid on Aerial Photograph (Adapted from Final Geology Report, Report No. C-34, DWR, 1968)**

- Denotes Strongly Weathered Rock after soil and loose rock removed
- Denotes Moderately Weathered Rock after soil and loose rock removed
- Denotes Slightly Weathered to Fresh Rock after soil and loose rock removed
- Core Block Foundation – Slightly Weathered to Fresh Rock over which the concrete Core Block was placed. Core Block serves as the base footing/foundation for the central clayey Zone 1 core in the lower river channel
- Zone1 Core Foundation – Slightly Weathered to Fresh Rock, grouted with slurry and curtain grouting over which the central clayey Zone 1 core was placed

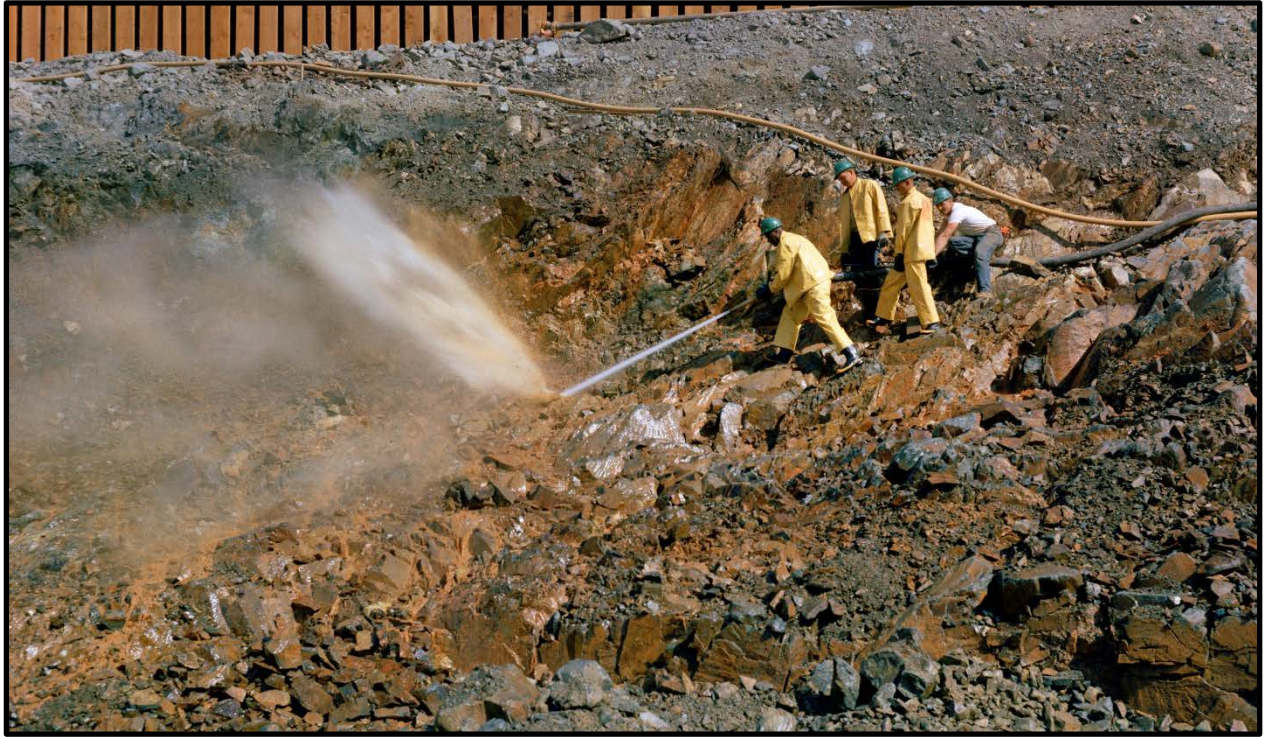
**Figure 2: Photograph of Foundation Clean-up Using High Pressure Water Hose in Central Concrete Core Block/Core Area (Photograph taken April 29, 1963, from DWR Photography Files)**

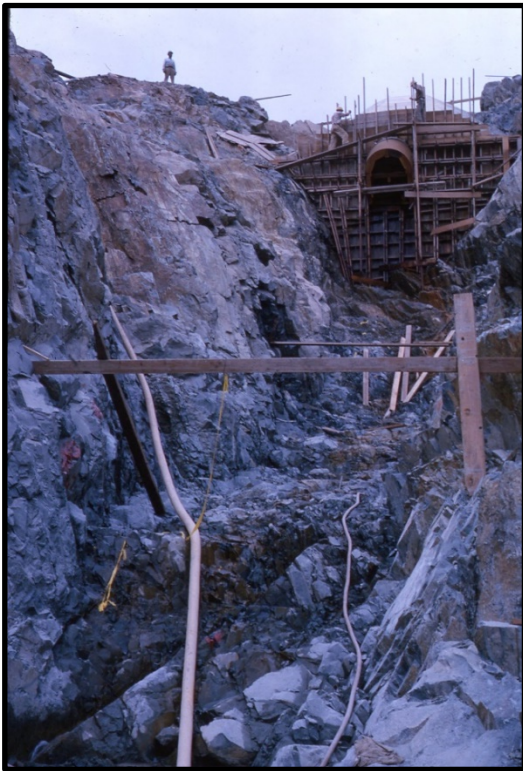
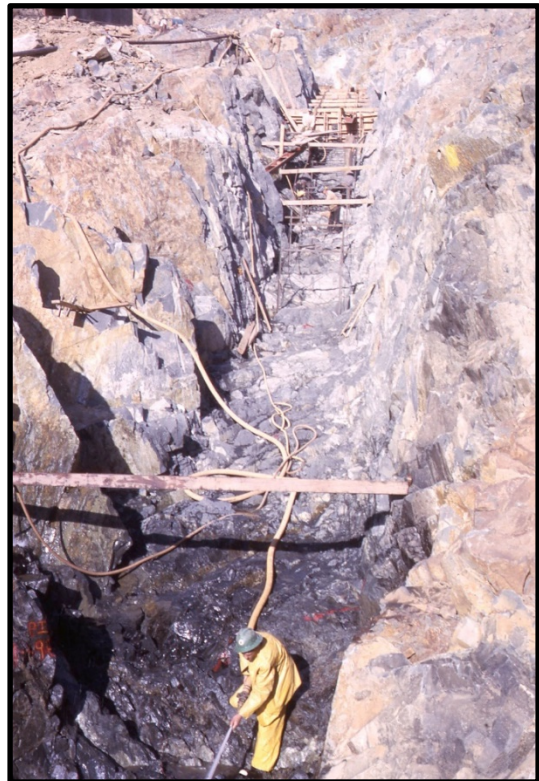
**Figure 3: Photographs of Slightly Weathered Rock Exposed in Excavation of Grout Gallery on Right Abutment of Oroville Dam (from DWR Photography Files)**
