CALIFORNIA DEPARTMENT OF WATER RESOURCES

Assessment of the Vegetation Area on the Face of the Oroville Dam

August 30, 2017

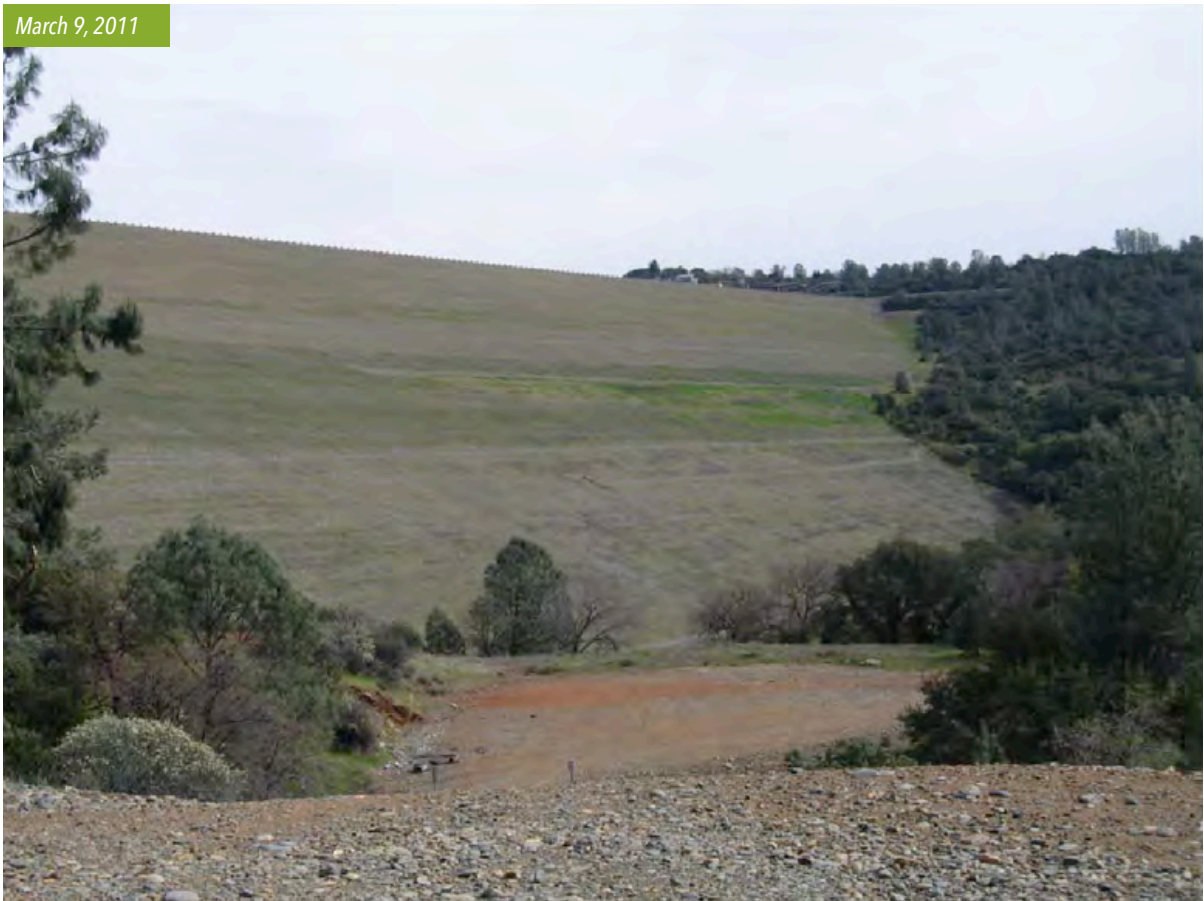
Since the mid-1960s, before original construction was complete, a band of vegetation has grown along the face of Oroville Dam during wet seasons. This band is approximately 100 to 150 feet wide, and generally located between elevation 570 and 670 feet, on the upper midpoint of the dam slope (see Figure 2). The area runs across the entire width of the dam, but is more concentrated on the right, looking upstream toward the reservoir. The vegetation area dries out during the hot summer months, turning yellow or brown during the dry season and becomes less visible. The cycle begins again during the next wet season.

FIGURE 2. View of vegetation on the downstream face of Oroville Dam. (Photograph taken on March 9, 2011, near the end of the rain season)

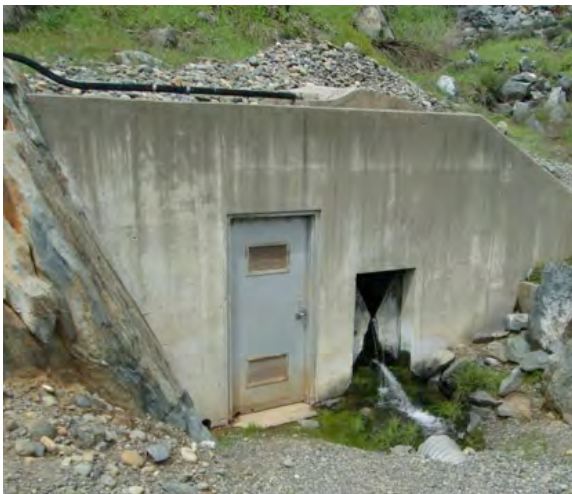
During the dry season, the seepage flow measured at the weir is only about 10 gallons per minute, an extremely low amount of seepage for a dam this size. Even wet season seepage flow measurements, commonly up to 100 gallons per minute, represent consistent seepage flows since construction was completed. By contrast, large zoned embankment dams with smaller heights commonly seep several hundred gallons per minute.

FIGURE 5. View of Seepage Measuring Vault which contains a Measuring Weir, and Interior Low Water Pool Level within Oroville Dam. (Photograph taken on April 22, 2017, when seepage flow was approximately 53 gallons per minute, a relatively low seepage amount.)

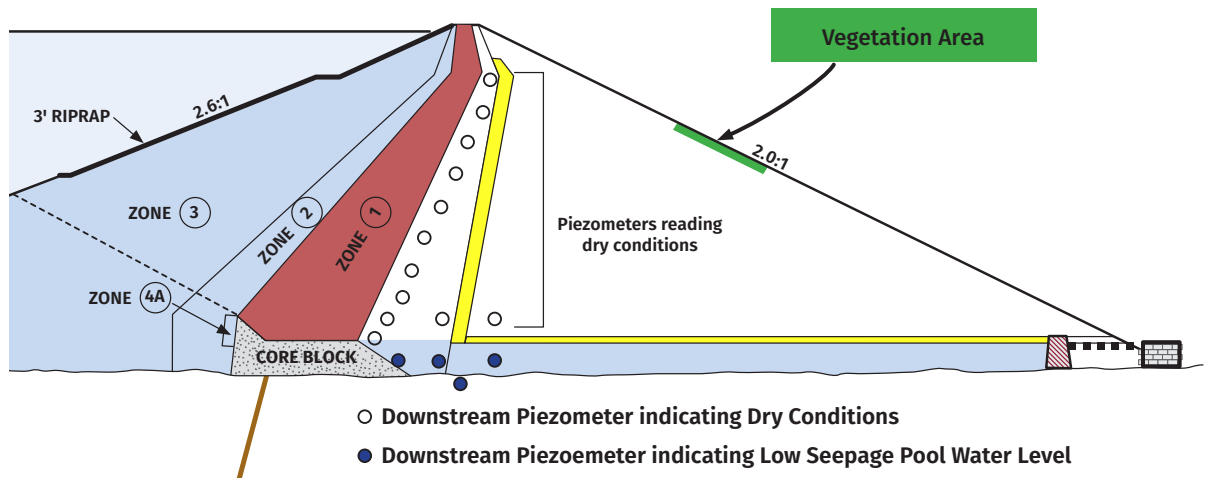
DWR engineers installed 16 piezometers to measure internal water levels downstream of the clayey core, 12 of which were placed above the low internal pool. Between initial filling of the reservoir in 1968 and the mid-1980s, the 12 downstream piezometers above the low seepage pool all showed dry conditions (see Figure 6).

FIGURE 6. Cross Section of Oroville Dam illustrating Water Levels Indicated by Downstream Piezometers between 1968 and mid-1980s.

Four downstream piezometers placed within the low seepage pool indicated water levels comparable to the top of the seepage pool (about elevation 240-245 feet, about 330 feet below the bottom of the vegetation area).

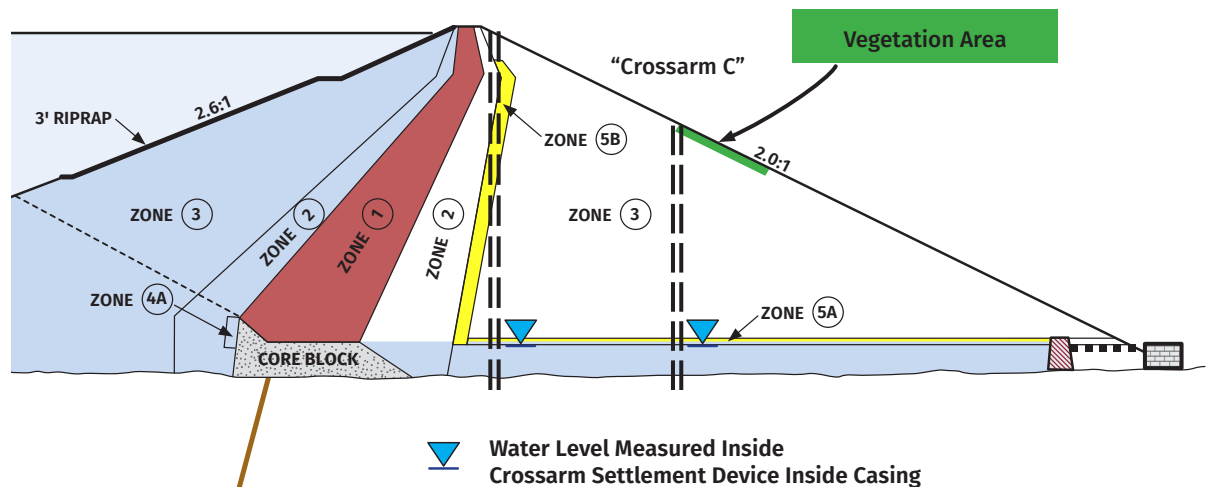
2.2.2. Two cross-arm settlement devices (Cross-arm “A” and Cross-arm “C”) were installed in the downstream slope of the dam. These instruments were installed to measure internal settlements of the downstream portion of the embankment. Water levels could also be measured inside the telescoping casings of these two instruments. Water levels measured in the 1960s and 1970s indicated water levels comparable to the top of the low internal pool (see Figure 7).

FIGURE 7. Cross Section of Oroville Dam illustrating Water Levels Indicated by Downstream Cross-Arm Settlement Devices in 1960s and 1970s.

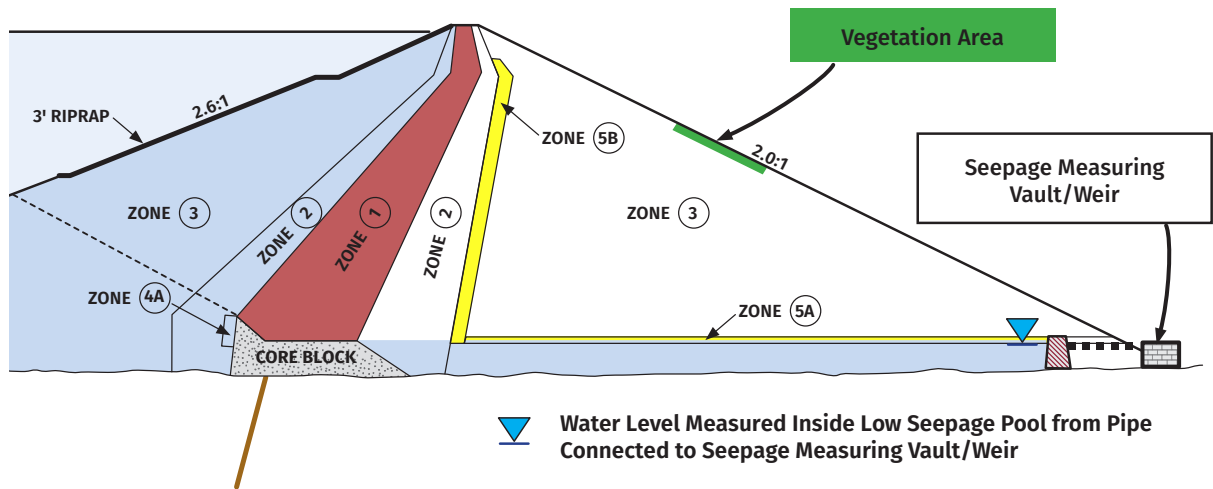
FIGURE 8. Cross Section of Oroville Dam illustrating Water Level Indicated by Downstream Toe Seepage Weir - 1960s to Present.

2.2.3. The pipe connected to the downstream seepage measuring vault/weir measures the water level within the low internal pool in the dam. This level has fluctuated between elevation 237 and 239.5 feet since initial reservoir filling in 1968 (see Figure 8). It continues to function and register a water level in the dam that is approximately 330 feet below the bottom elevation of the vegetation on the face of the dam.

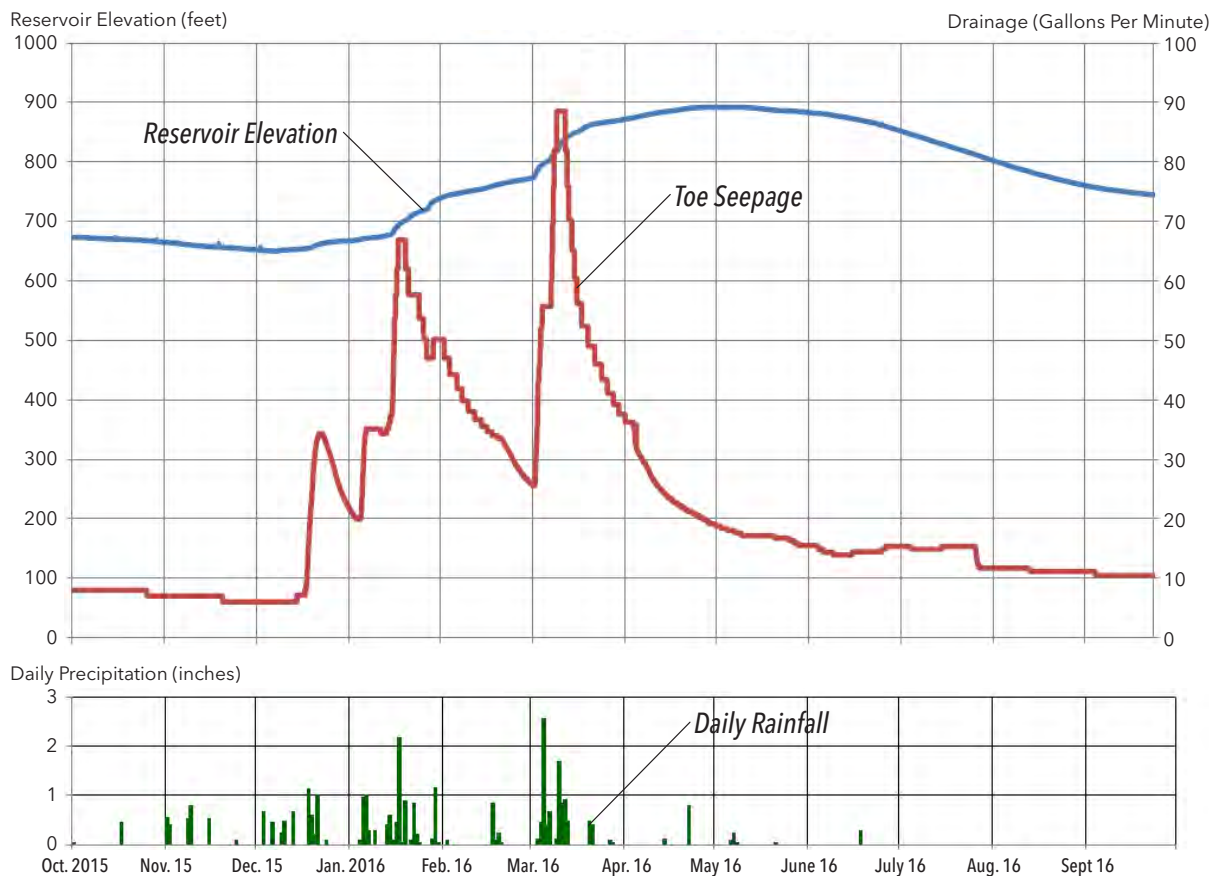
In recent years, DWR has implemented higher frequency automated data collection of the seepage rate. The measured seepage flows continue to be significantly affected by rainfall, but during the dry season weir measurements indicate flows commonly about 10 gallons per minute, and as low as eight gallons per minute (see Figure 9). As stated previously, this is an extremely low level of seepage considering the height of Oroville Dam, but compares very well with the five gallons per minute calculated using the average permeability measured in the clayey core during construction.

FIGURE 9. Water Year 2015-2016 Rainfall and Seepage Measurements made at the Seepage Weir Located at the Base of Oroville Dam.

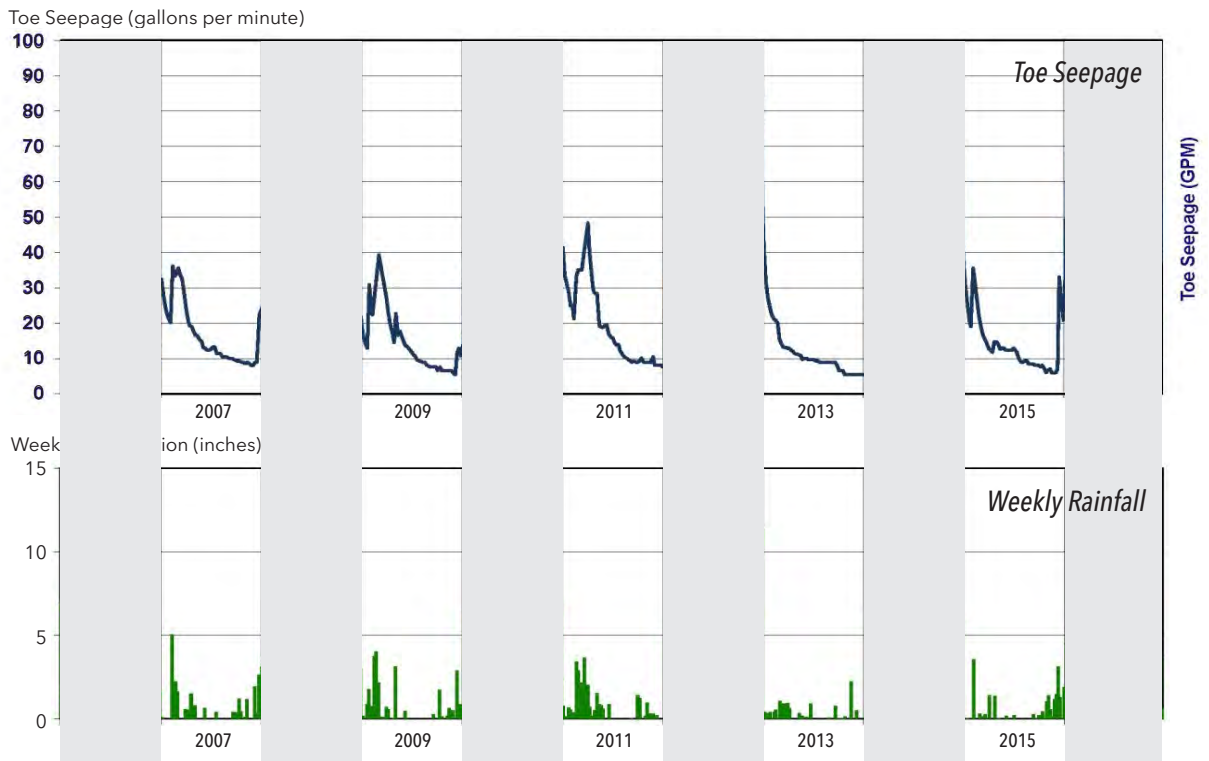
2.3.2. The effects of rainfall on seepage do not immediately end after it stops raining. Both seepage measurements and construction piezometer data show that the effects of precipitation continue for months after rainfall has ended, with gradually reducing seepage and water levels persisting through the summer and fall months (see Figure 10).

The effects of winter and spring rainfall commonly last until October each year as rain water slowly drains out of the dam. The seepage levels then start rising when the rainy season begins. This cycle began in 1966 before the reservoir was filled.

FIGURE 10. 2006-2016 Rainfall and Seepage Measurements made at the Seepage Weir Located at the Base of Oroville Dam.

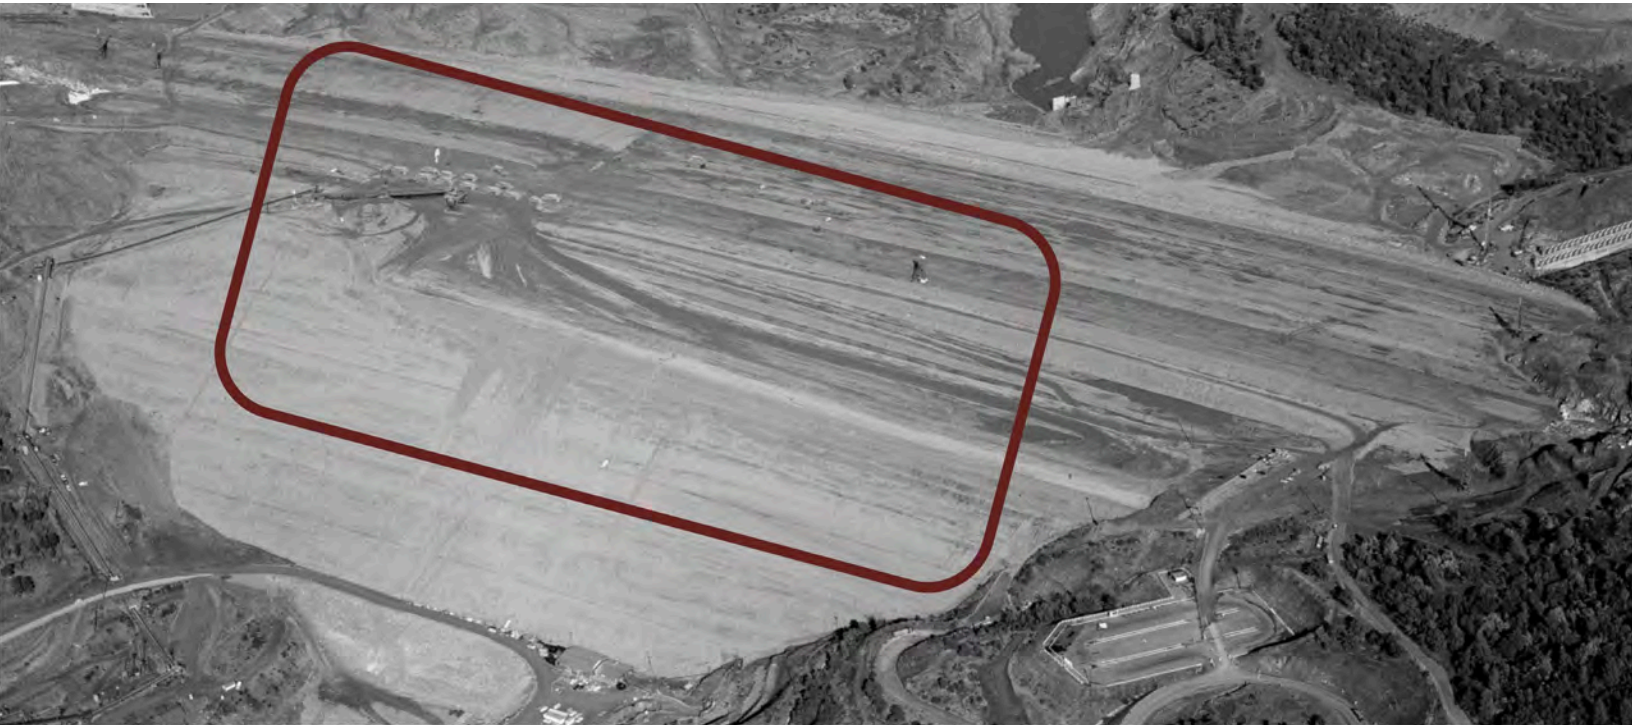
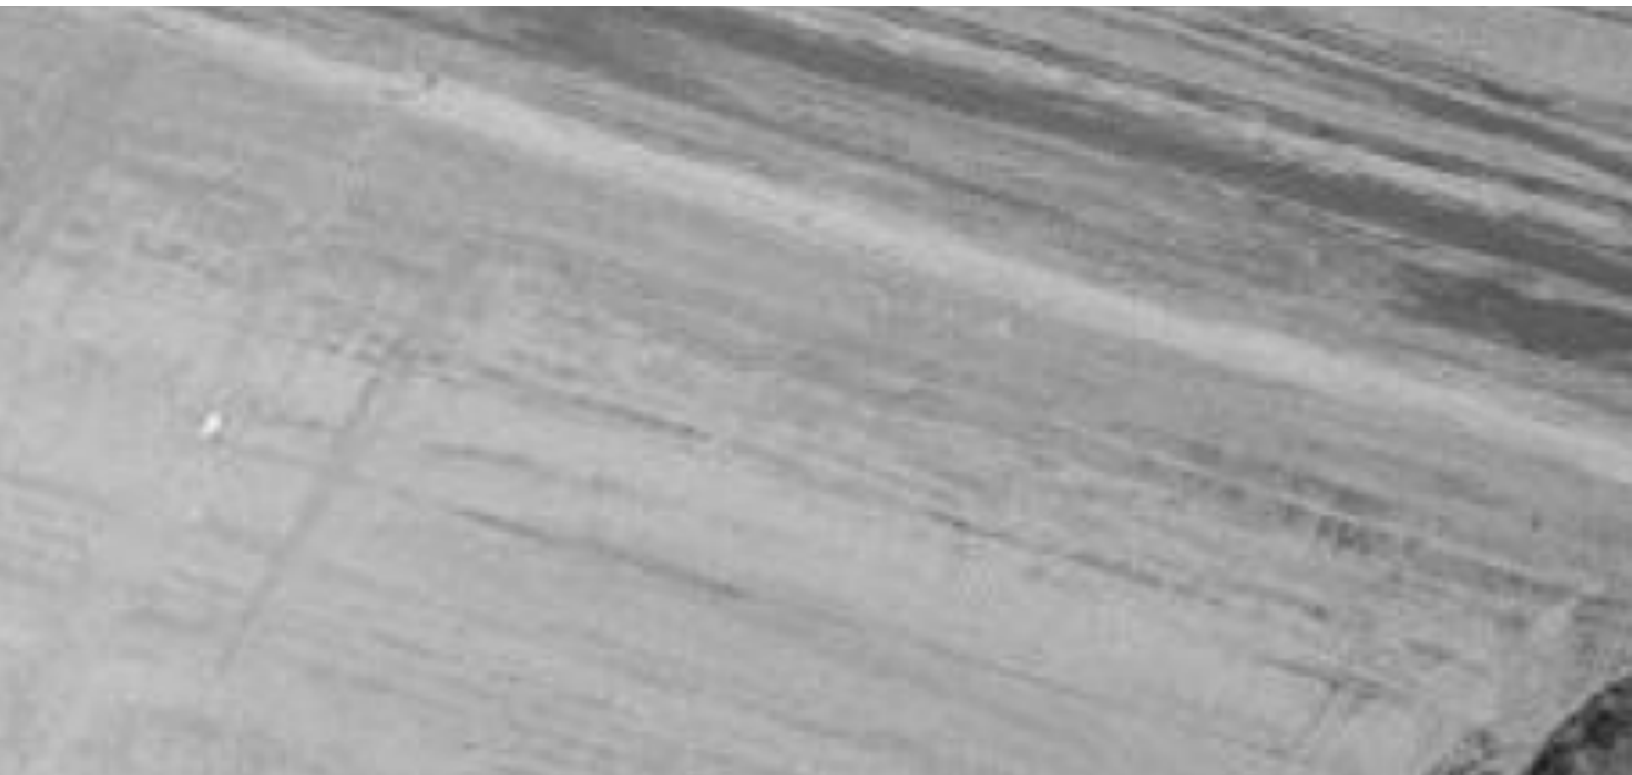
Lines of wet earth in the vegetation area were first observed during dam construction in 1966 and 1967, following rainfall and the formation of erosion rills on the dam surface (see Figures 11 and 12). It has been monitored and observed since that time.

3.1.1. Perched lines of wet areas shown in the construction photographs are from before the reservoir was first filled in 1968.

FIGURE 11. *Lines of wet areas, ponded water, and erosion rills prior to initial filling of the reservoir in future vegetation area.
(Construction photograph taken on November 22, 1966)*

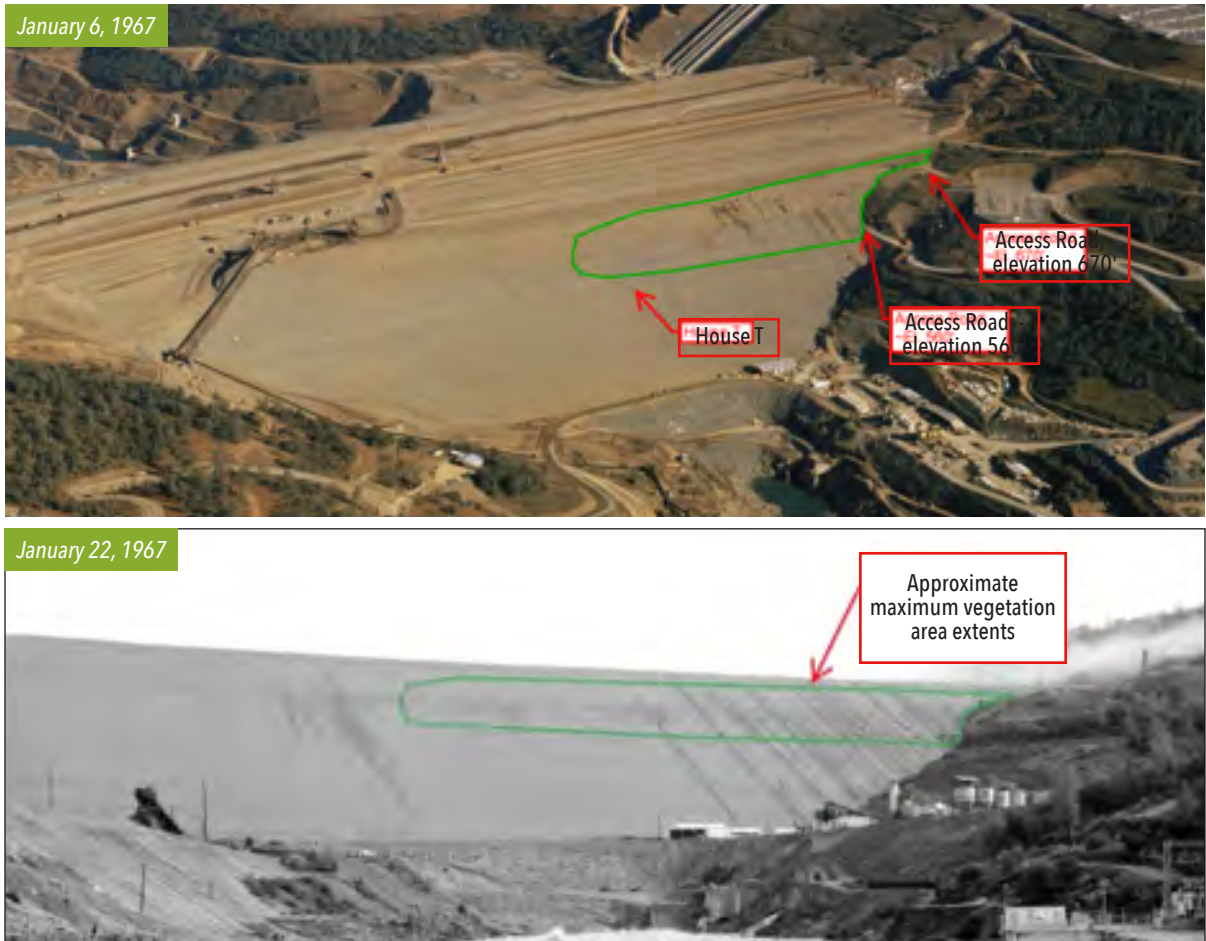
FIGURE 12. Vegetation area showing lines of wet areas and erosion rills prior to initially filling the reservoir.
(Construction photographs taken in January 1967)

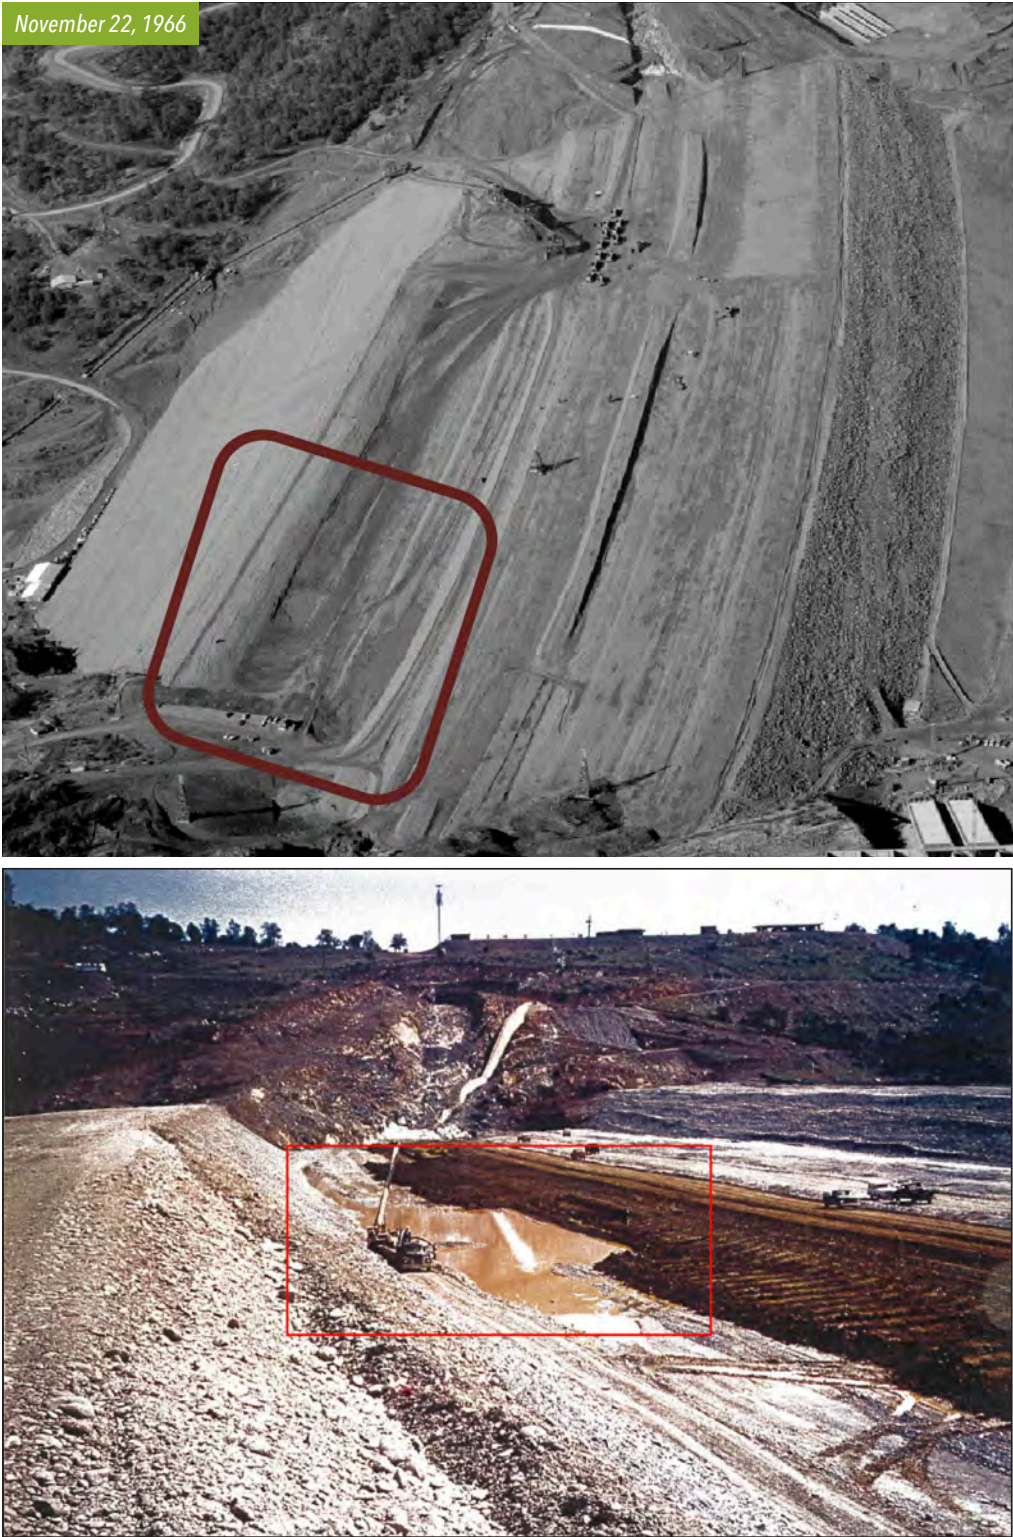
3.1.2. In addition to causing erosion rills or gullies in the downstream slope during construction, rainfall also resulted in the ponding of water on the surface of Zone 3 fill placement within the elevation range of the vegetation area (see Figure 13). Precipitation during construction periods tends to wash sandier and finer material into the ponds, creating layers of less pervious material with a tendency to trap water within the dam.

FIGURE 13. Photographs of Ponded Water on the Construction Surface within the Vegetation Area Elevation Range.

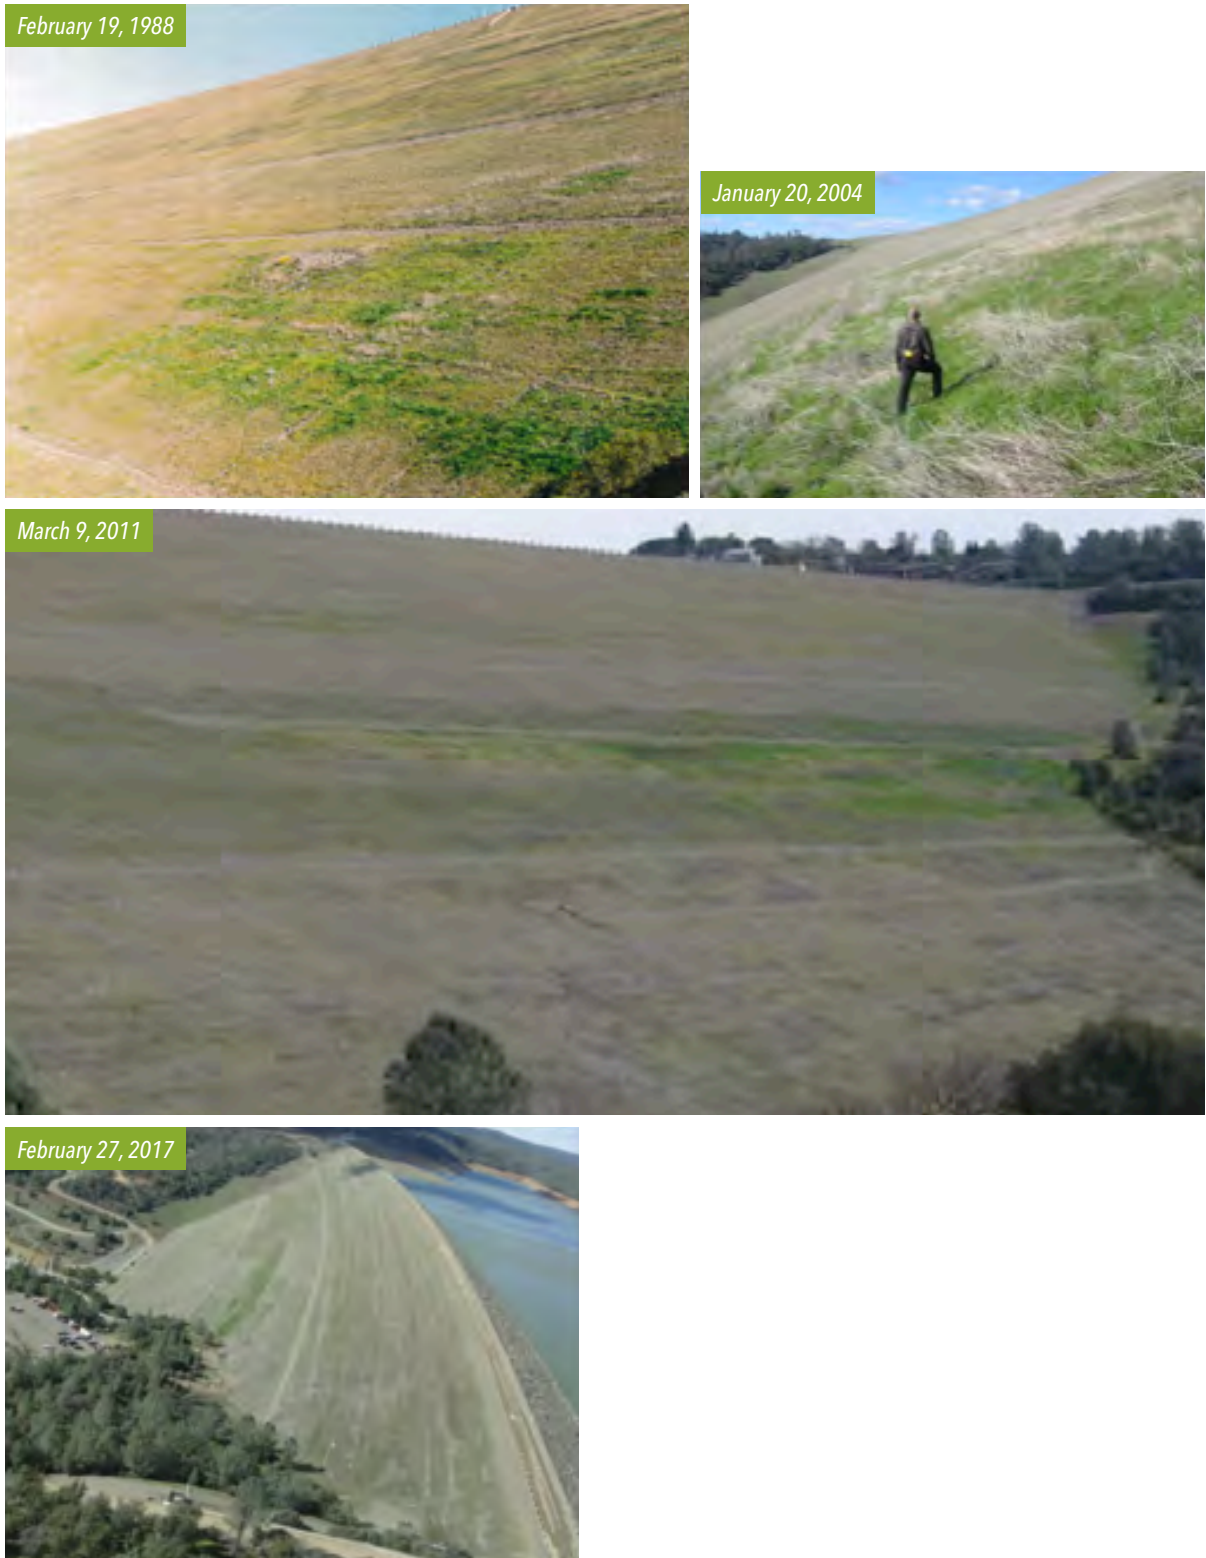
3.1.4. During the wet season of each year, the vegetation area turns green in the same general band across the dam face (see Figure 14).

FIGURE 14. Photographs of the vegetation area taken during the wet seasons over several decades.

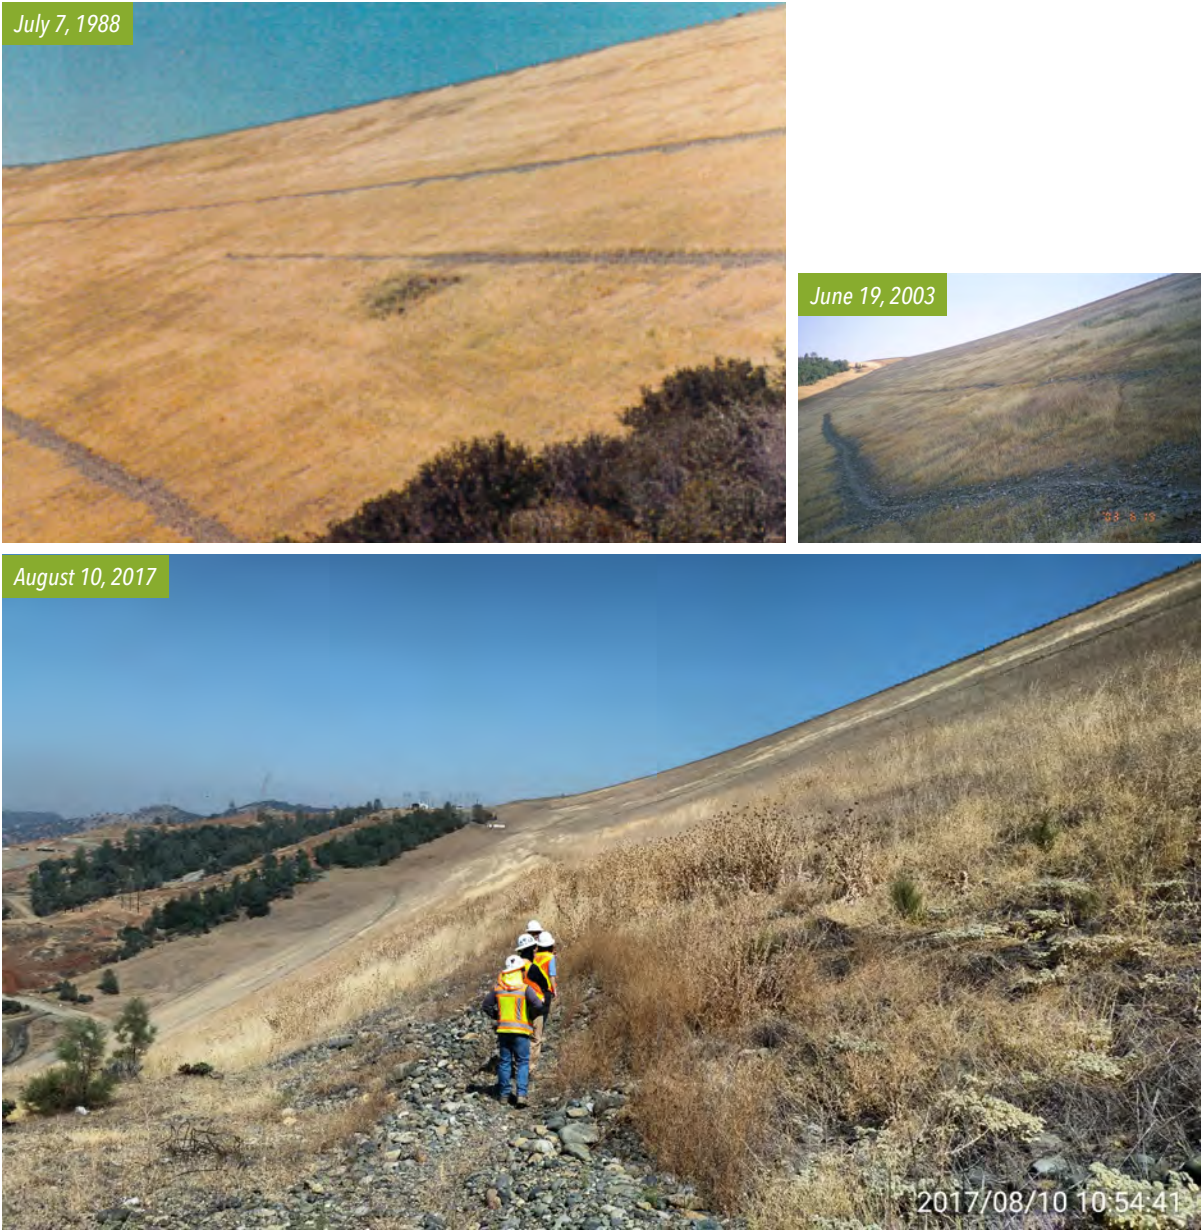
3.1.5. The vegetation area dries out every year, turning yellow and brown during the dry season (see Figure 15).

FIGURE 15. Photographs of the vegetation area taken during summer months.

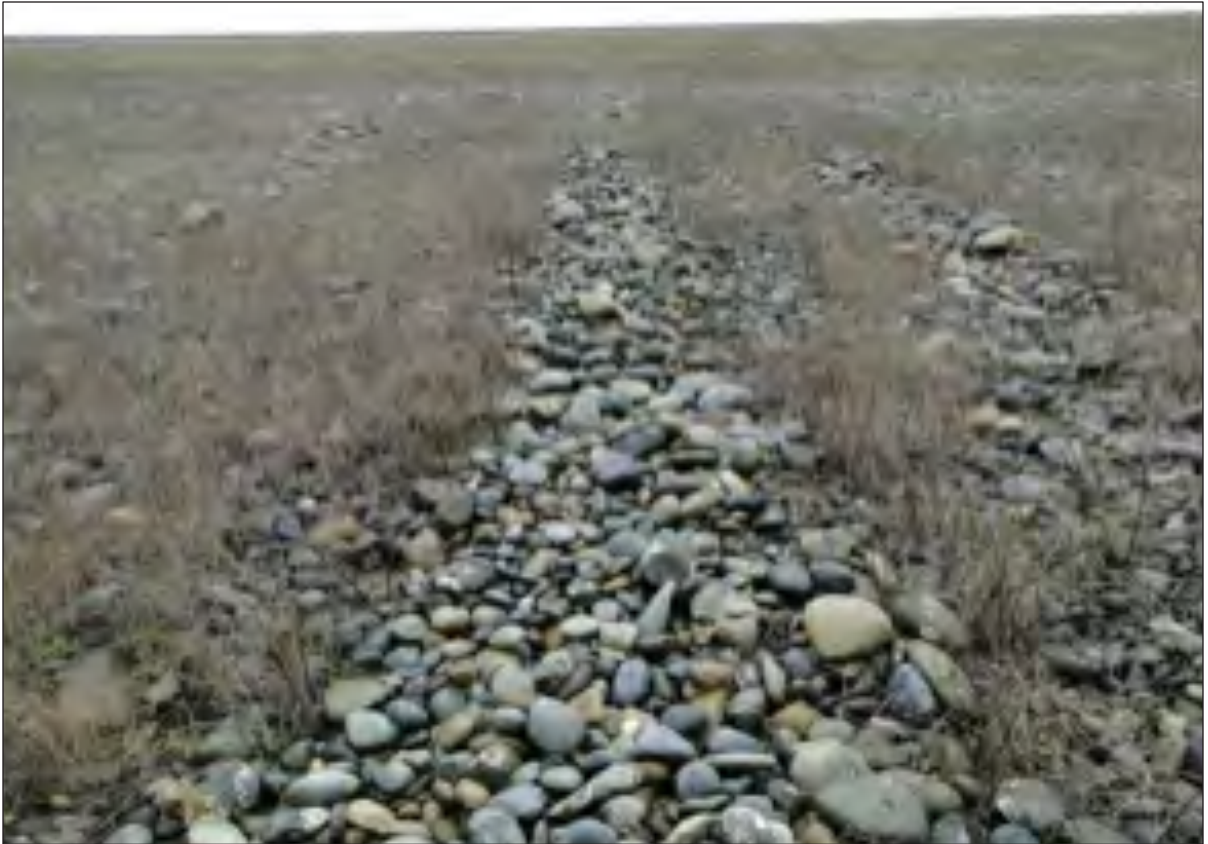
3.1.6. As previously noted, the vegetation area occurs in an area of the dam that developed erosion rills and gullies due to rainfall during the construction of the dam. These erosion rills and gullies were repaired during original construction by filling them in with cobbles, not regular dam fill (see Figure 16). These highly pervious cobble fills encourage the percolation of rain water into the dam face in the region of the vegetation that grows on the face of the dam, rather than running down the slope.

FIGURE 16. Eroded rills or gullies in the vegetation area that were filled with cobbles. This encourages rain water percolation into the fill instead of running down the slope. (Photographs taken January 20, 2017)

- Vegetation grows on an area of the dam that developed erosion rills and gullies due to rainfall during original dam construction. These erosion rills and gullies were repaired by filling them in with cobbles, not regular dam fill. These highly pervious cobble fills encourage the percolation of rain water into the dam face, rather than rainfall running down the slope.

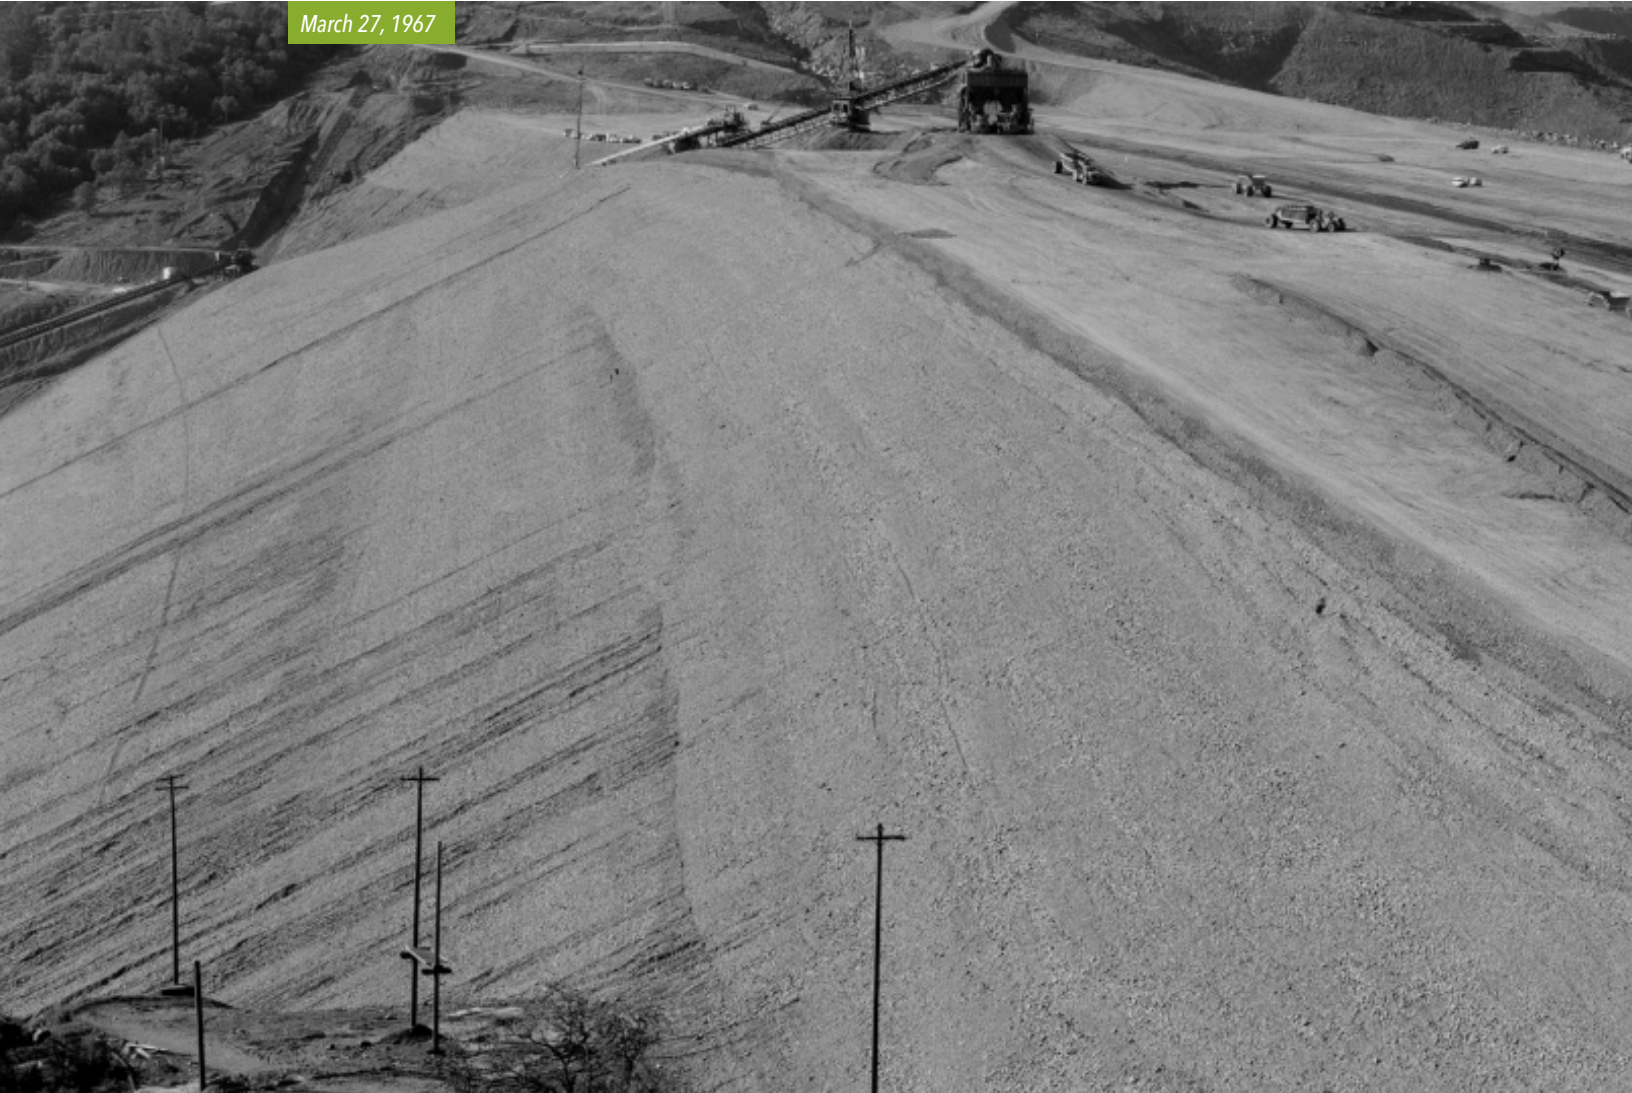
March 27, 1967 photo of Oroville Dam before the dam was completed and the reservoir was first filled.

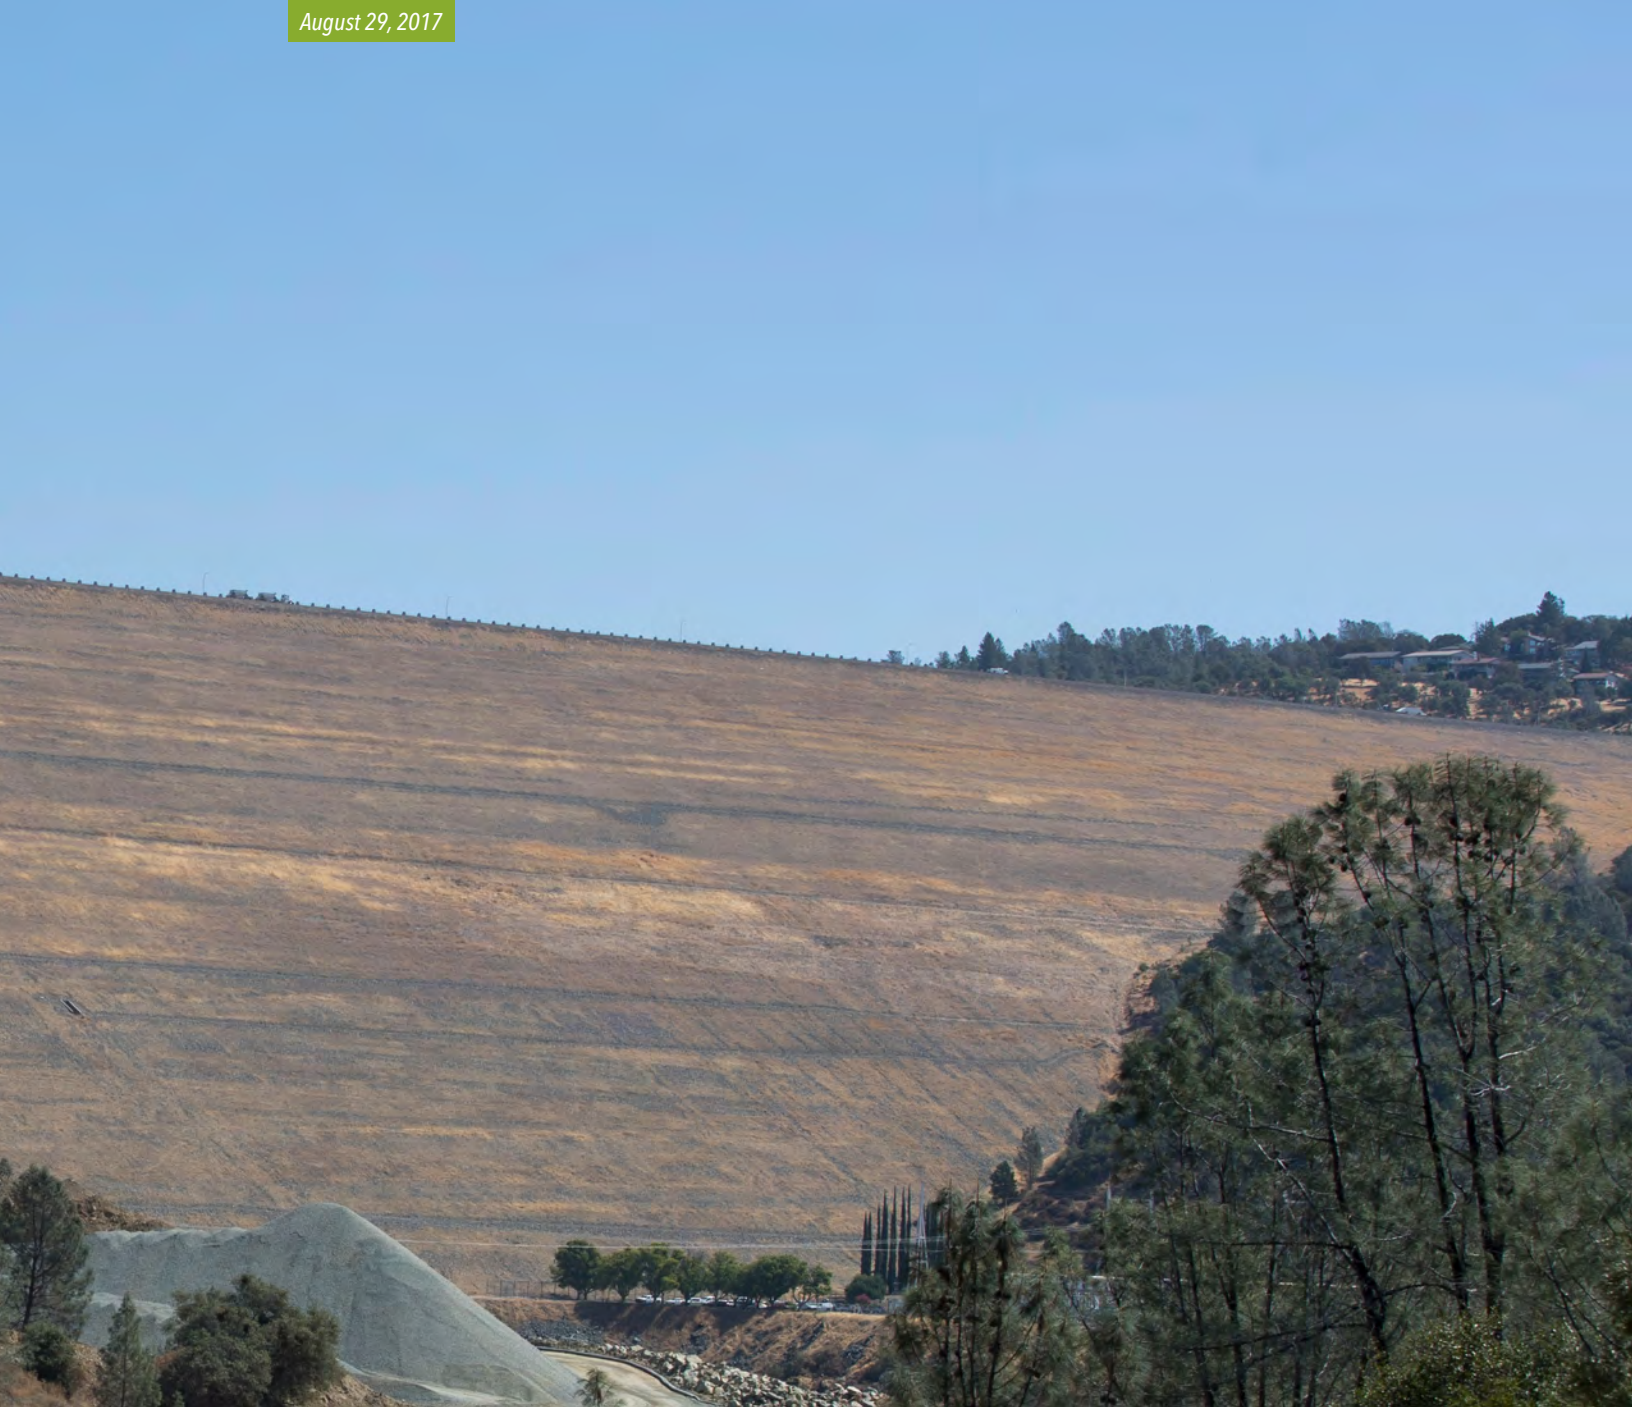
August 29, 2017

Oroville Dam, showing vegetation area, in Butte County, California. (Photo taken August 29, 2017)
