## Lake Oroville Spillways Emergency Recovery

# Board of Consultants Memorandum No. 14 – December 1, 2017

SUBJECT: Memorandum No. 14

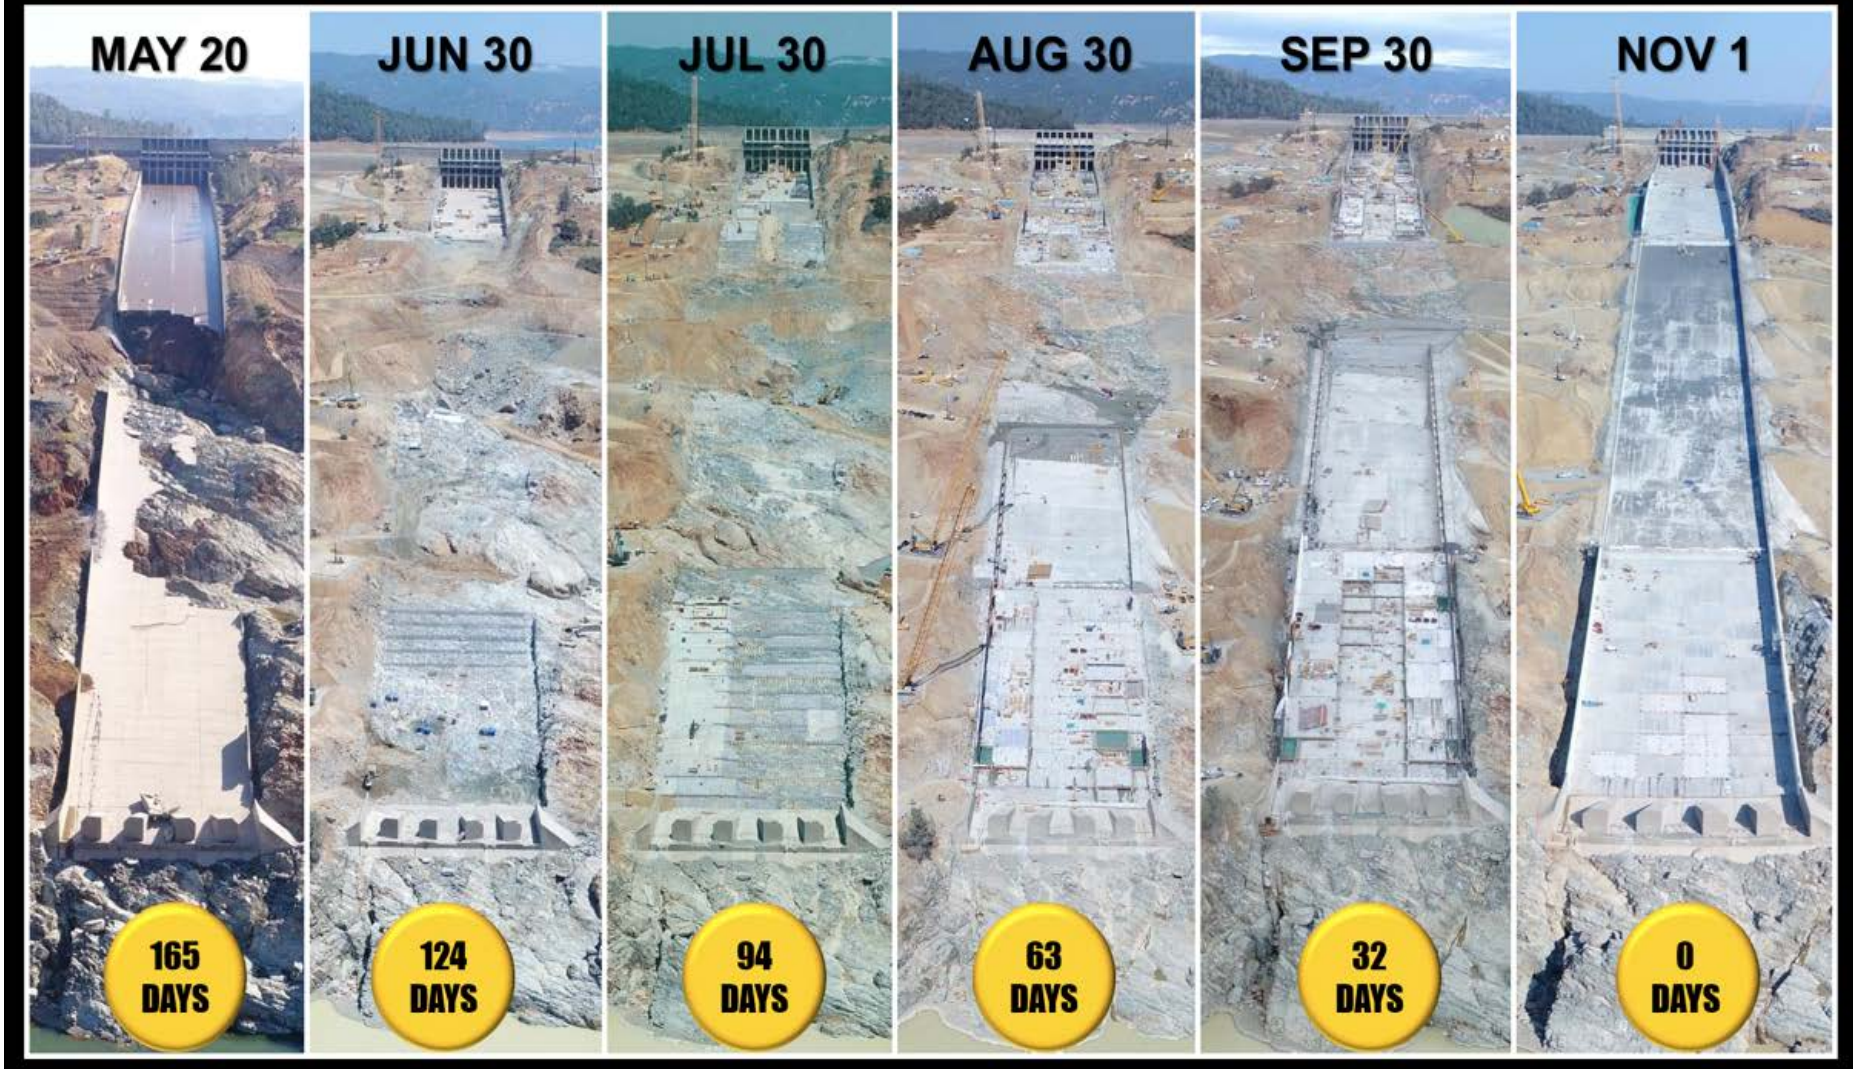
The BOC congratulates the Design Team, the Contractor, and the regulatory agencies for expediting the project and completing the required construction work by the November 1, 2017 deadline. The completed work is of high quality and the FCO with its interim features is ready for service during the 2017-2018 wet season, if needed. Photographs showing construction progress of the reconstructed FCO spillway are shown in Figure 1.
