# OROVILLE EMERGENCY RECOVERY – SPILLWAYS

## Board of Consultants Memorandum

DATE: March 29, 2018

SUBJECT: Memorandum No. 16

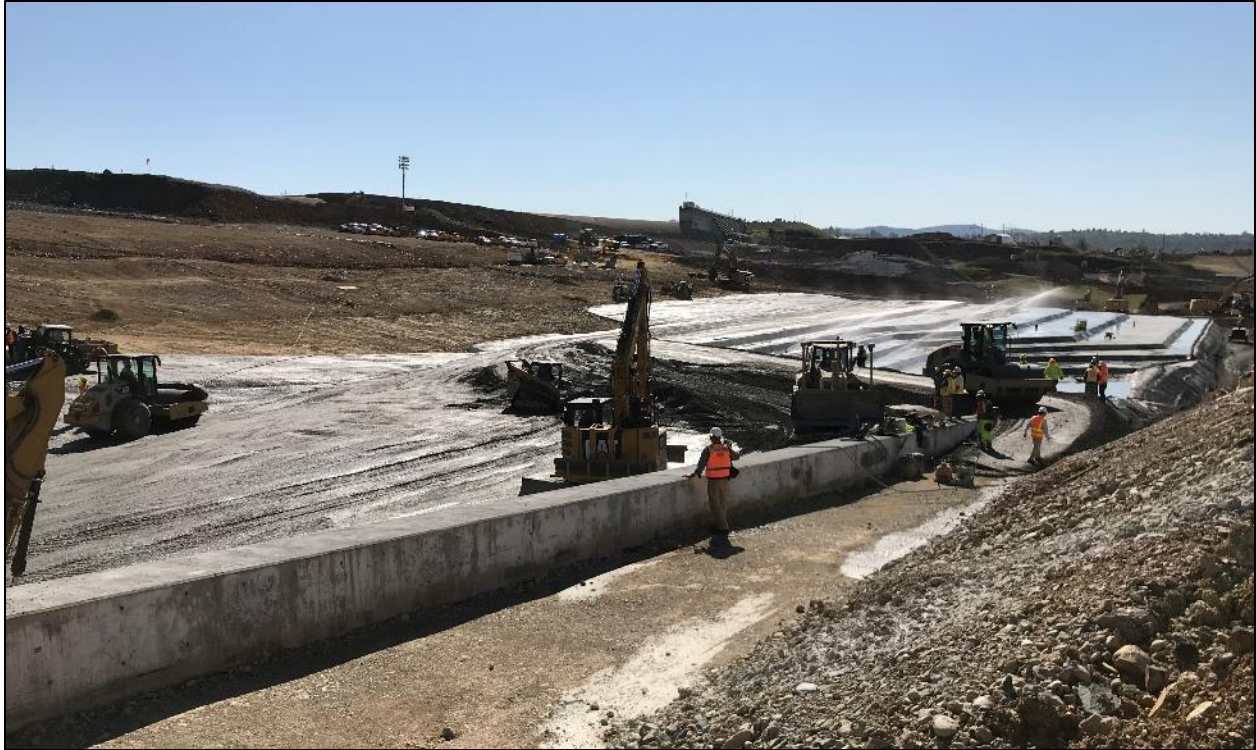
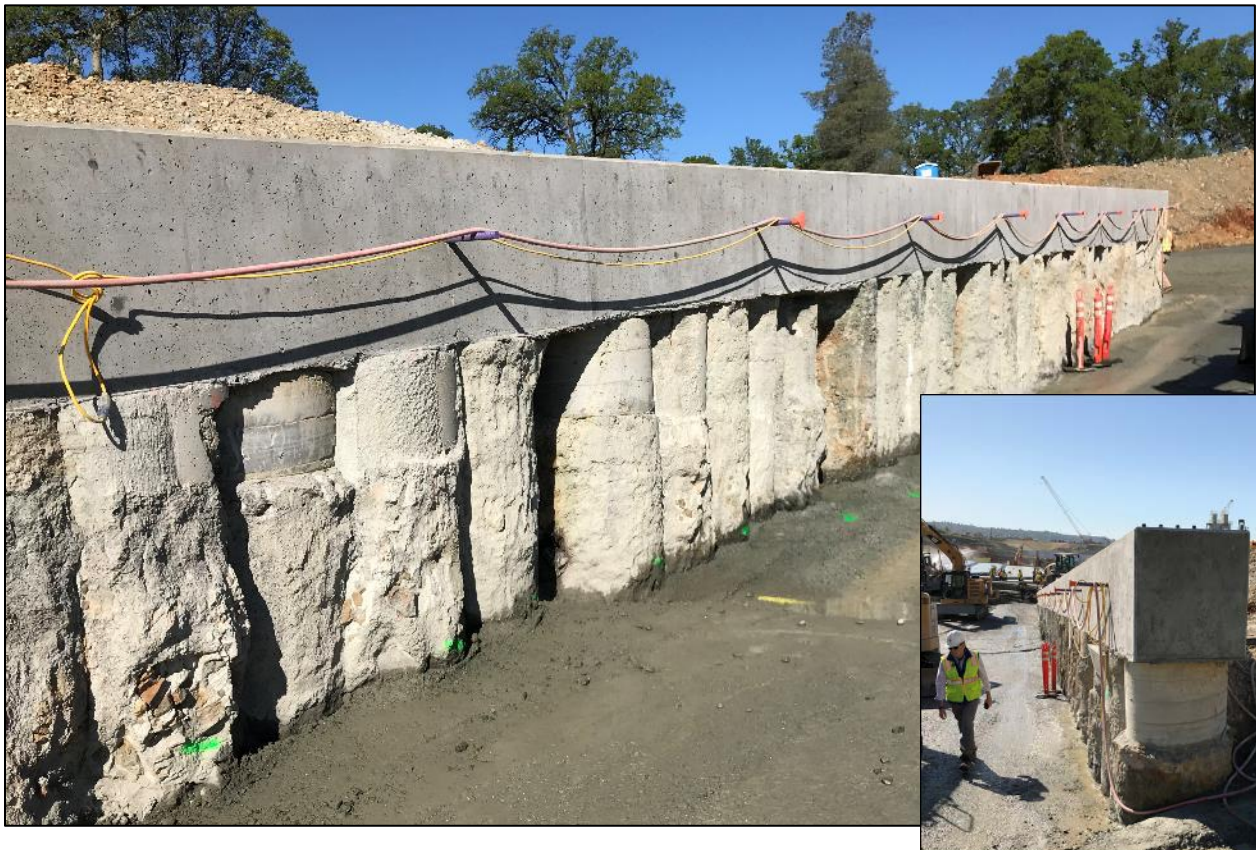
The BOC is pleased to see the construction progress being made at the Emergency Spillway. Construction of the cutoff wall and secant pile wall have been completed. Placement of the RCC apron which commenced February 28, 2018 is progressing well. RCC placement began at the low point in the Secant Pile Wall (Station 15+50 to Station 16+00) and is progressing uphill and outward. Foundation preparation continues in an uphill direction. Upon acceptance, the foundation is immediately covered with a lift of RCC. The contractor is on track to complete the RCC apron in mid-August. Photographs of RCC construction work observed by the BOC are presented on Figure 1.

The BOC concurs with the decision to use sloped RCC steps (1H:1V) instead of vertical RCC steps. The RCC is placed in one-foot-thick lifts (two consecutive lifts per step) and compacted with a vibratory plate compactor attached to an excavator. The BOC understands that the specified compaction is being achieved.

Figure 1. Photographs Showing RCC Apron (Top) and Secant Pile Wall (Bottom)

The BOC concurs that the filtered drain detail under the RCC apron that penetrates the secant pile wall is adequate to transmit seepage that could accumulate. The BOC recommends frequent monitoring of flow out of the drain pipe to help assess ground water conditions beneath the apron, and the effectiveness of the vertical drilled drains to be installed through the RCC section.

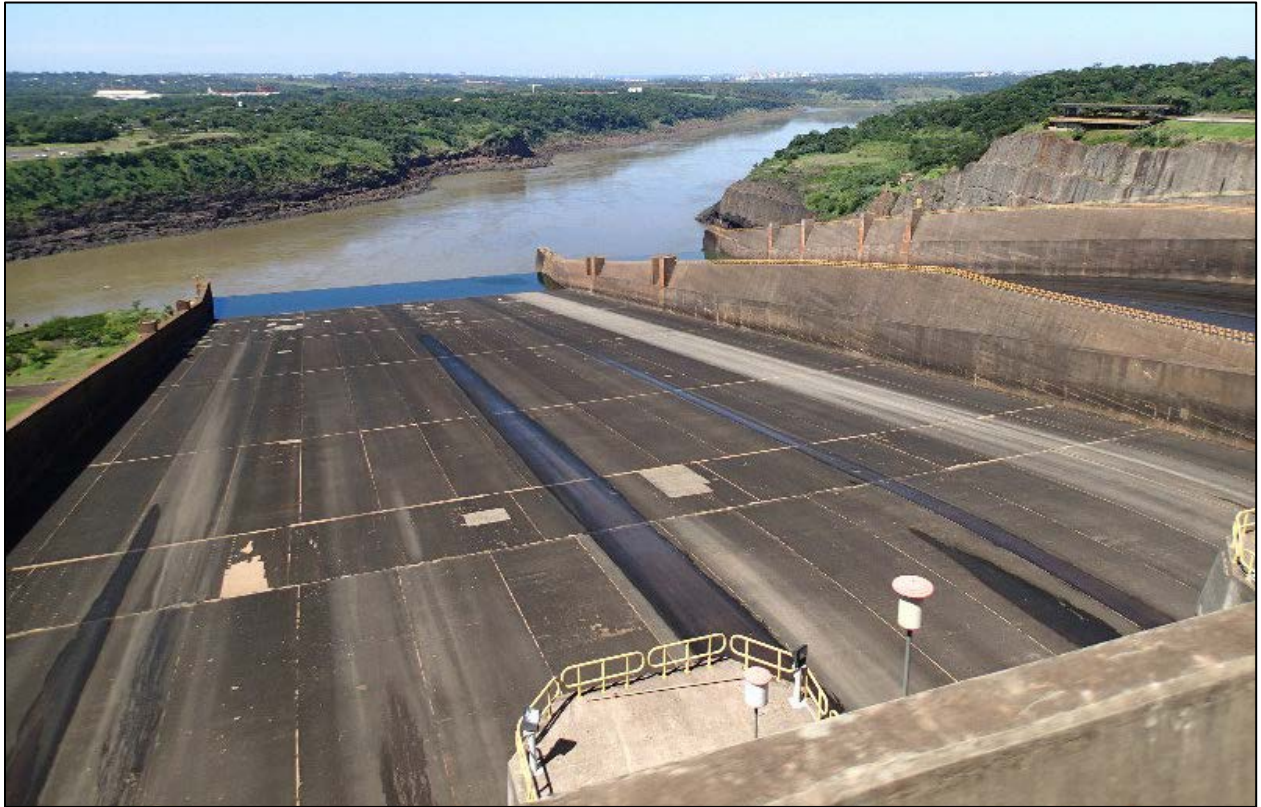
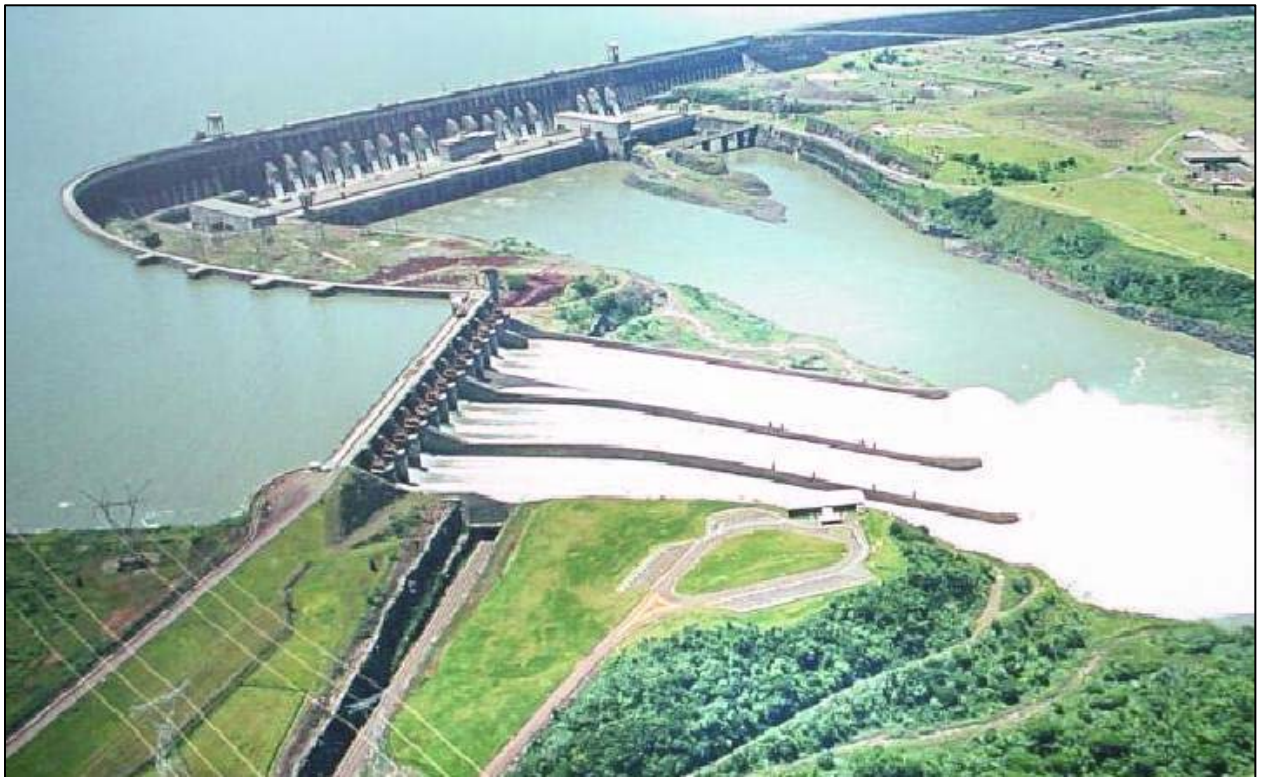
The plan to defer the decision on adding aeration provisions until the performance of the FCO Spillway demonstrates that this would be necessary is, in the opinion of the BOC, validated by the experience at the very large Itaipu hydroelectric project in Brazil. This 643-foot-high dam constructed in 1982 uses a steep chute spillway which was constructed with air inlet chimneys. Construction of the air slots in the chute were intentionally omitted. It was decided during the design phase to rely on a high-quality surface finish of the concrete chute and only complete the aeration provisions in the chute if operational experience demonstrated this would be necessary. The spillway has undergone 36 years of operation passing four discharge events greater than 600,000 cfs. The chute operated continuously for the first 8 years of operation. There have been no problems with significant cavitation damage. It is reported that a few concrete patching repairs in the chute had popped out and had produced a very limited amount of damage immediately downstream of an offset to the flow at the end of the chute upstream of the flip bucket. Photographs of the Itaipu spillway are presented in Figure 2.

Figure2. Photographs of Itaipu Spillway (Source Wikipedia)
