# OROVILLE EMERGENCY RECOVERY – SPILLWAYS

## Board of Consultants Memorandum

DATE: July 17, 2018

SUBJECT: Memorandum No. 19

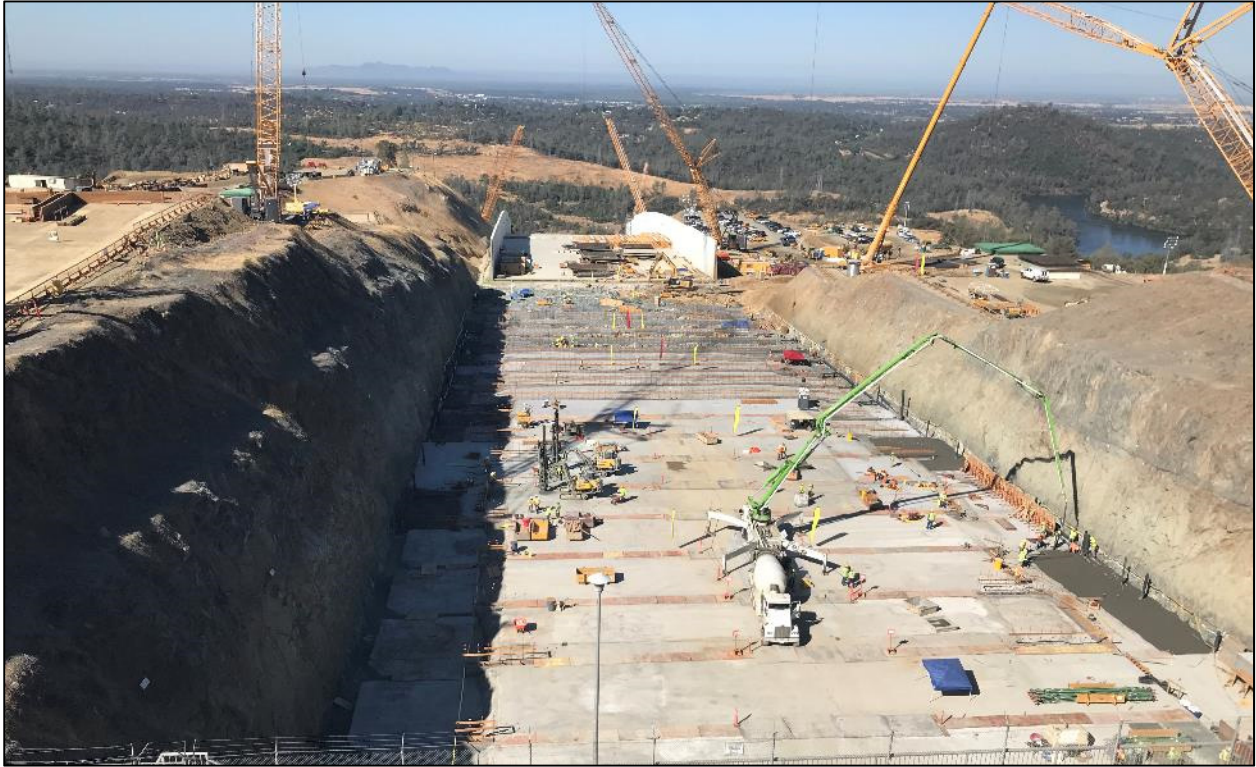
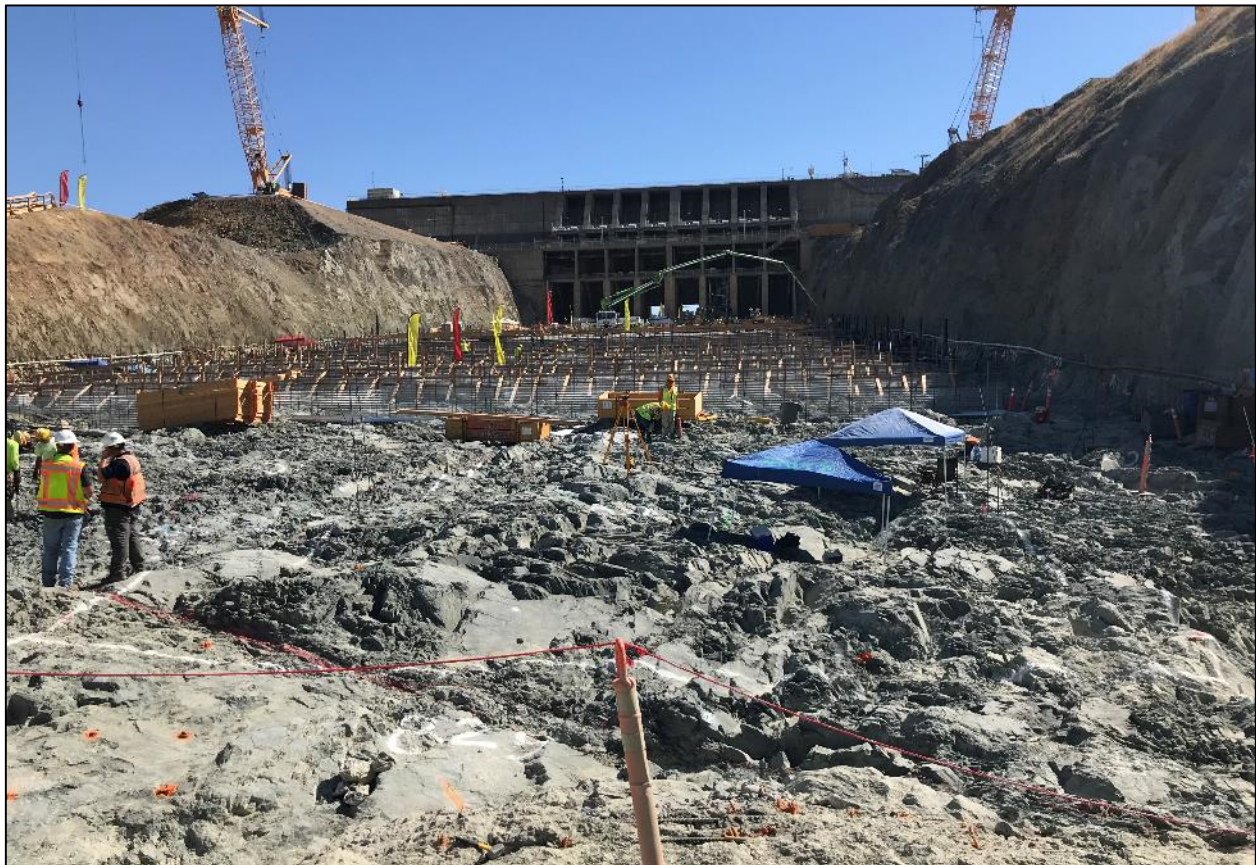
**Figure 1. Photos of the foundation preparation at the upper section of the FCO chute.**

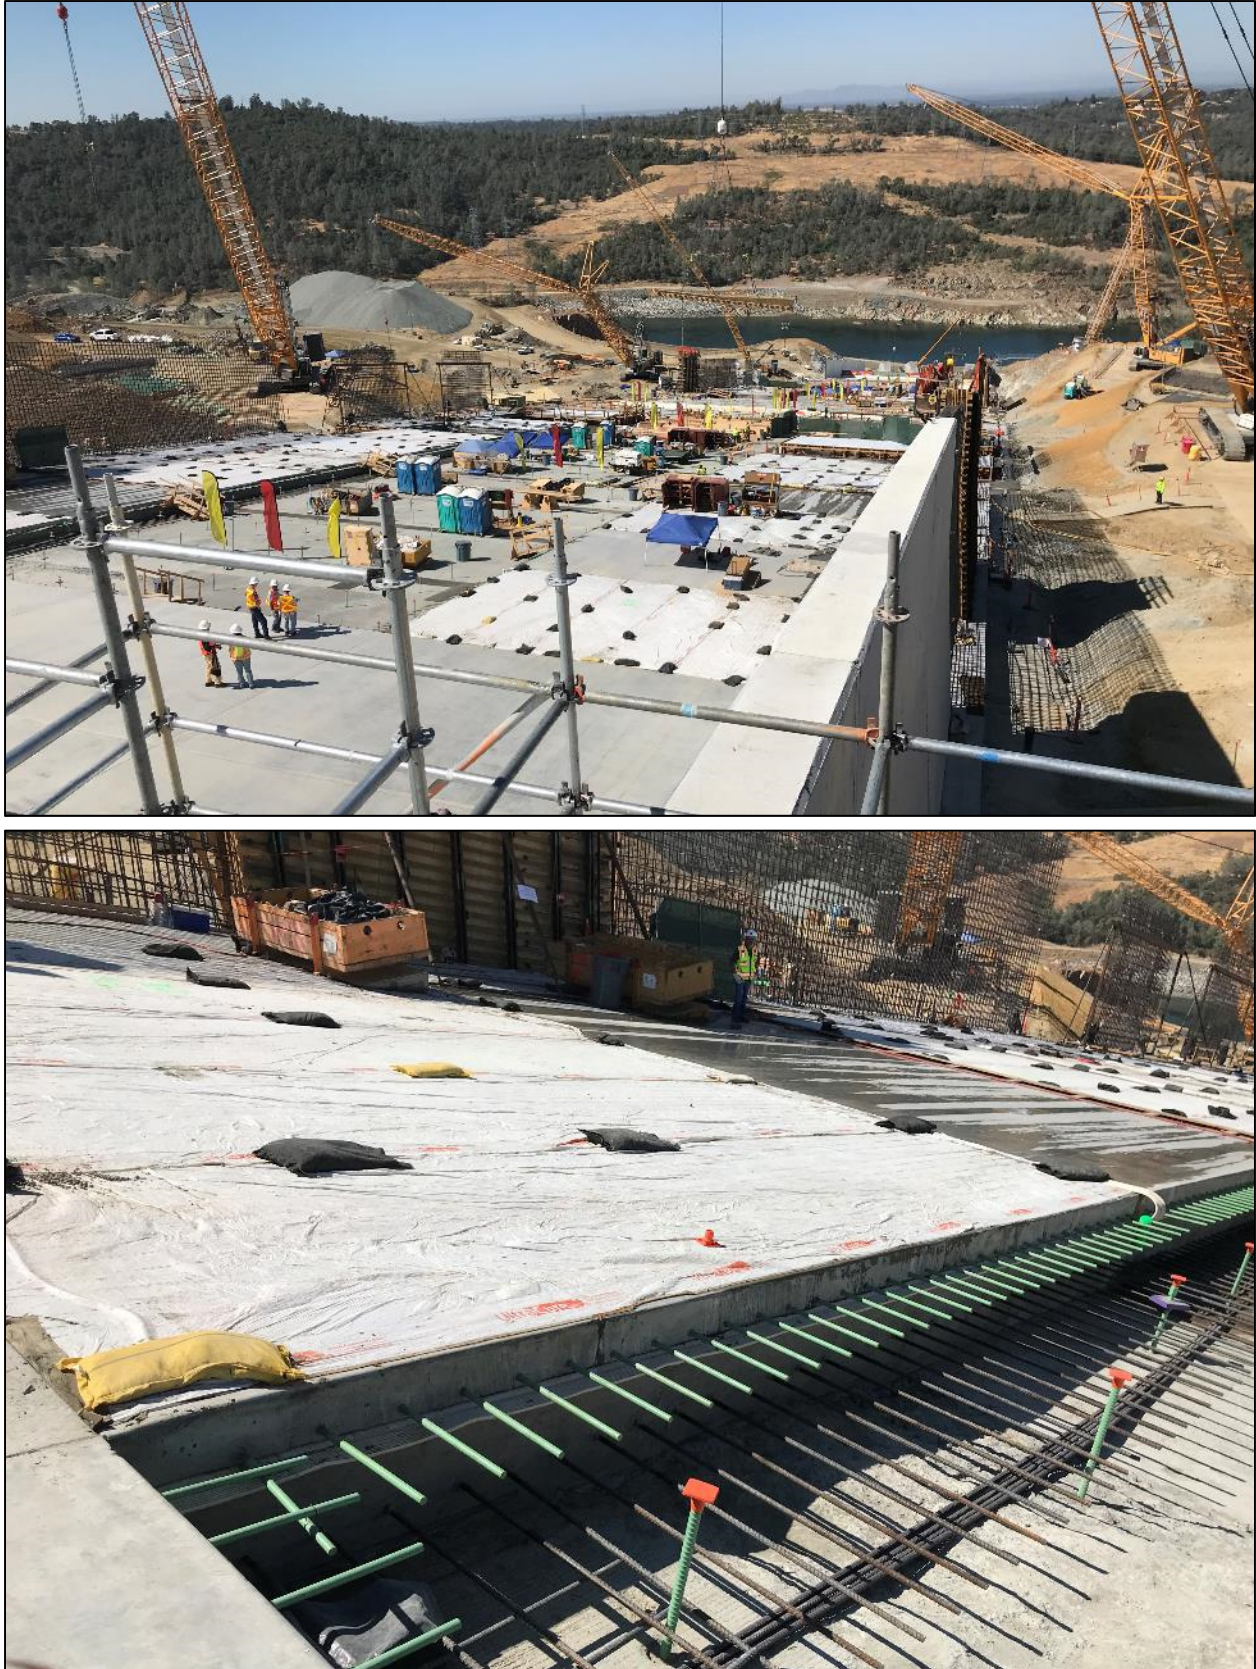
The BOC was pleased to see the new concrete slab moist curing method being employed in the middle FCO chute. This method is an improvement over the previous conventional moist curing approach. This, along with the new system used to screed the slabs, will help provide a durable long-term concrete surface. The completed RCC apron for Phase 1 of the Emergency Spillway appears to be of excellent quality. The finish on the exposed RCC stepped surface is exceptional.

Figure 2. Photos showing slab construction at lower section of FCO chute.

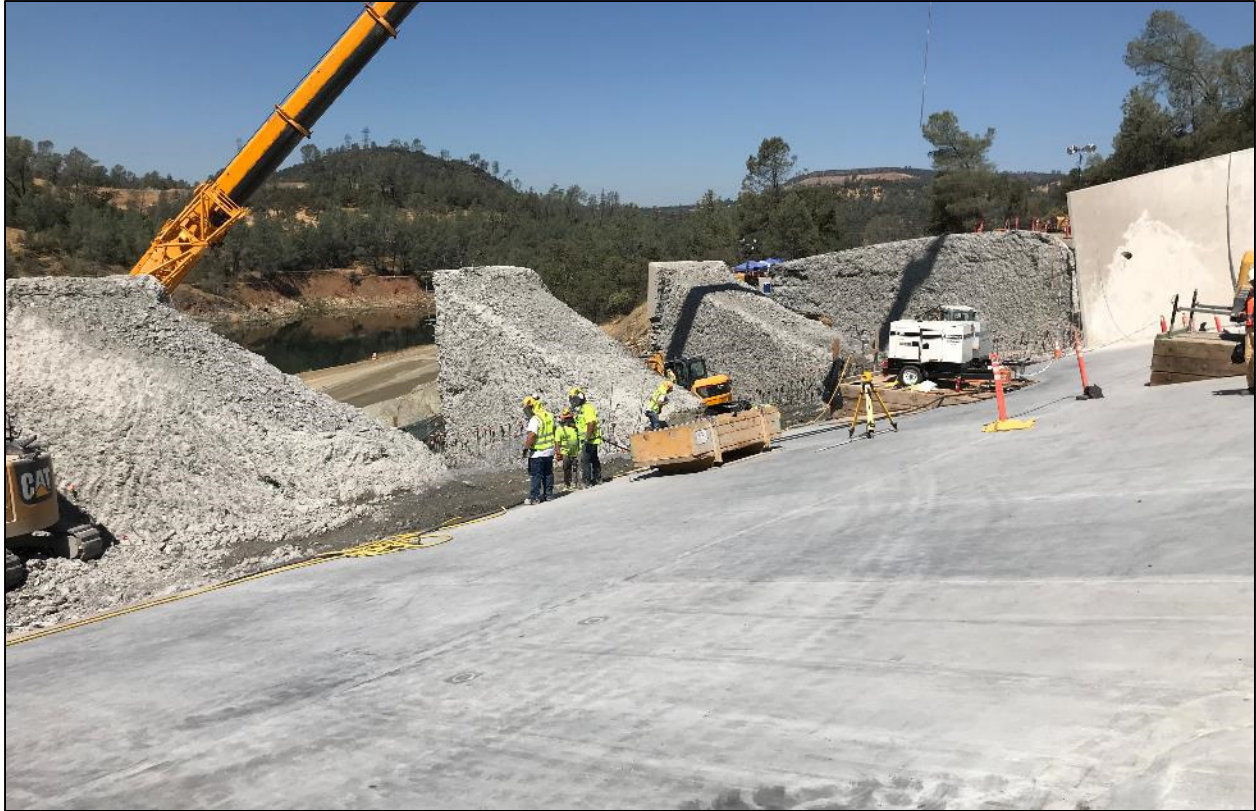
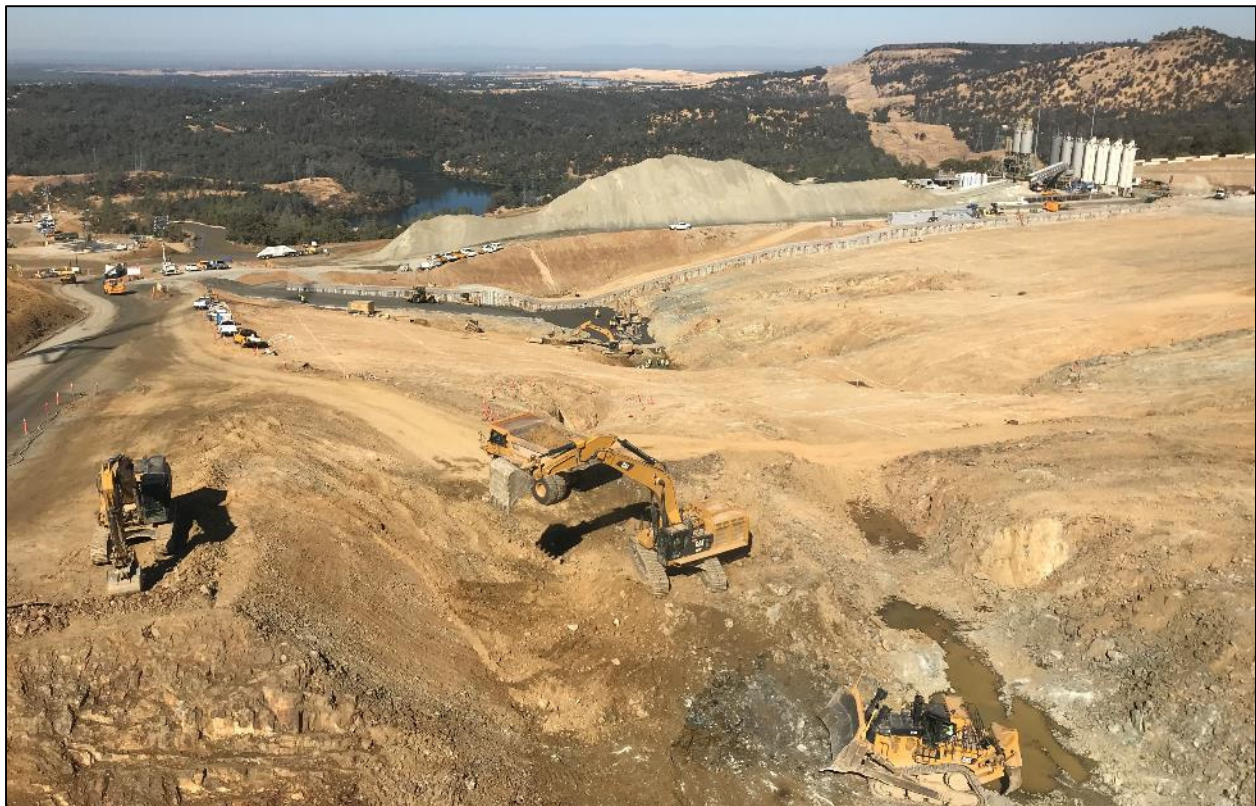
**Figure 3. Photos showing FCO dentates and left side of Emergency Spillway RCC foundation preparation.**

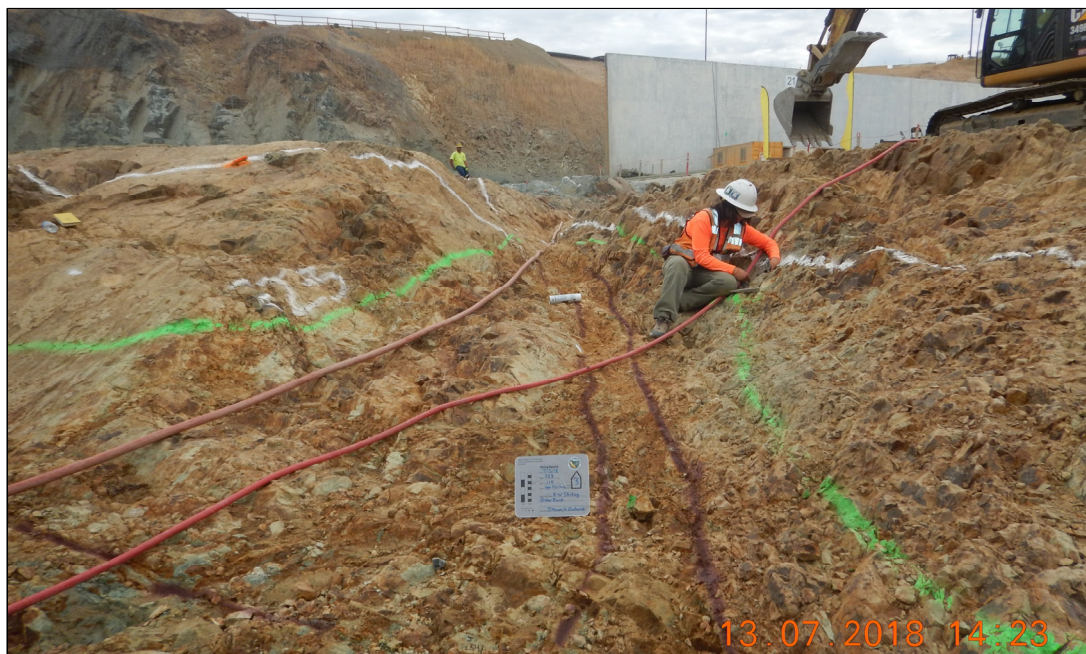
Bedrock conditions in the upper FCO spillway show an overall slightly weathered to fresh rock surface. This is not surprising as this area of the chute was created by excavating more than 60 feet deep in a bedrock ridge composed of amphibolite. As observed throughout the FCO foundation, local weathering at depth tends to be controlled by the presence of continuous bedrock shears. In these areas, the bedrock is more easily excavated and results in greater thicknesses of backfill concrete and longer slab anchors. The BOC observed one such area in the right side of the FCO spillway near Station 20+00 (see Figure 4). The BOC was pleased with the effort being made to prepare and treat the deeper shear and weathered zones within the upper FCO chute and with the quality of the bedrock foundation.

**Figure 4. Example of local more highly-weathered zone (between green paint lines) in FCO bedrock foundation.**

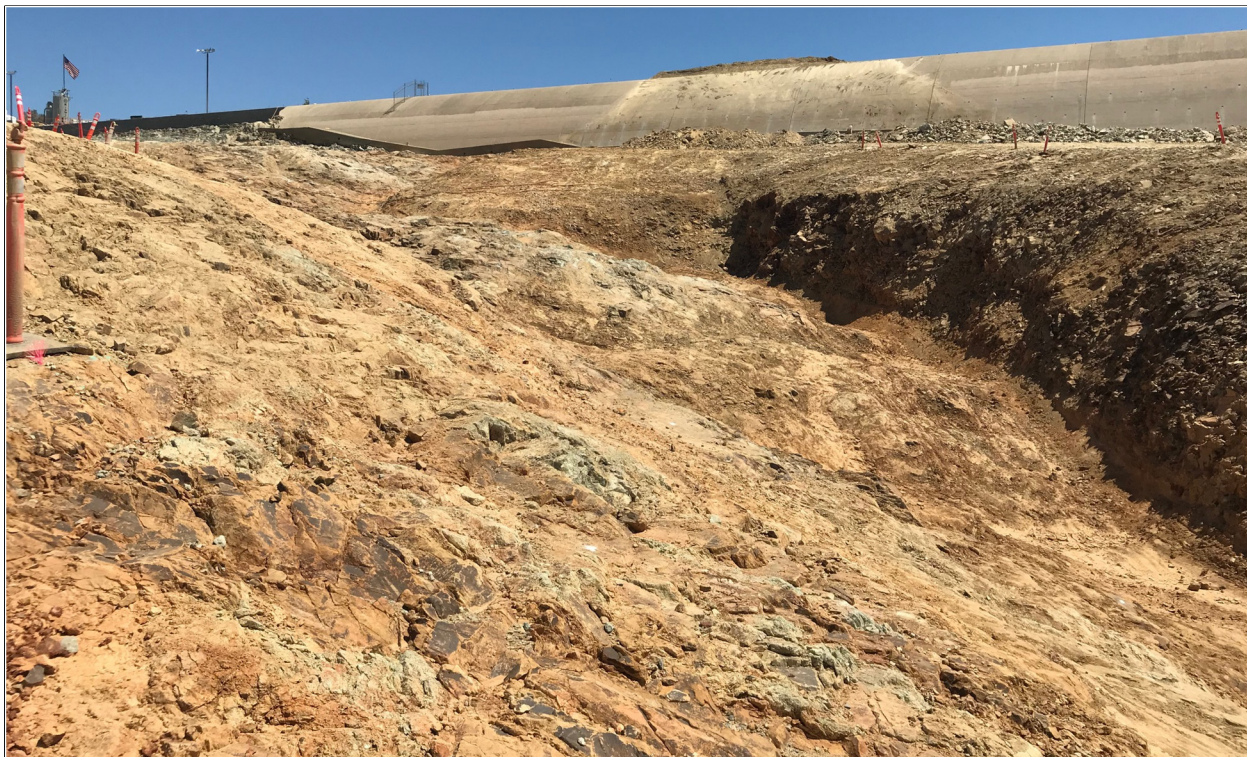
**3. Backfilling Deep Erosion Features in the Emergency Spillway Using Concrete and RCC.** Presentations on the preparation and backfill of the large erosional channels created during the February 2017 Emergency Spillway flows was discussed in both the Geologic and Geotechnical Engineering presentations. The BOC appreciated the thoughtful and detailed analyses that appropriately incorporates the knowledge of three-dimensional rock weathering variation, discontinuity effect on this weathering, and how excavation and backfill operations use this information to produce a plan for backfill. The BOC believes that the ultimate rock surface being obtained for the RCC apron will provide a surface that meets design intents. In a few areas, very steep, almost vertical slopes were produced by the erosion event (see Figure 5).

**Figure 5. Erosional channel in Emergency Spillway apron foundation that will be filled with backfill and RCC concrete**

Attempting to layback the slopes is unnecessary and the BOC endorses the backfill concepts discussed that use a combination of backfill concrete and RCC. The precedent for this approach was well established for the FCO spillway.
