OROVILLE EMERGENCY RECOVERY – SPILLWAYS

Board of Consultants Memorandum

DATE: September 6, 2018

SUBJECT: Memorandum No. 20

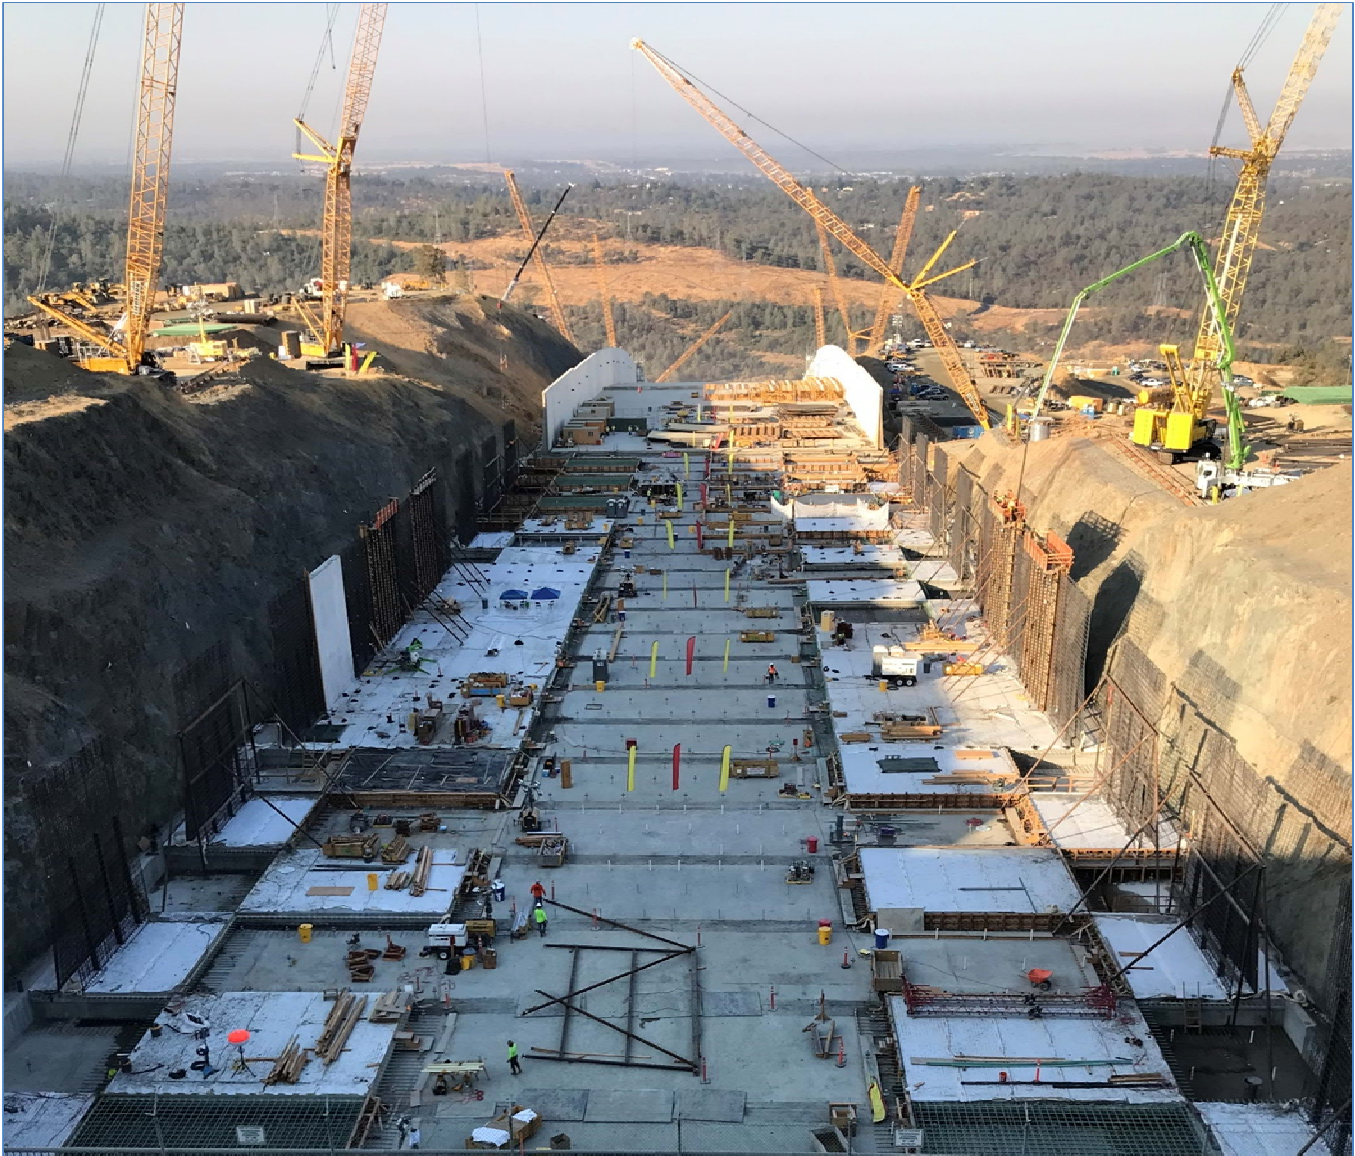
Figure 1. Construction of chute slabs and walls in the upper section of FCO chute.

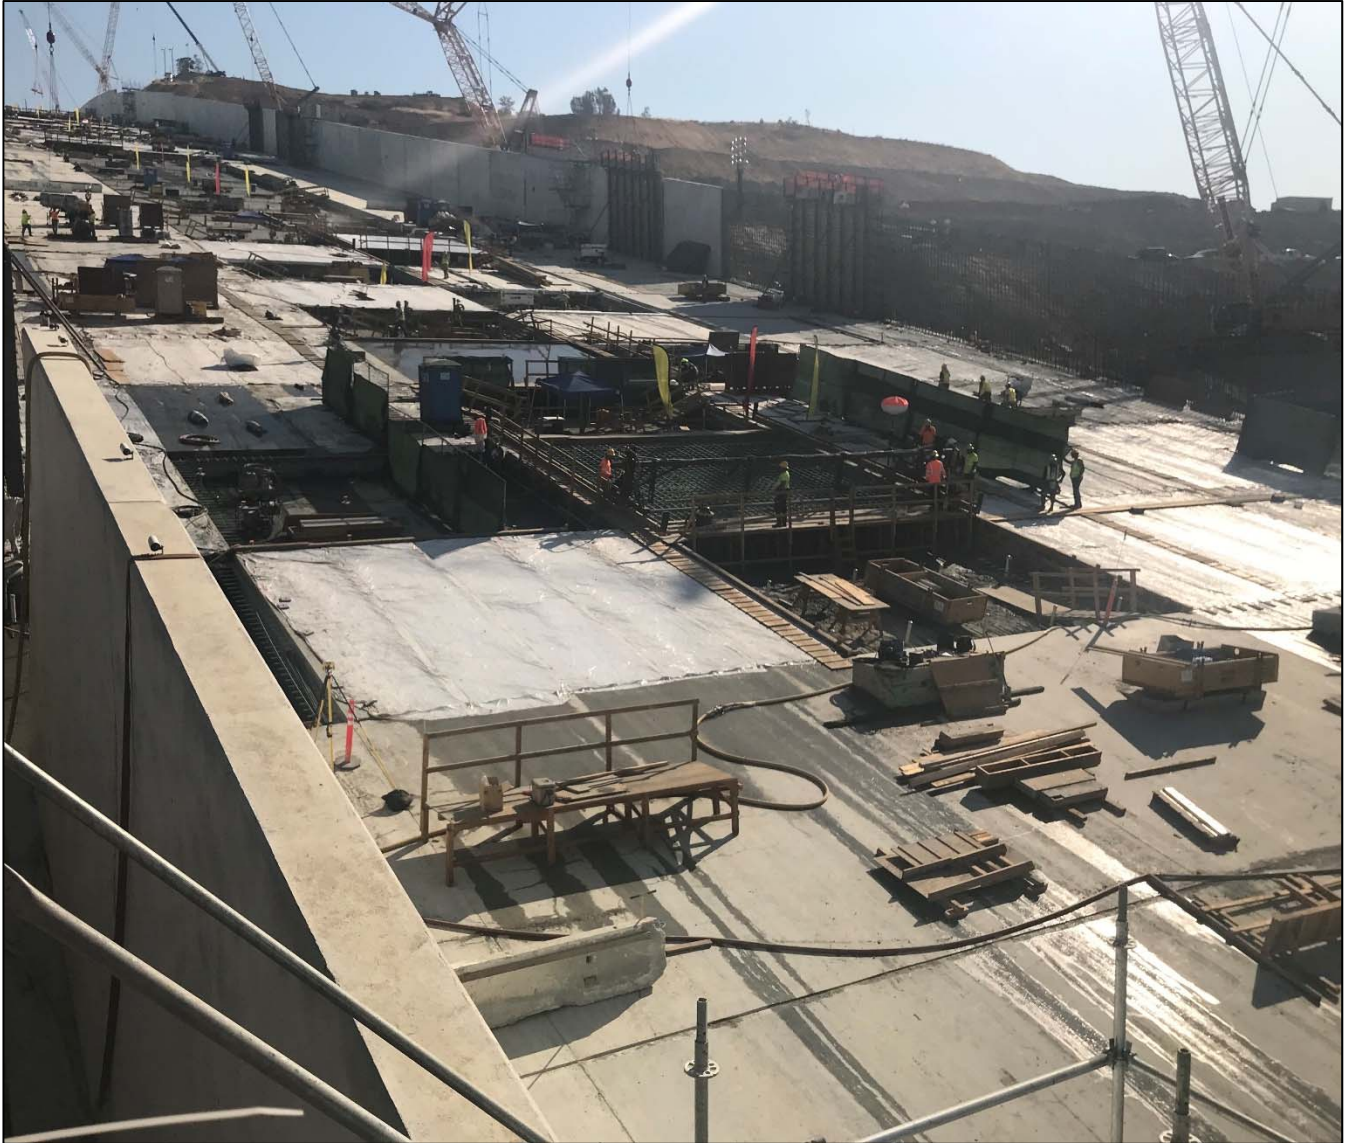
Figure 2. Construction of chute slabs and walls in the middle section of FCO chute.

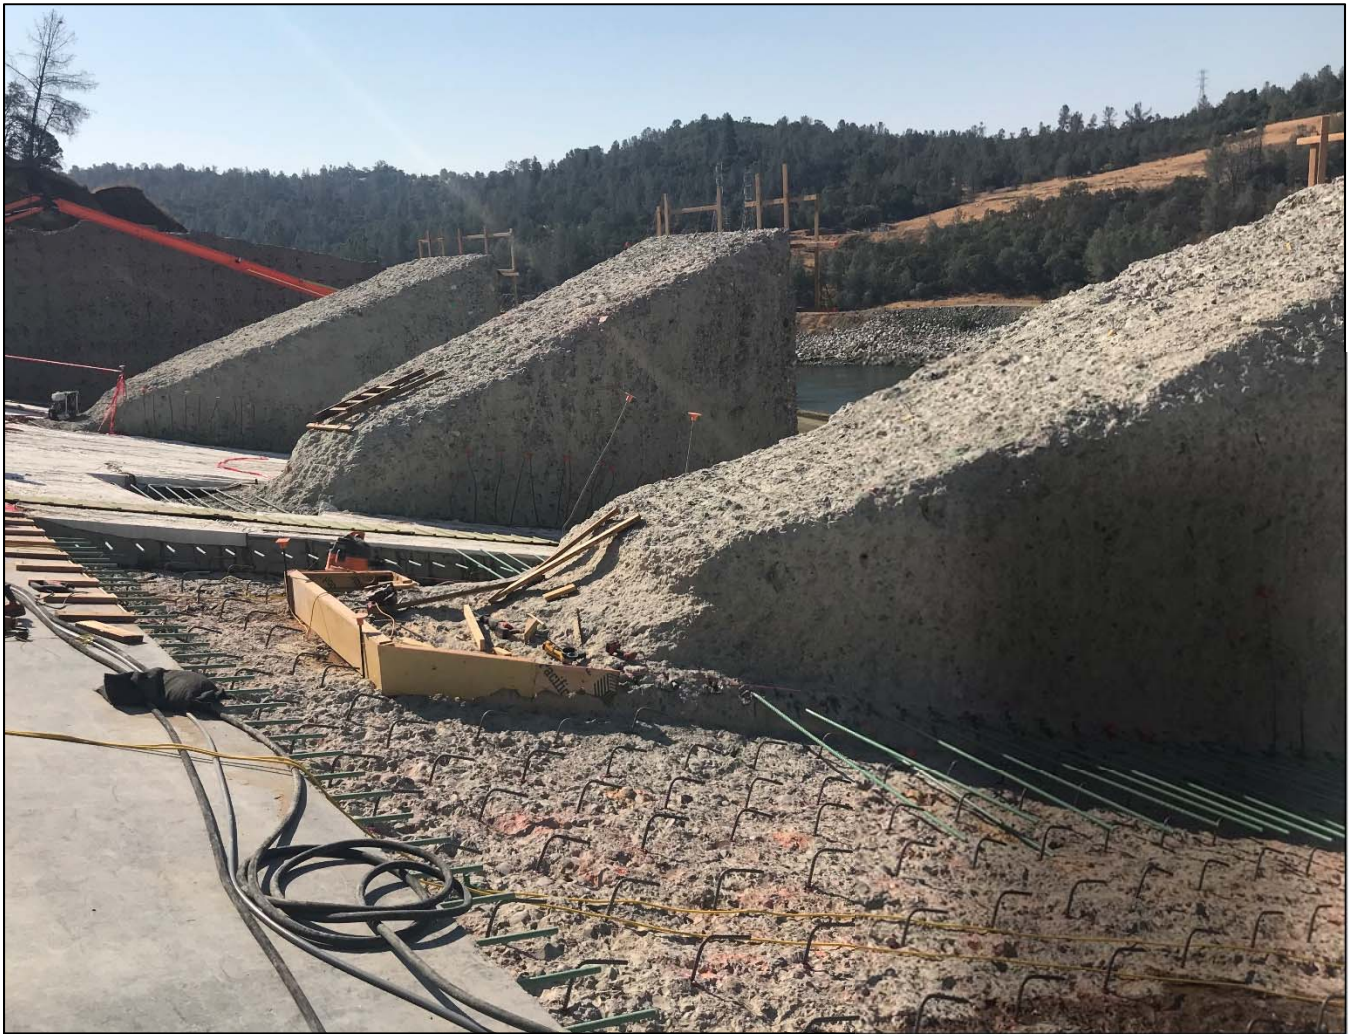
Figure 3. Final surface preparation and initial placement of reinforced concrete to rehabilitate the FCO terminal structure. Photo inset shows concrete spall on the downstream face of a dentate.

The BOC noted a spalled area on the downstream face of one of the dentates that needs to be saw cut and chipped out before placing the new concrete overlay on the walls (see Figure 3 photo inset). It was understood by the BOC that all removal of concrete on the dentates had been finished, but no doubt, it is intended that this spalled area be prepared before the wall is repaired.

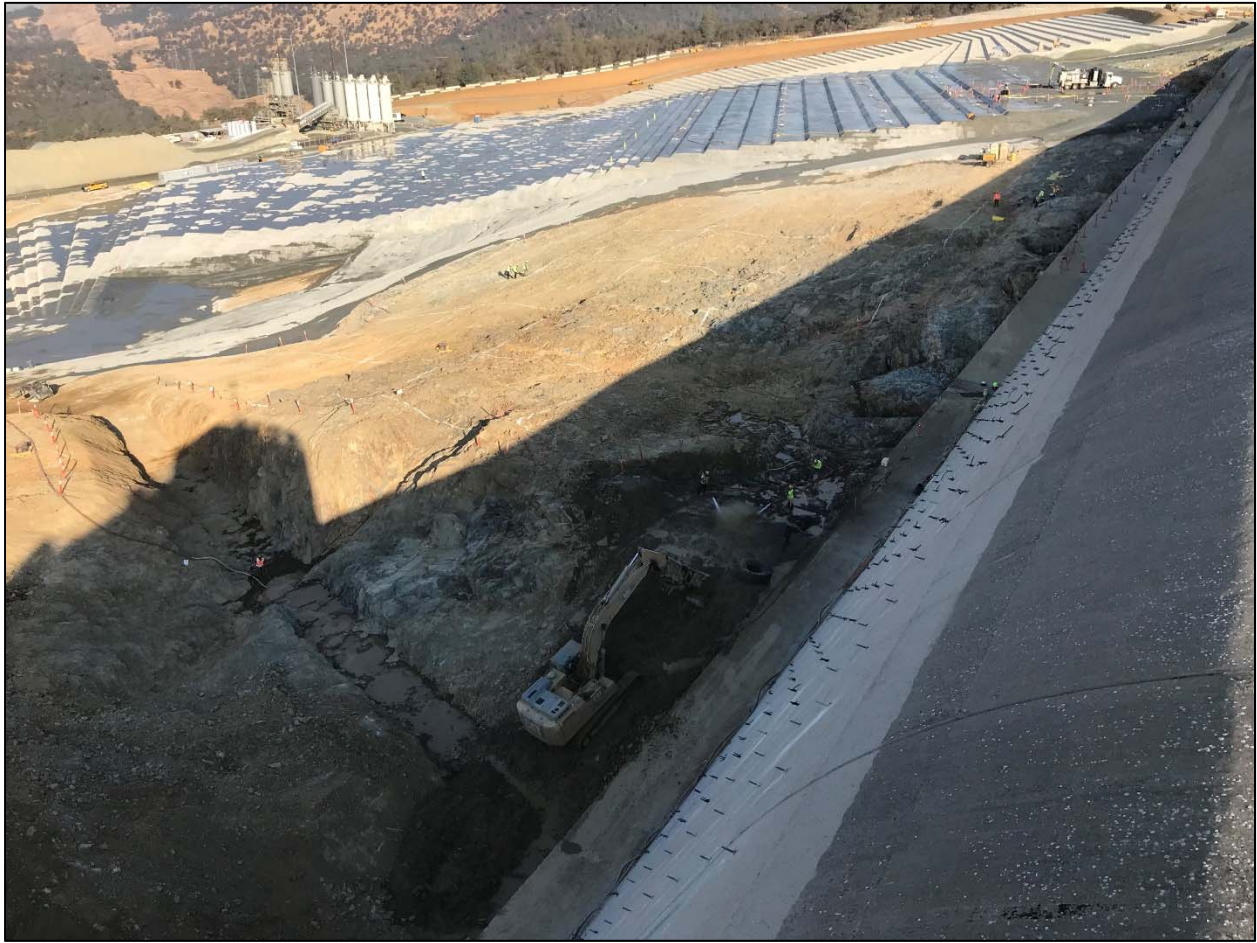
Figure 4. Final excavation and foundation preparation for the RCC apron on the left side of the Emergency Spillway.

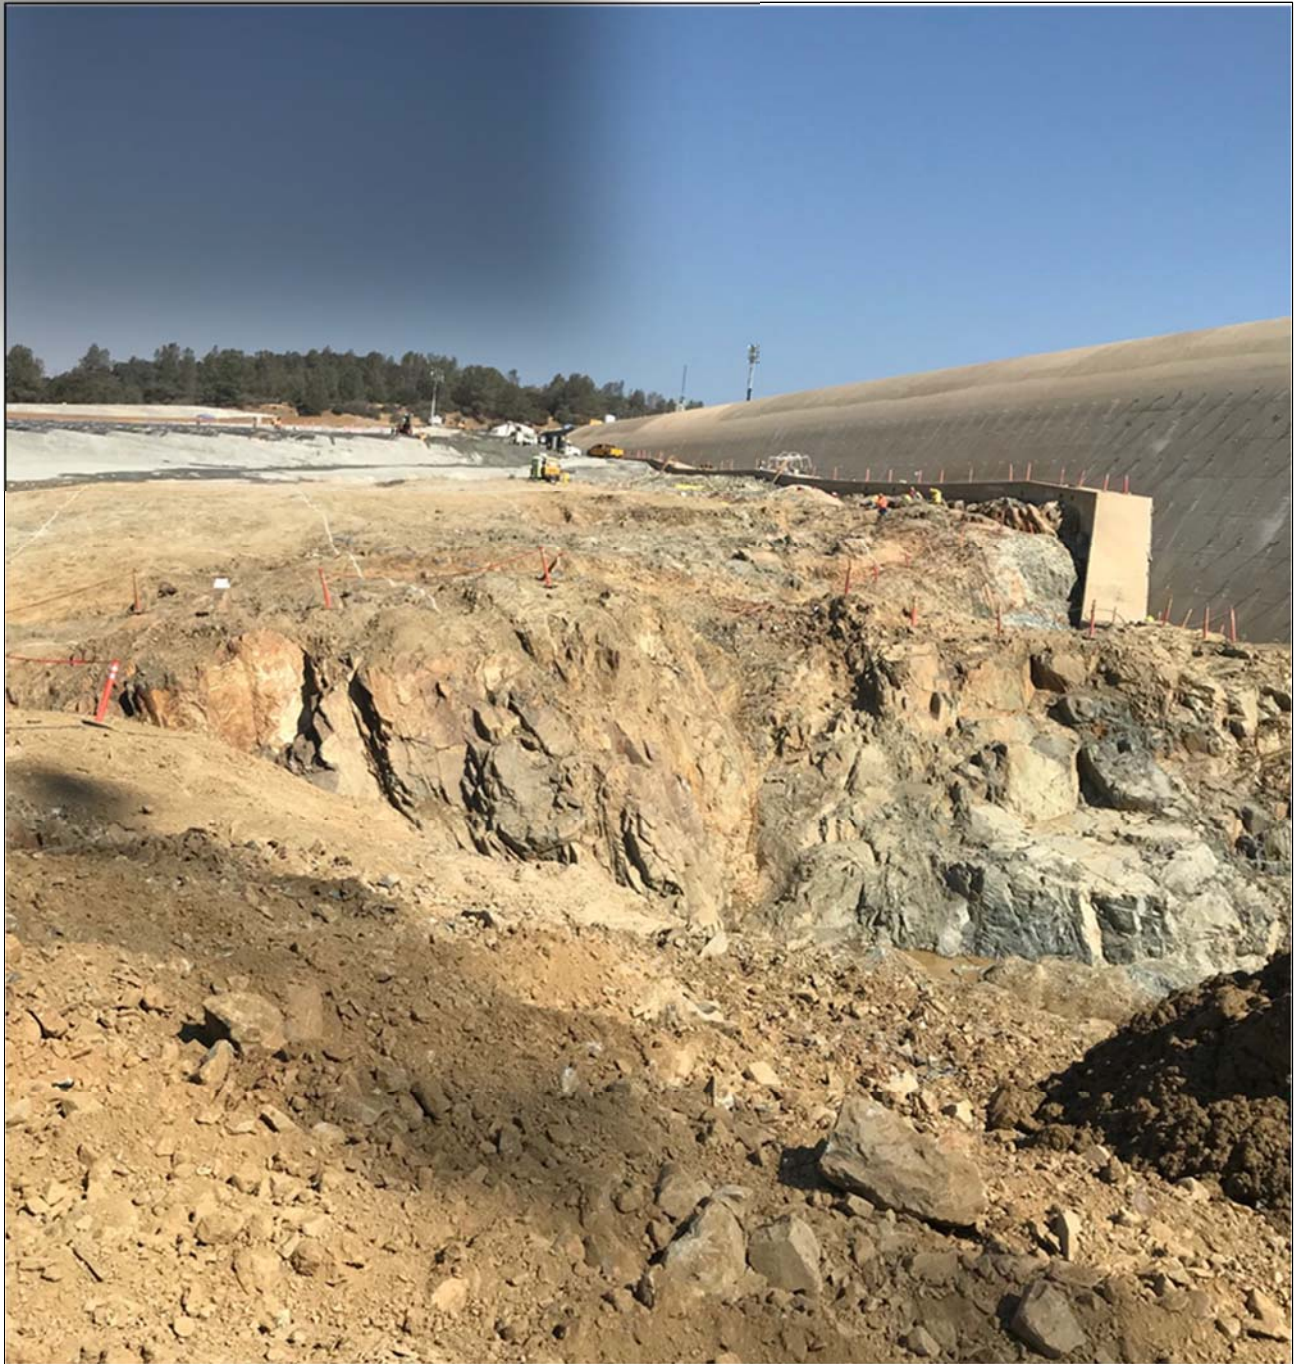
Figure 5. Final excavation and foundation preparation for the RCC apron and RCC buttress on the left side of the Emergency Spillway

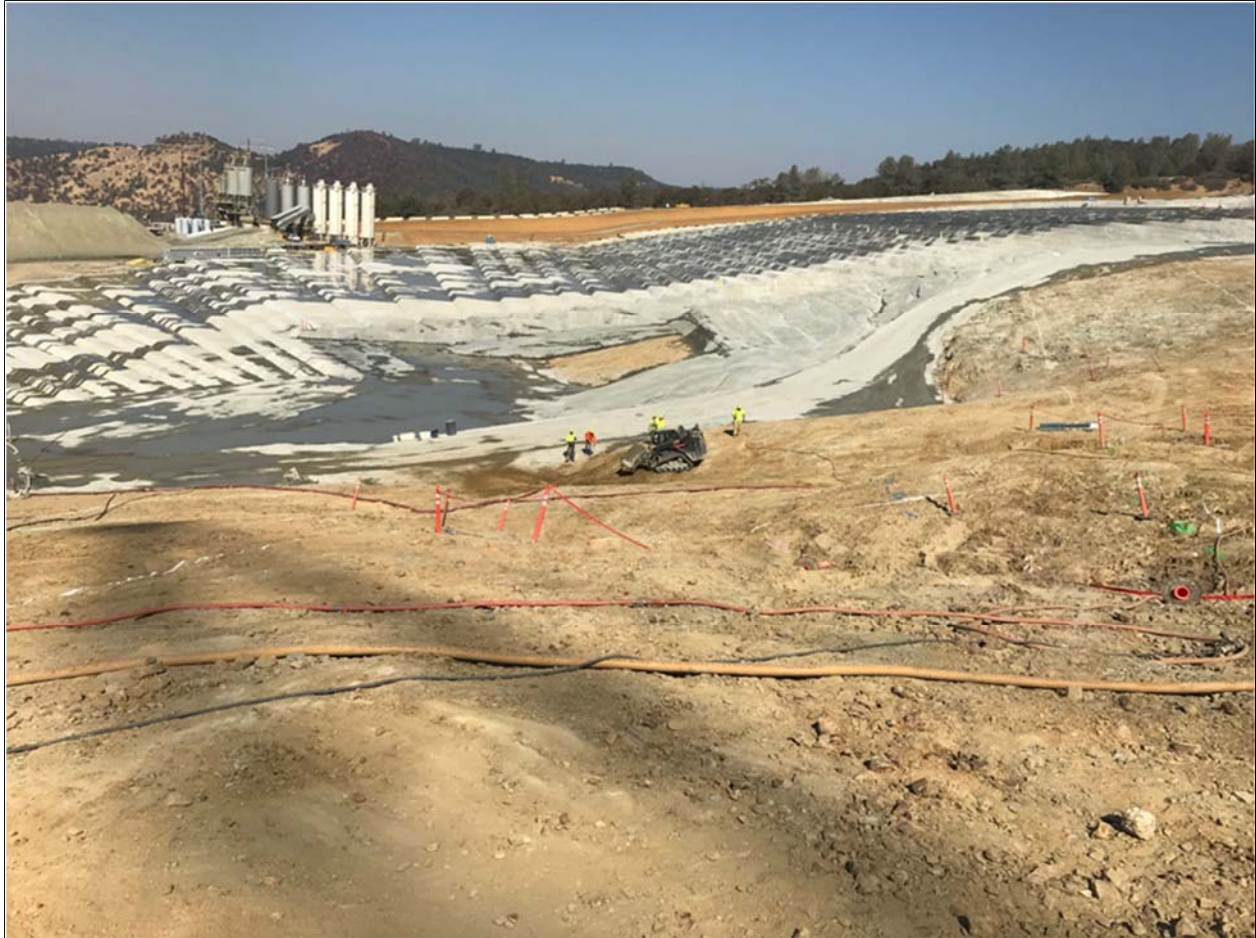
Figure 6. View of Emergency Spillway completed Areas 1 and 2A. Area 2B is the foreground area.
