# Lake Oroville Spillways Emergency Recovery

## Board of Consultants Memorandum No. 8 – June 23, 2017

## Board of Consultants Memorandum

SUBJECT: Memorandum No. 8

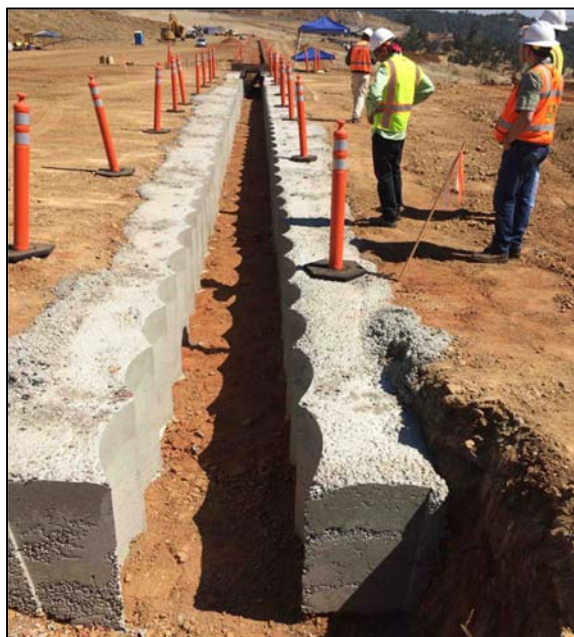
The BOC viewed construction progress of the north end of the secant pile erosion cut-off wall where working platforms with guide walls for the secant drilling are being prepared from about Sta. 12+50 to Sta. 18+00 (see Figure 1). The Contractor has created level working platforms and about 300 to 400 feet of scalloped concrete guide walls with another 500 feet of exposed trench where guide walls have yet to be formed. The BOC was informed that about 200 feet of the northern end of the cutoff wall has been removed and this leaves 1,500 feet of total secant pile wall that will be constructed.

**Figure 1. Photo of secant guide wall trench at approximate Station 13+00. View to the south.**

- M8-1            The BOC believes good construction progress is being made on the secant pile erosion cut-off wall and looks forward to seeing actual drilling progress information in the near future.

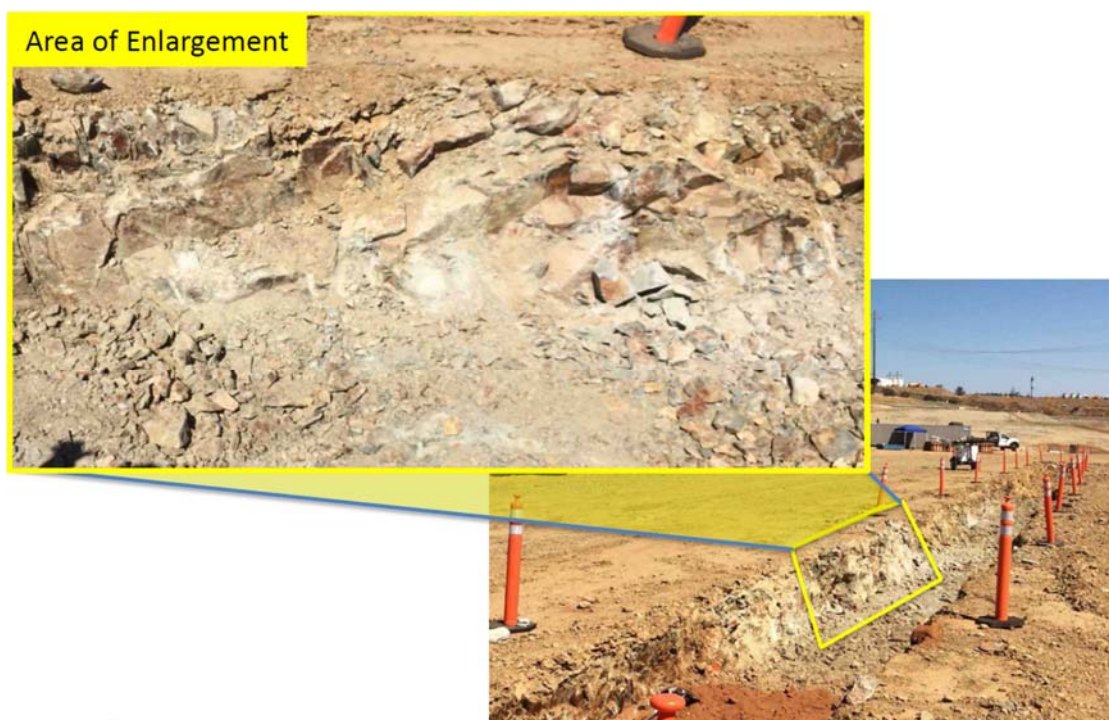
As part of the Geology presentation, the BOC was shown a geologic cross section that has the planned bottom of the wall depth superimposed. The geology is based on seismic refraction data and 12 geotechnical exploration borings. The wall is designed to have about 15 feet of embedment within slightly weathered rock. The BOC observed exposed amphibolite rock in the southern end of the trench that is intensely to slightly weathered (see Figure 2). At the location of the aforementioned rock exposure, the planned depth of the cutoff wall will be approximately 65 feet. The BOC believes this is good construction progress and awaits the actual drilling progress information for the wall construction, especially in areas where better quality rock is close to the natural ground surface.

**Figure 2. Photo of moderately weathered amphibolite rock exposed in a portion of the secant guide wall trench near approximate Station 17+00.**

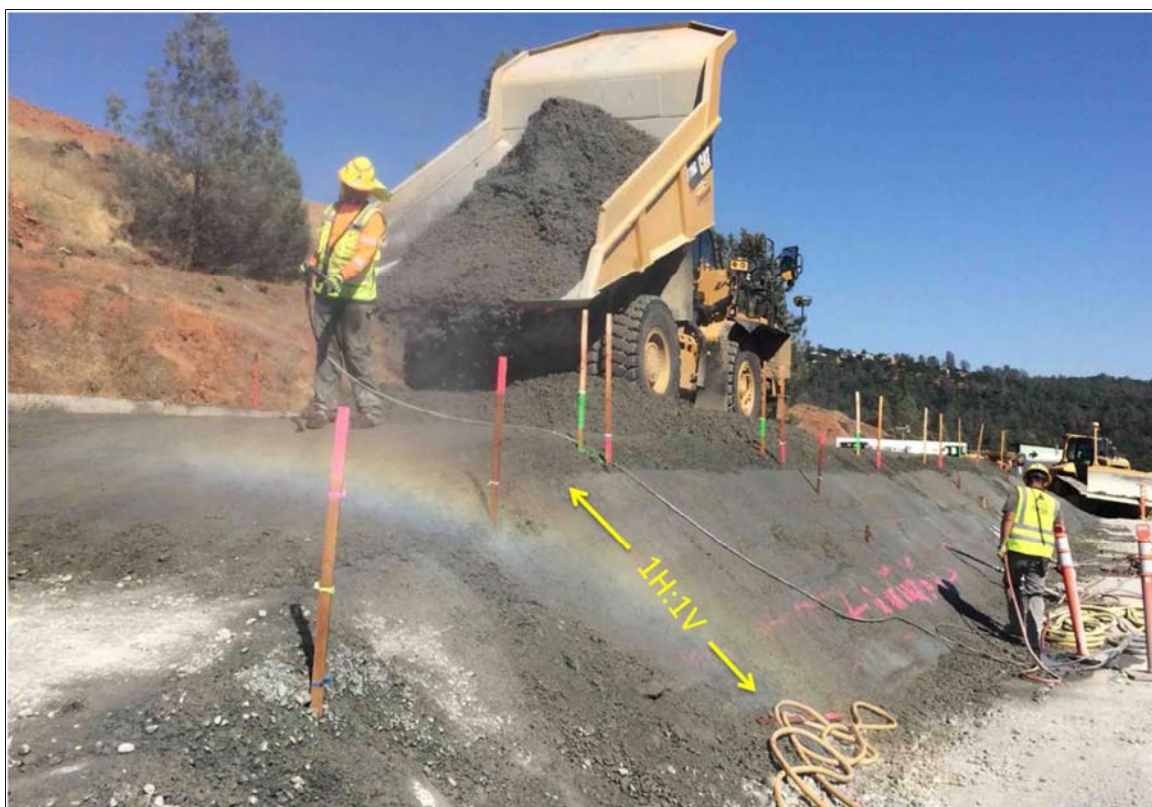
Figure 3). The BOC observed the RCC placement and found the RCC mix to be workable with no segregation, easily compacted, and can be placed within the temperature restrictions, despite high ambient temperatures exceeding 100 degrees Fahrenheit. The Contractor's workers demonstrated the necessary skills. The equipment used to spread and compact the RCC appeared to be new and appropriate for the work. The BOC was pleased with the demonstration.

**Figure 3. Photo of RCC placement of lift 8 and the vibratory finish of the 1H:1V slope.**

1. Because of the accelerated construction schedule and need to remove the RCC test section to provide access for construction equipment, there will be no opportunity to obtain, examine and test core samples to confirm bonding of RCC lifts with “Hot Joints”, the effectiveness of the grout-enriched vibratable RCC (GEVR), and in-place RCC properties. The BOC recommends that during removal of the RCC test section, efforts be made to learn as much as possible regarding these features. For example, the effectiveness of the “Hot Joint” treatment

can be confirmed by the lifts of RCC remaining bonded and coming apart in monolithic chunks during demolition as opposed to the RCC coming apart in unbonded layered slabs. Similarly, the GEVR should be examined during demolition to see how well the RCC mix has been consolidated.

- M8-8 The BOC recommends that during removal of the RCC test section, efforts be made to learn as much as possible regarding the bonding of the RCC lifts, the consolidation of the GEVR and other RCC properties.

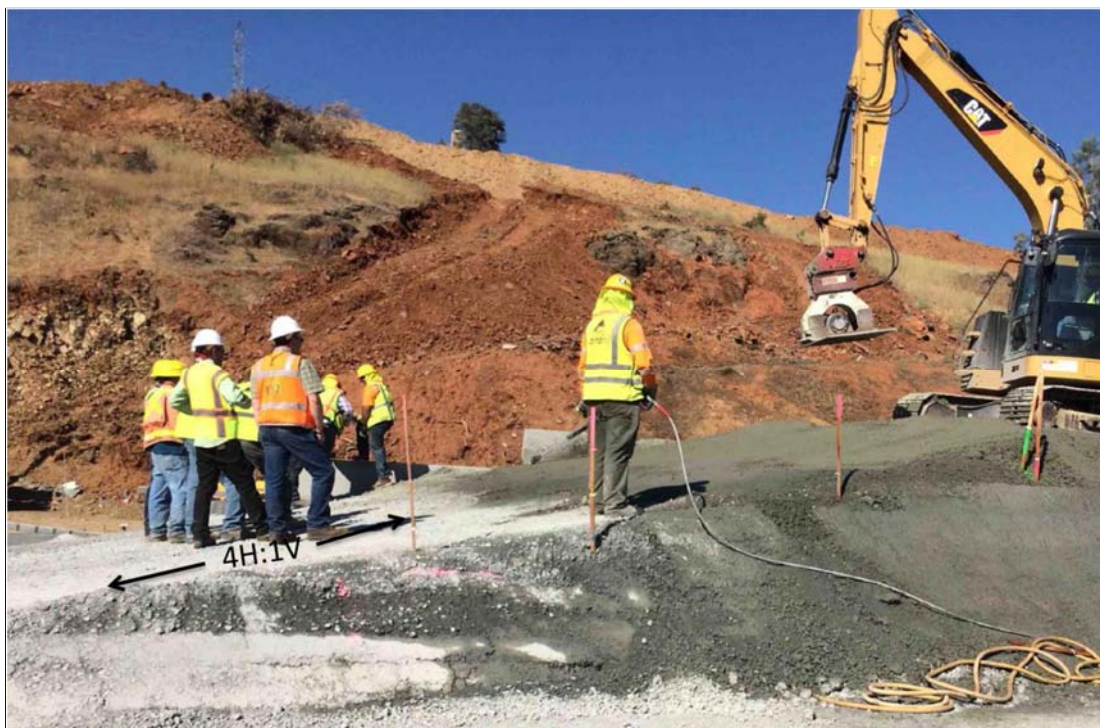
**Figure 4. Photo of the 4H:1V ramp on the RCC Test Section that is planned to be formed by vibratory rollers.**

3. At the time that BOC Meeting No. 8 ended, all eight horizontal RCC lifts had been placed for the test pad and a trial lift is planned to be placed and compacted on the 4H:1V slope to prove out the ability to use the compaction rollers on this slope. The BOC believes that this needs to be demonstrated, as it may be an important procedure in construction of the chute foundation, and looks forward to a presentation of the test results.

2. Prior to removing the RCC test section, the BOC recommends that the exposed 4H:1V RCC slope receive “Cold Joint” cleaning treatment to determine what the surface will look like prior to placing the new concrete slabs (see Figure 4). Photographs of the 4H:1V surface should be taken prior to and after it has been pressure washed in accordance with the specifications for cold joint treatment.

- M8-9 Prior to removing the RCC test section, the BOC recommends that the exposed 4H:1V RCC slope receive "Cold Joint" cleaning treatment to determine what the surface will look like prior to placing the new concrete slabs. Photographs of the 4H:1V surface should be taken prior to and after it has been pressure washed in accordance with the specifications for cold joint treatment.

- M8-10 As of the time of the close of BOC Meeting No. 8, all eight horizontal RCC lifts had been placed for the test pad and a trial lift was planned to be placed and compacted on the 4H:1V slope to prove out the ability to use the compaction rollers on this slope. The BOC believes it is important that this be demonstrated and looks forward to a presentation of the results.

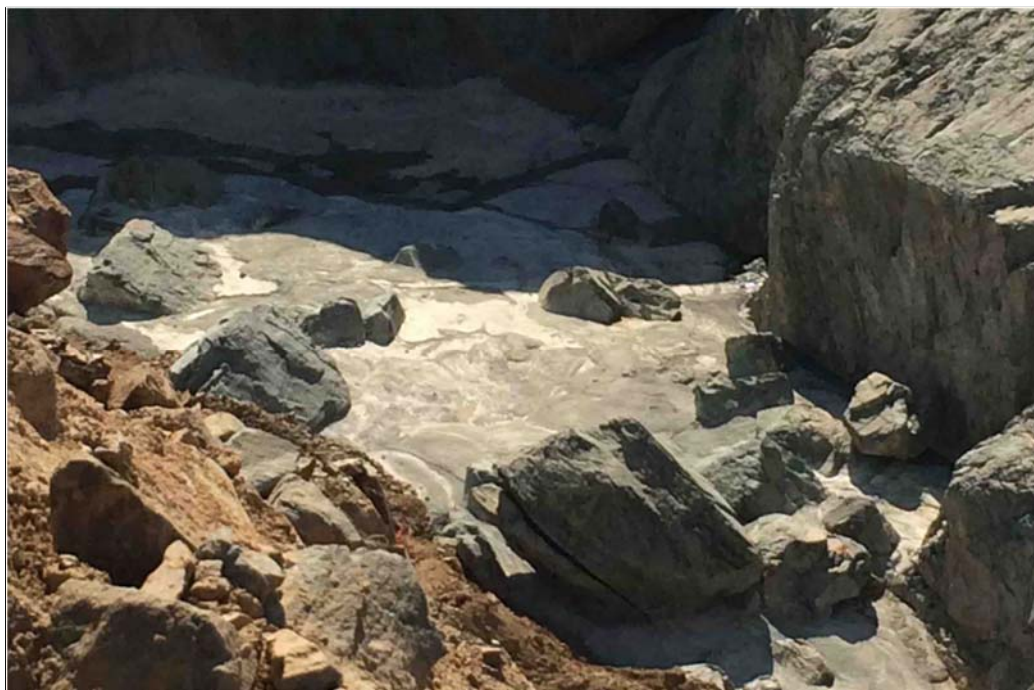
- 1. Use of Flowable Fill in FCO Spillway Foundation.** It appears that less flowable fill will be placed in the lower portions of the FCO Spillway foundation than originally anticipated, and that more RCC is planned to be placed instead. The flowable fill that has been placed is in the bottom of the downstream scour hole (see Figure 5). Placement of RCC in tight spaces and around large boulders that project above the lift surface appears challenging. The infilling of the upper scour hole has not been started since access to the area will cross the lower RCC placement. The BOC is of the opinion that the use of additional flowable concrete in these bottom areas of the infilling to provide working surfaces for RCC placement would facilitate construction.

**Figure 5. Flowable fill that has been placed in the scour hole near approximate Station 32+00.**

As the RCC infill is raised, there will also be narrow crevices that can only be effectively filled by flowable fill or dental concrete. The BOC suggests that a combination of RCC and flowable fill placed concurrently be considered in tight spaces where compaction of RCC cannot be accomplished with equipment.

- M8-11 The BOC is of the opinion that the use of additional flowable concrete in the bottom areas of the FCO Spillway infilling to provide working surfaces for RCC placement would facilitate construction. The BOC suggests that a combination of RCC and flowable fill placed concurrently be considered for filling narrow crevices and small areas where RCC compaction is not possible.

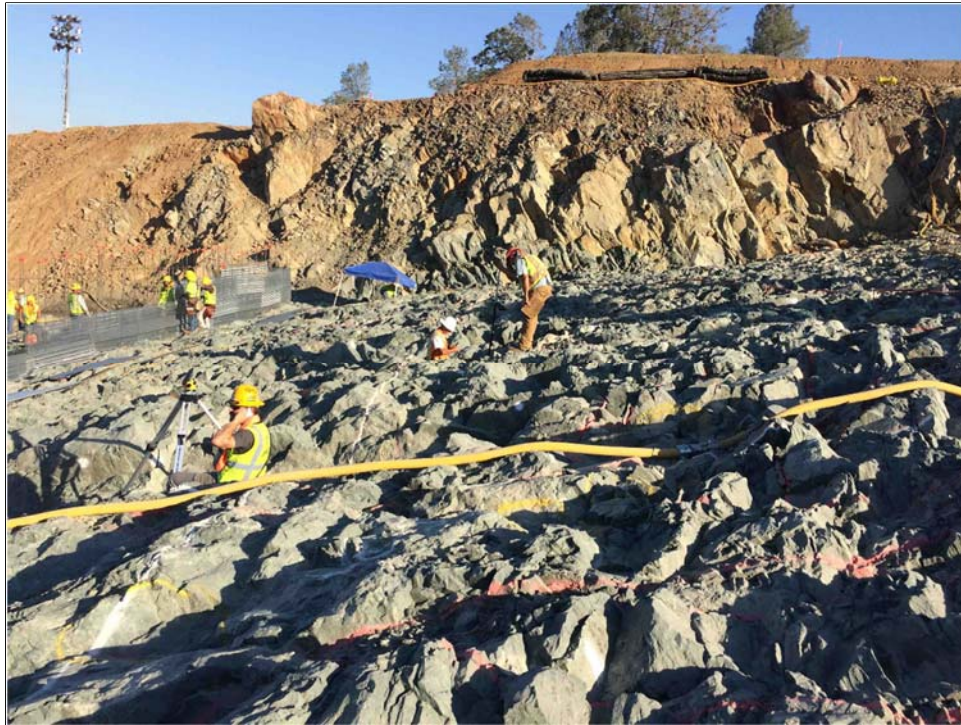
The cleaning of areas of the chute foundation for placement of RCC or leveling concrete that were observed by the BOC (see Figures 6 & 7) appear to have been well done and represent a significant improvement in contrast to the prepared foundation surface for the original FCO Spillway construction.

**Figure 6. Cleaned FCO spillway chute rock that has been geologically mapped and is close to being accepted for concrete placement. Near approximate Station 33+00.**

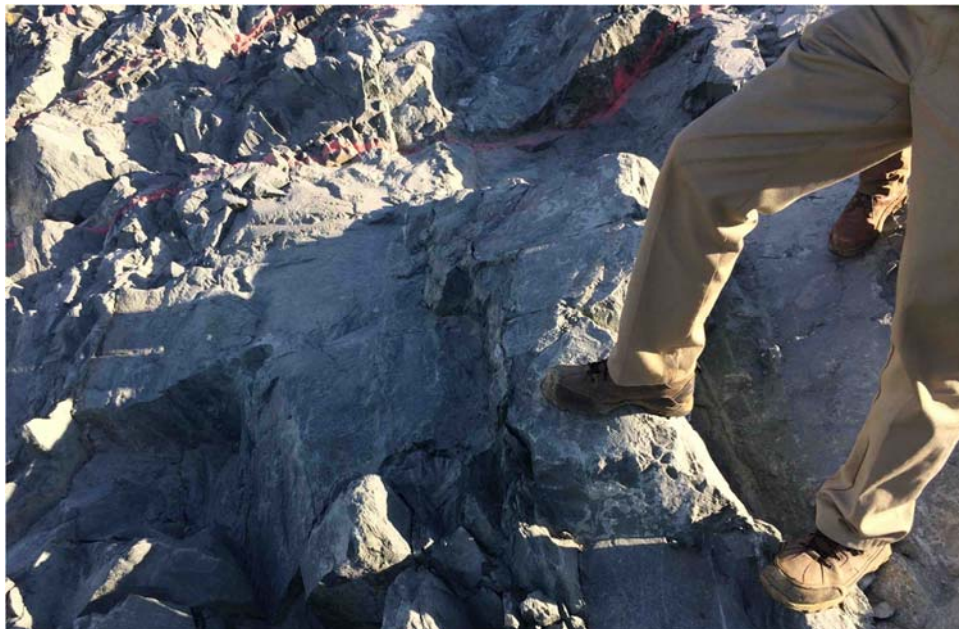
**Figure 7. Close-up of cleaned rock surface near Station 33+00 in FCO spillway chute foundation.**

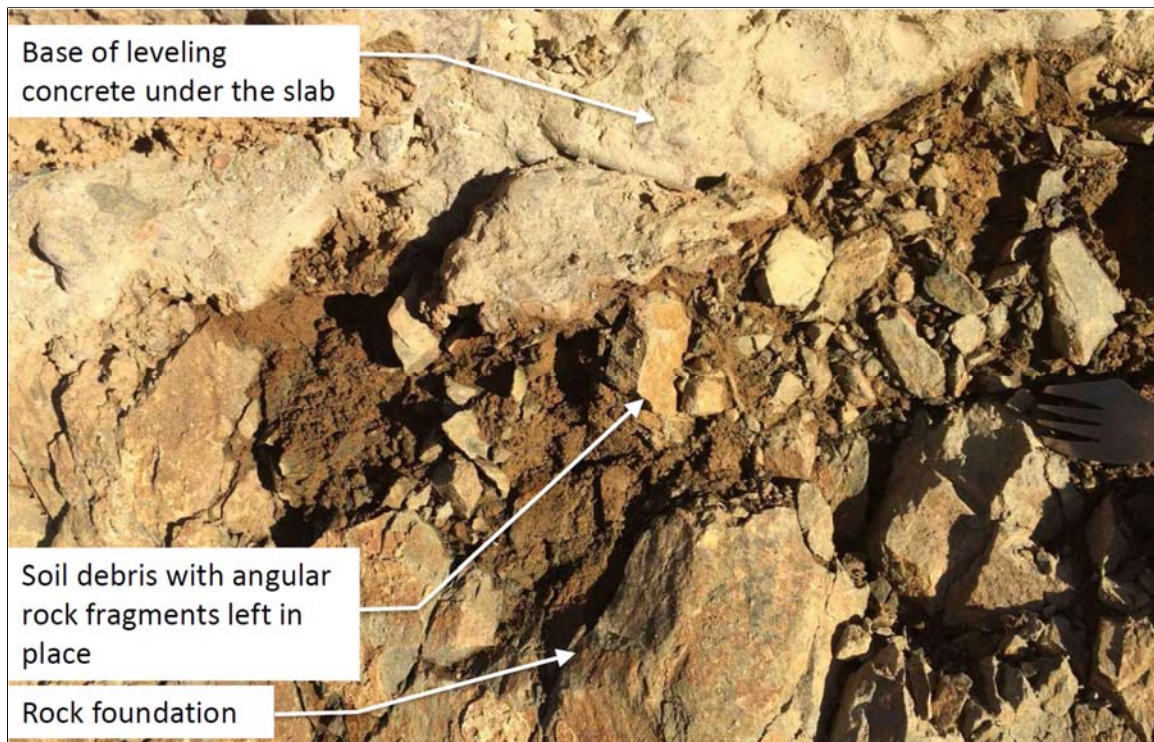
2. **Update on investigation of existing FCO spillway chute foundation condition.** The BOC was provided an update to findings on the investigation of the interface between the concrete and rock material. Four concrete cutouts were excavated and exposures described. Subsequently, and as part of the concrete removal, the Contractor created a 200-foot-long centerline exposure of the interface from Stations 25+00 to 27+00. Where present, the soil material that did exist appeared to be semi-consolidated fines and angular rock debris that was not removed as part of the initial (1960's era) foundation surface cleanup. The interpretation of the investigators was that the localized occurrence of the soil and its angular nature did not appear to be fill that was purposefully placed as bearing material. A photo of this material is shown as Figure 8.

**Figure 8. Soil material left in place in the existing FCO chute spillway foundation interface. Location is near Station 25+30. Tool at right is 1.5 inches wide.**
