# TISDALE WEIR REHABILITATION AND FISH PASSAGE PROJECT

## Sediment Budget Analysis Technical Memorandum

Prepared for  
California Department of Water Resources

October 2019

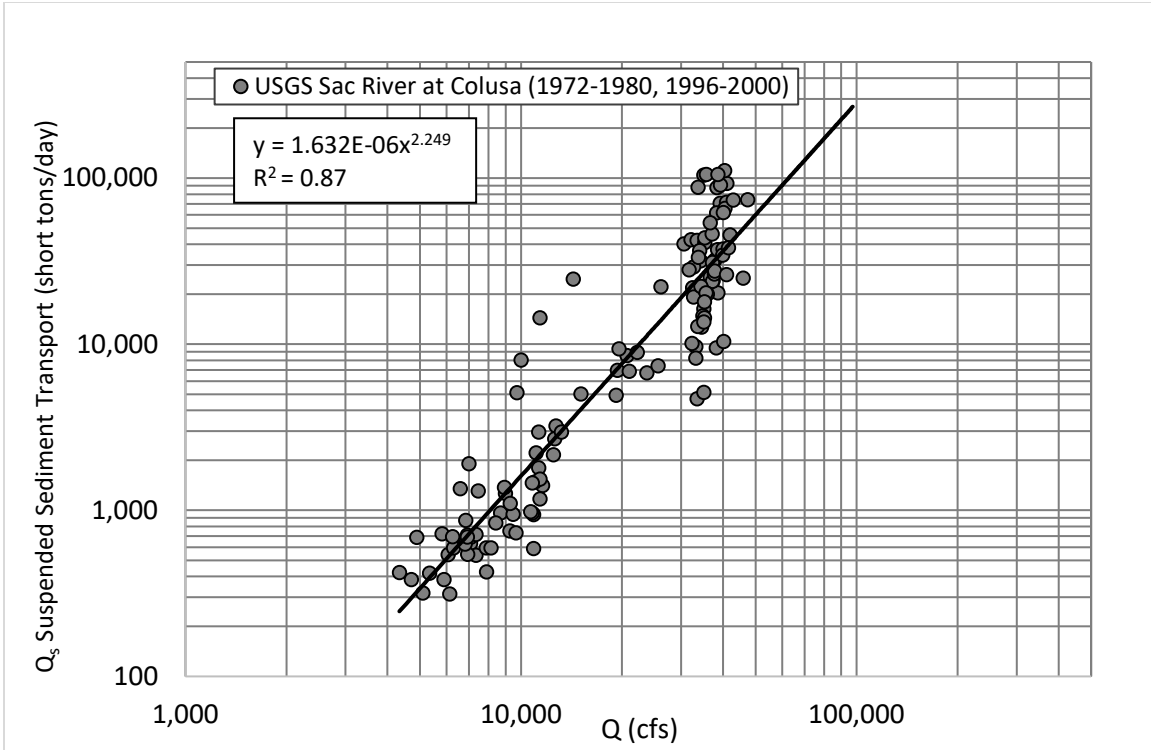
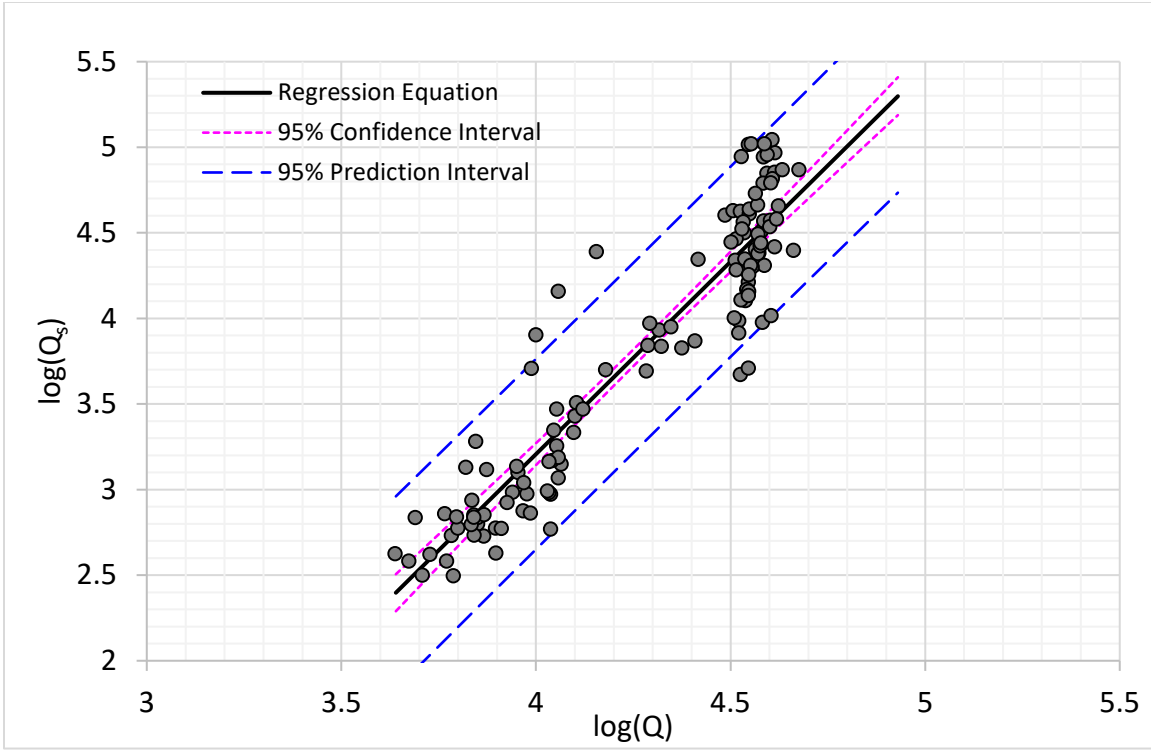
**Figure 2**  
 (Top) Suspended sediment rating curve. (Bottom) Log-transformed suspended sediment rating curve and statistical intervals.

A suspended sediment rating curve was developed using suspended sediment flux (short tons/day) versus discharge for the Colusa gage (**Figure 2**). There is considerable scatter in the data at the top end of the rating curve due to the influence of the Colusa Weir (which is upstream

of the Colusa gage), which truncates the flow at the Colusa gage during flood conditions, but the overall relationship between flow and sediment discharge appears reasonable. Following methods outlined in Glysson (1987), the rating curve was derived by performing a simple linear regression on the log-transformed values of flow and sediment discharge. Figure 2 also presents the 95-percent confidence and prediction intervals for the log-transformed data following the methods presented by Helsel and Hirsch (2002).<sup>4</sup>

There is notable variability and thus uncertainty in the sediment rating curve relationship (Figure 2). The 95-percent confidence interval constrains the mean sediment discharge for a given flow fairly well, though the width of the 95-percent prediction interval illustrates there is substantial variability in the range of sediment discharge at a given Sacramento River flow. Many factors can influence and control this variability, including, but not limited to, sediment transport

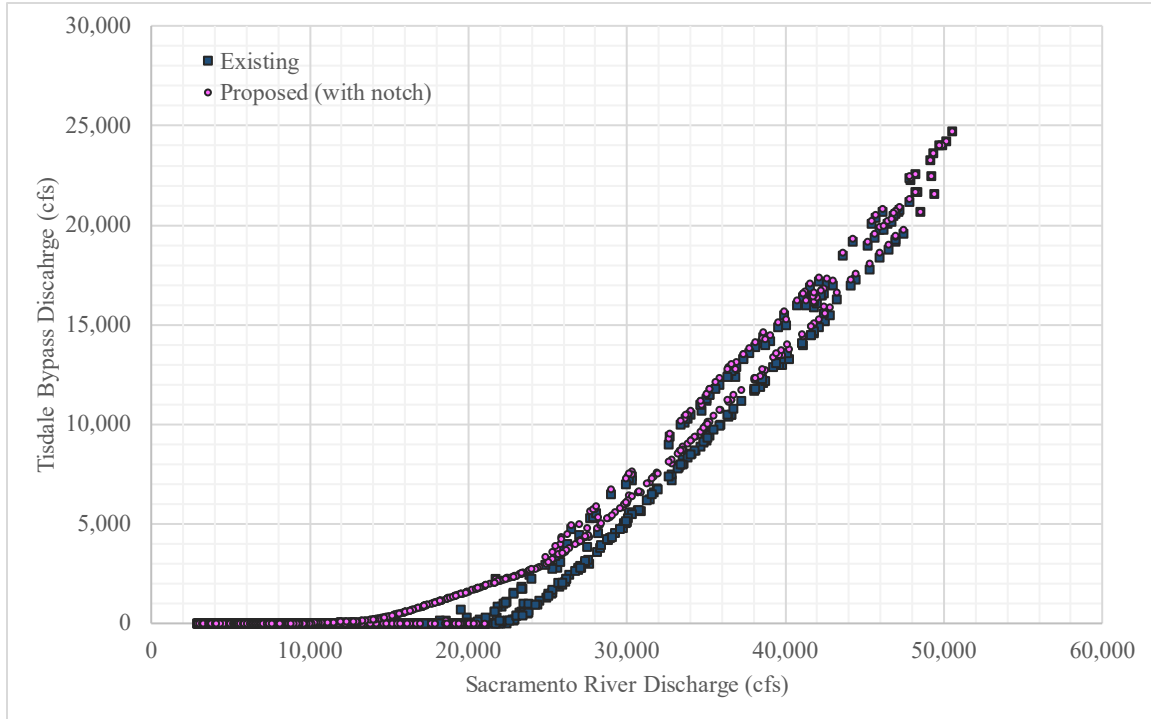
**Figure 3**  
Tisdale Bypass flow versus upstream Sacramento River discharge (11/15/2007 to 10/5/2017).

river water surface elevation was below the crest of the weir. Curves relating flow into the bypass for a given flow in the Sacramento River, for existing (weir spill only) and Project conditions (weir spill plus flow through a notch), are shown in Figure 3. Under Project conditions, the volume of sediment was calculated separately for days with flow only through the proposed notch and for days where there is flow over the weir and through the proposed notch. The volume of coarse (sand-sized) suspended sediment from days with flow only through the proposed notch comprises less than four percent of the total volume of coarse sediment entering the bypass under Project conditions.

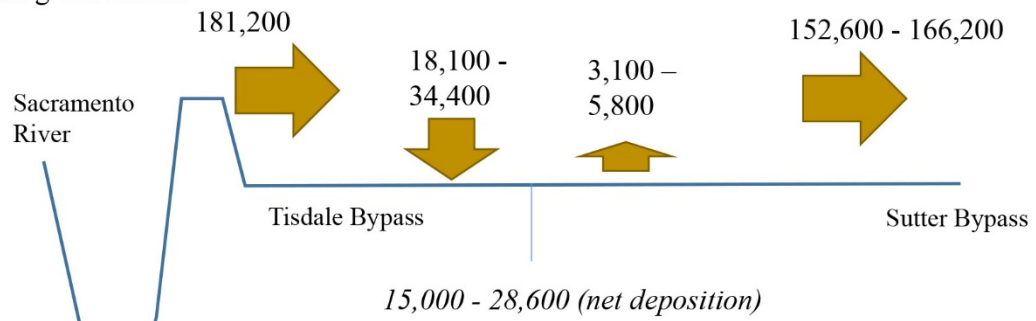
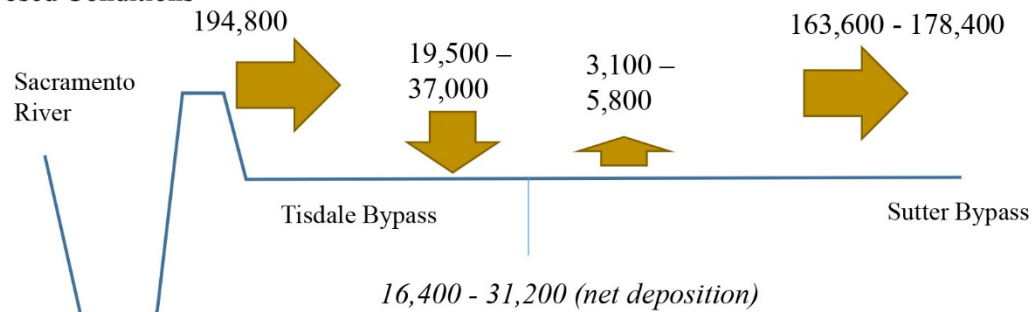
**Figure 5**  
Tisdale Bypass annual suspended sediment budget estimates (cubic yards per year).

**Figure 5** summarizes our estimated annual suspended sediment budget for the Tisdale Bypass for both existing and Project conditions. To complete and refine the estimated flux-based sediment budgets for the bypass, we used the eroded volumes derived from the topographic change analysis to estimate the amount of sediment that may be removed from the bypass through erosion and/or resuspension (i.e., the gross erosion volume was approximately 17 percent of the gross deposition volume for the topographic change detection analysis, see Table 1). We did not assess how erosion or resuspension of sediment within the bypass may be influenced by the proposed Project, and therefore this part of the budget is left unchanged. However, it is reasonable to assume that most of the measured erosion within the bypass occurs during large flood events when the weir is overtopping, and in these cases the influence of the proposed notch on flow or other hydraulic processes throughout the bypass would be minimal. Thus, the proposed Project may increase the suspended sediment volume delivered to the Tisdale Bypass and areas downstream by approximately 8 percent, and it may increase the *net* volume of sediment deposited within the Tisdale Bypass by up to approximately 9 percent (assuming the eroded volume would not change). The sediment that accumulates within the Tisdale Bypass would likely be periodically removed as part of the continued and ongoing maintenance implemented by DWR.

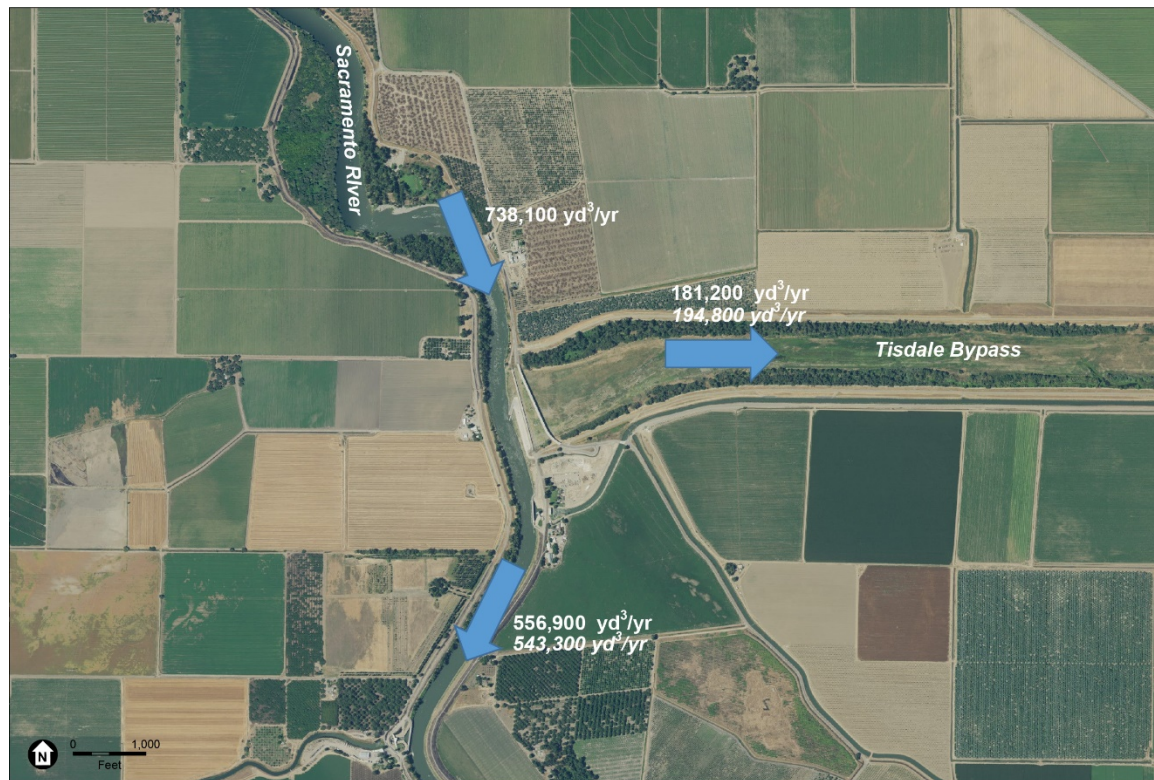
NOTE: (Project conditions shown in *italics*).

**Figure 6** summarizes the broader-scale suspended sediment budget estimates in the context of the Sacramento River (based on 2007-2017 conditions). The upstream Sacramento River estimate was derived using the same suspended sediment rating curve, though applied to the total river flow instead of just the flow discharged into the Tisdale Bypass. The downstream Sacramento River estimate represents the upstream estimate less the flux of the sediment into the Tisdale Bypass.
