TISDALE WEIR REHABILITATION AND FISH PASSAGE PROJECT

Engineering Feasibility Report

Prepared for
California Department of Water Resources

January 2020

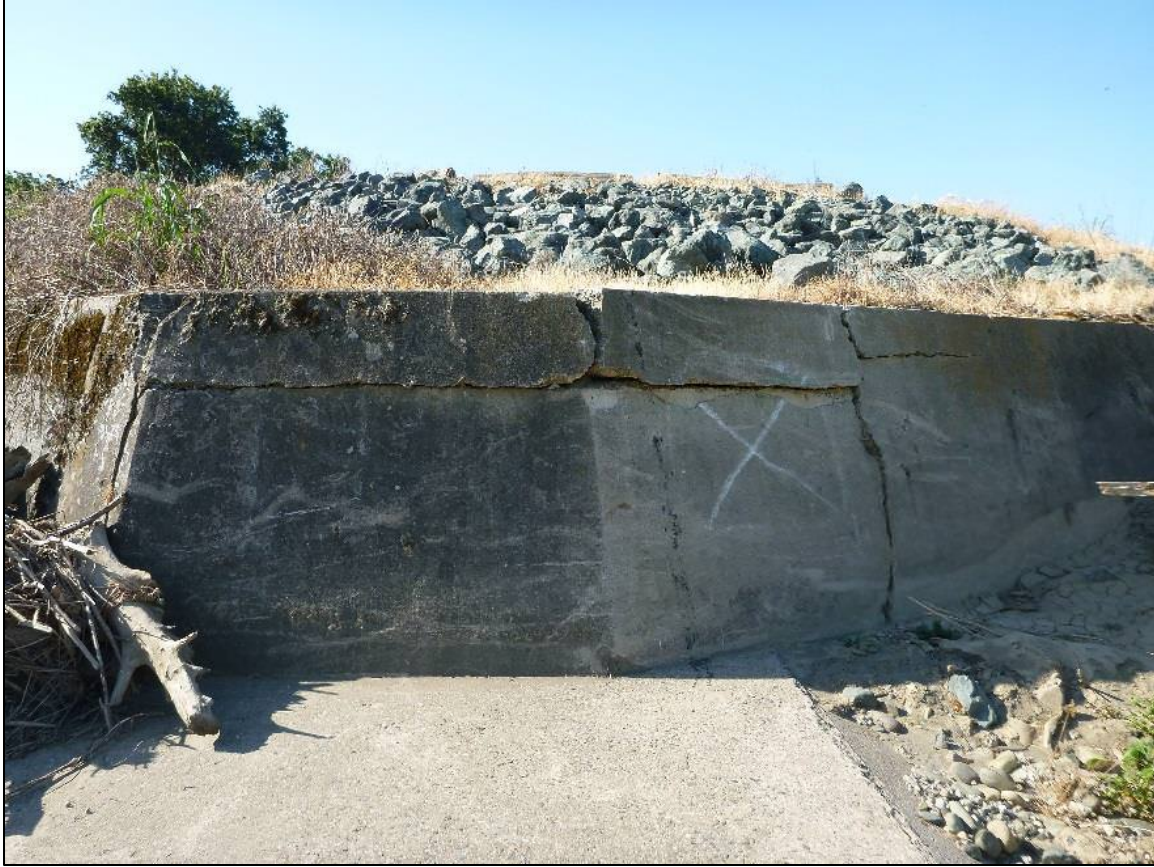
Figure 5**Vertical and Horizontal Cracking of the South Abutment Wall**

3. Weir abutments – A 9-foot-long west segment of the south abutment wall is displaced out of plane and extensive horizontal and vertical cracks are visible (**Figure 5**). The wall of the north abutment has about a foot of missing concrete across the entire face with exposed rebar, and the concrete wing walls are falling apart. There is vertical and horizontal cracking throughout the walls. At the south end of the energy dissipation basin near the south abutment wall, there are large boulders and rocks covering the basin.

Based on field inspections, the existing energy dissipation basin and north and south abutment walls are not salvageable given the extent of the concrete deterioration, and the lack of information available in the existing as-built drawings inhibits the ability to assess the original design conditions. Thus, these weir features should be replaced. The top weir cap is visually in generally acceptable condition given its age; therefore, there may be an opportunity to conduct a simple rehabilitation of the weir cap by resurfacing the top of the weir cap to an acceptable finish thru the application of a thin restoration overlay.

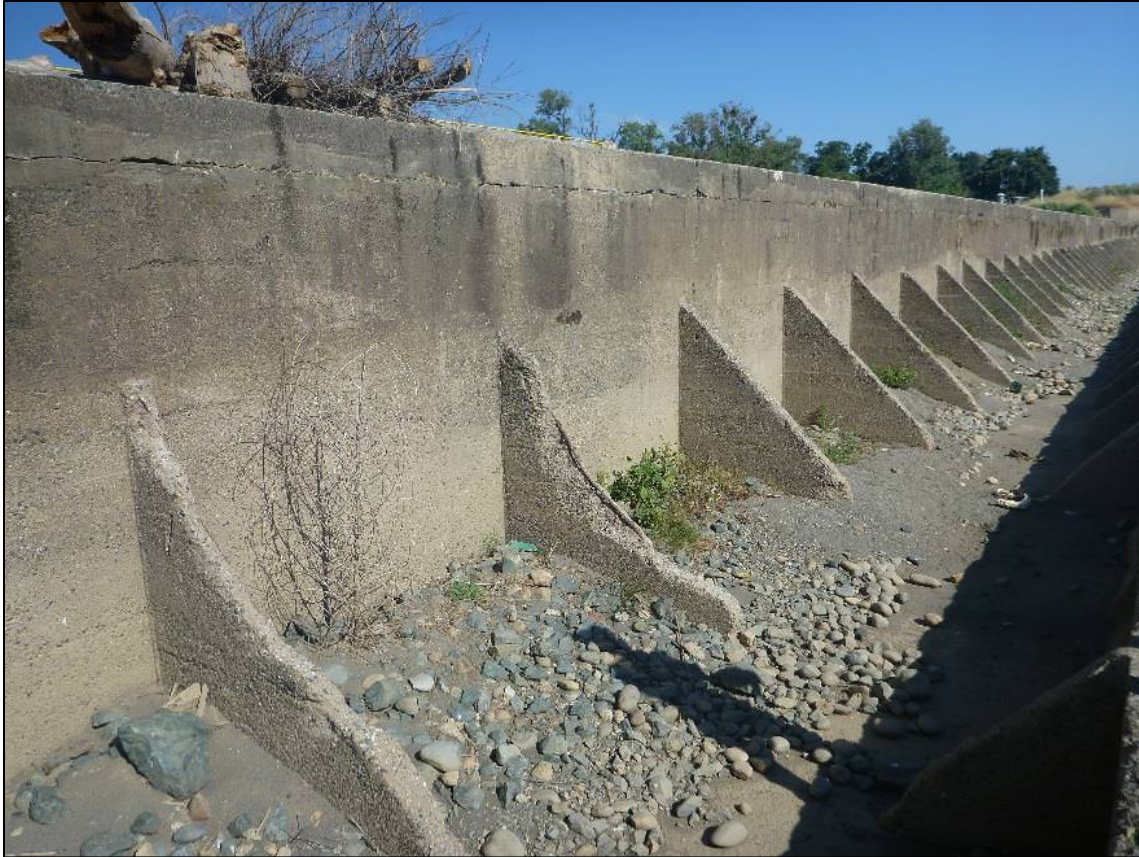
Figure 6
Deterioration of Energy Dissipation Basin and Buttresses

4. Weir sill – The weir sill concrete has eroded and exhibits exposed aggregate, spalls, cracks, and many patches; some locations show signs of exposed rebar. The cold joint above the energy dissipation basin (basin) wall appears to have some cracking and spalling along the entire length of the joint. The basin along the east side of the weir is badly damaged on the north end with concrete deterioration and exposed rebar, and a buttress wall is missing.

5. Energy dissipation basin – Numerous buttresses in the basin (40 short and 4 tall) are missing or badly damaged, and the basin concrete is showing signs of heavy erosion (**Figure 6**). Scour holes have routinely formed along the edge of the energy dissipation basin and require regular repair and maintenance. Sediment, including large rocks, and vegetation are present in the basin.

6. Revetment – The rock revetment adjacent to the top of the concrete weir sill is shown to be inconsistent throughout the length of the weir. The original rock revetment was comprised of small cobble and is routinely displaced during high flows causing scour holes that require annual maintenance. The revetment that is eroded away from the weir sill is transported over the weir and dispersed all around the lower area, including inside the dissipation basin.

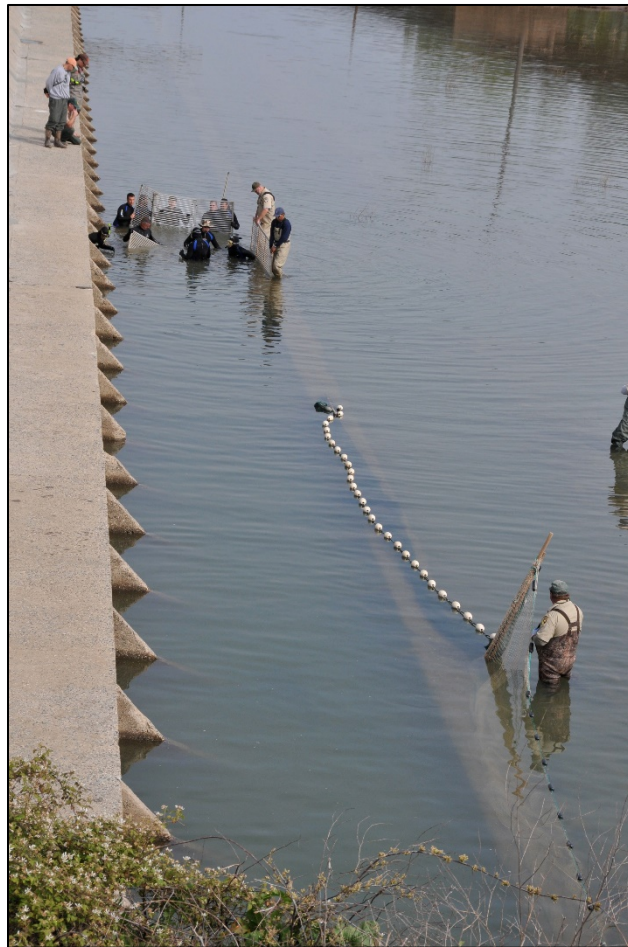
Figure 7
Fish Rescue at Tisdale Weir

After some stranding events, fish rescues by the California Department of Fish and Wildlife (CDFW) have been conducted at the Tisdale Weir to rescue juvenile and adult salmon, steelhead, and sturgeon from the weir’s existing energy dissipation basin (**Figure 7**). While trapped in the basin, fish are ultimately subject to lethal and sublethal conditions; their survival is dependent upon a timely fish rescue (i.e., removal and release). Additional information on fish stranding and rescues is provided in ESA (2019). Rescue efforts at this location have been limited to the weir apron and inundated areas immediately east of the weir.

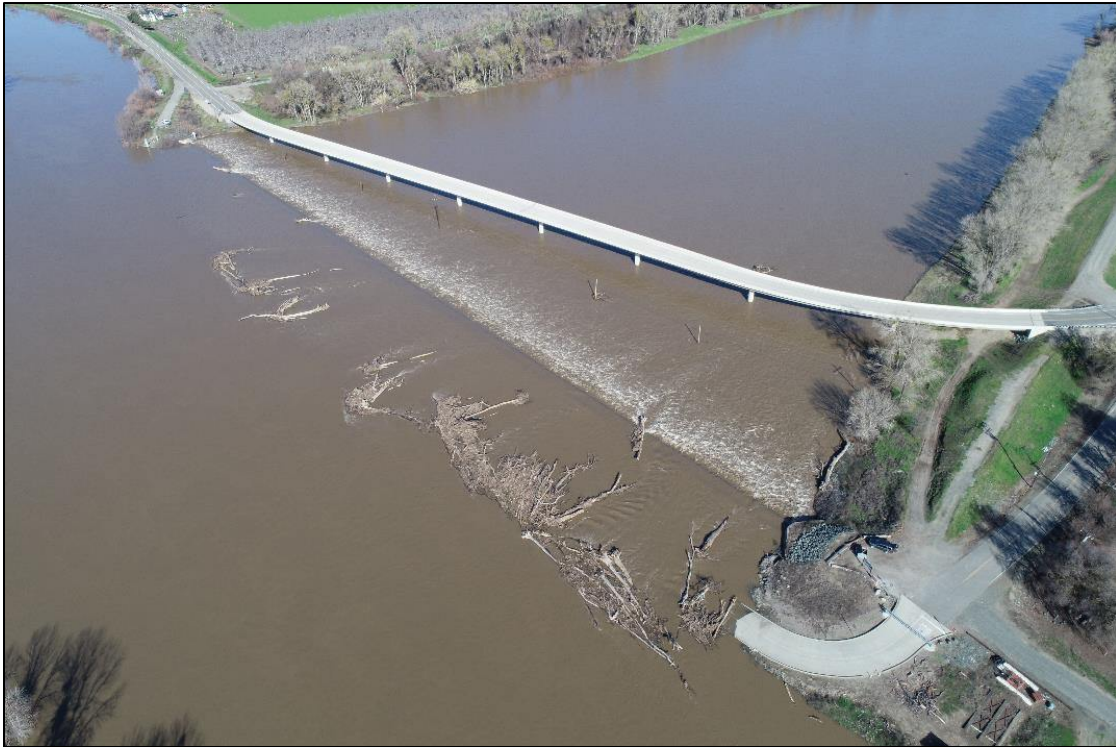
Figure 8
Large Wood Debris Accumulation on Tisdale Weir – January 22, 2019

1. LWD accumulation and removal – Since construction of the boat ramp and parking lot on the west side of the weir in 2009, the bulk of LWD accumulation has repetitively occurred on the parking lot surface, with additional accumulations on the weir itself and in the bypass (**Figure 8**). These accumulations create problems both for operations and for maintenance. For example, the gage at the north abutment records the stage on the Sacramento River and this stage information is then used to develop and maintain a stage-flow relationship (rating curve) over the weir and this is computed based on the assumption that the weir is clear of debris; however, LWD has been observed to obstruct and reduce flow over the weir in isolated locations, and this can result in variable flow across the weir, leading to inaccurate estimates of flow over the weir when debris is present. The physical removal of the LWD is a problem because the mass of debris requires cutting up large-diameter wood so it can be chipped and/or placed in trucks and hauled offsite.

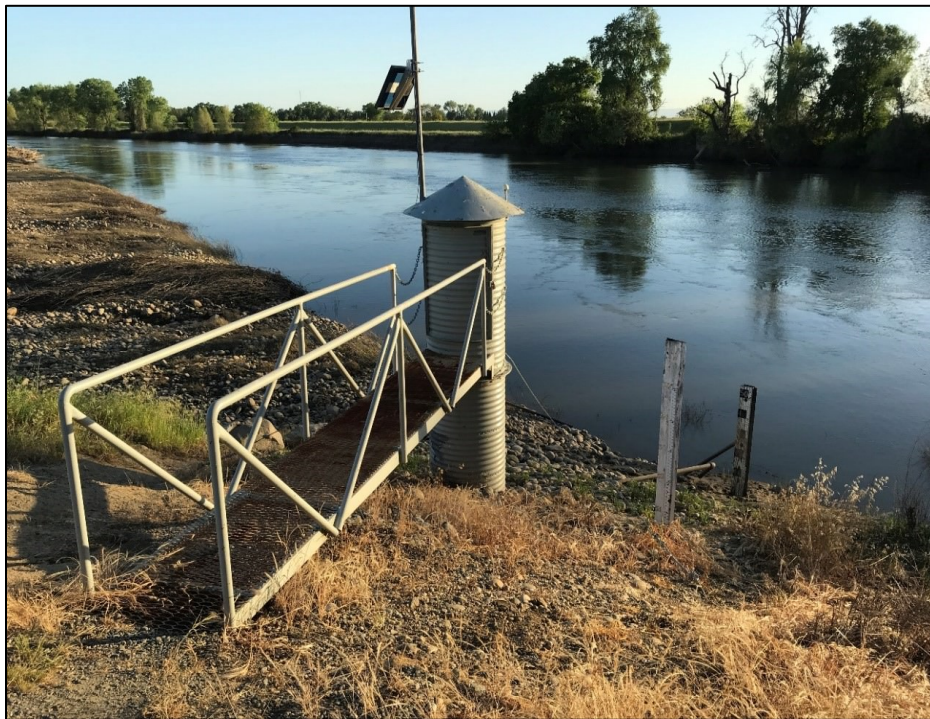
Figure 9
Sacramento River Water Stage Recorder at the
Northern End of Tisdale Weir

3. Weir flow measurement – The existing stage recorder located at the northern end of the weir along the Sacramento River bank (**Figure 9**) is operated by the DWR North Region Office and requires maintenance to ensure proper operation. It does not measure lower Sacramento River stage elevations (below weir crest), which would be necessary to measure and record river stage for the range of stage elevations when any fish passage structure(s) constructed through the weir may be operating. Even with this single gage functioning properly, observations of differential flow over the weir due to LWD accumulations indicate that more than one stage measurement location may be helpful. For example, at least one additional gage could be installed at the south end of the weir, and ideally stage monitoring would occur at multiple locations across the weir in the direction of the overflow. Any future effort to establish a new stage-flow relationship across the weir with the installation of fish passage facilities(s) should also involve the conversion of all water surface elevation measurements (and reporting) from the existing USED vertical datum to the standard NAVD88 vertical datum.

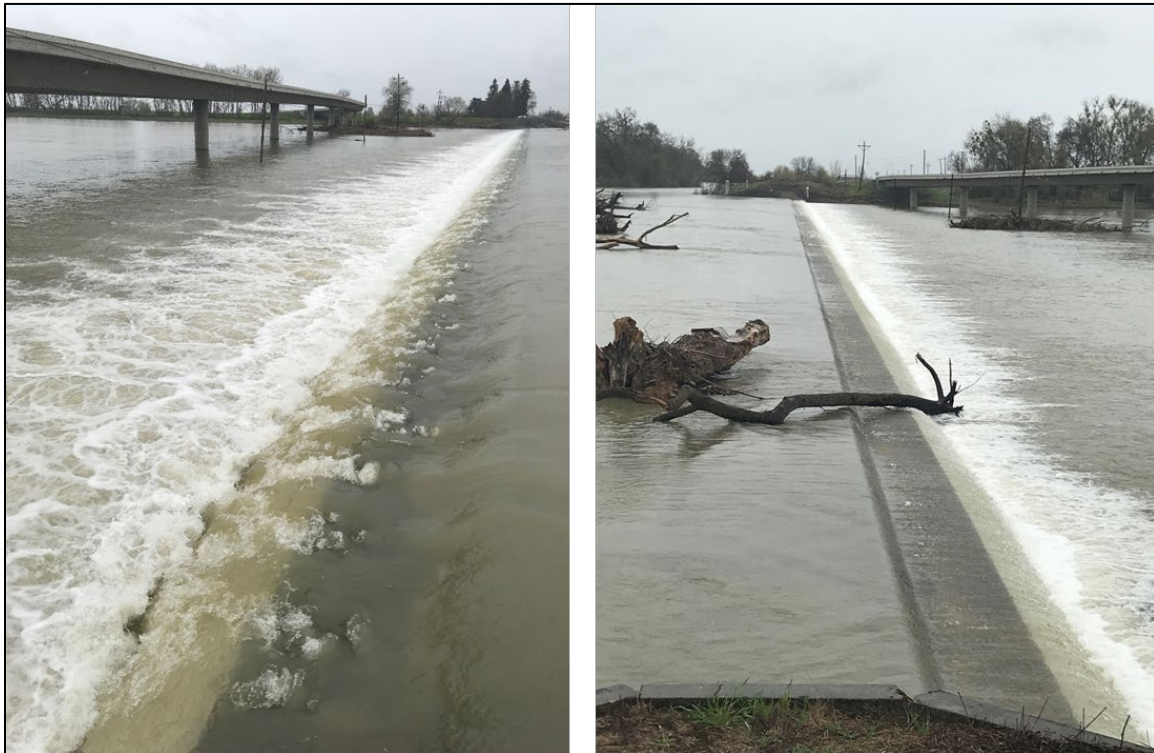
Figure 10
Weir Overflow Depth Variation on North (left) and South (right) – March 22, 2019

- LWD impacts on weir flow – Field observations and a historical assessment of LWD accumulations at the weir indicate that a majority of debris is deposited along the southern two-thirds of the weir, with the largest accumulations occurring in the parking lot area. This uneven pattern of deposition has been observed to induce an associated variation in flow depths from the north to the south ends of the weir (deep to shallow) (**Figure 10**), indicating that LWD can obstruct flow across the weir. LWD accumulations at the weir may also limit the ability of the weir to perform its authorized function/design capacity, forcing more water downstream in the Sacramento River, potentially increasing risk to the Sacramento River levees downstream.

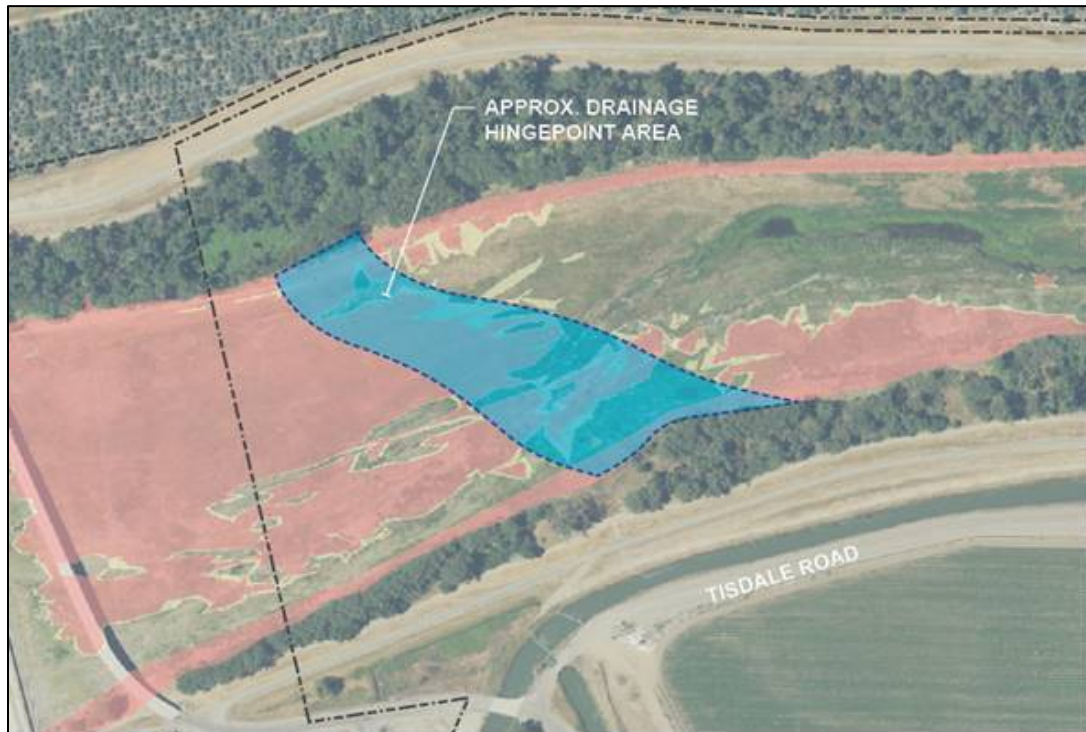
Figure 11
Approximate Location of Tisdale Bypass “Hinge Point” Area

Besides the major topographic constraint imposed on bypass flows by the weir sill elevation, topography in the bypass itself varies and there is, in effect, a “sill,” or “hinge point” at elevation 37 feet in the bypass located approximately 1,000–2,000 feet east of the weir sill (**Figure 11**). This elevation roughly corresponds to the water surface elevation in the bypass at which eastward flow through the bypass ceases, due to the elevation of this topographic “hinge point.” In other words, in the absence of the weir, the Sacramento River would not flow beyond this point in the Tisdale Bypass if the river water surface elevations were below this elevation.

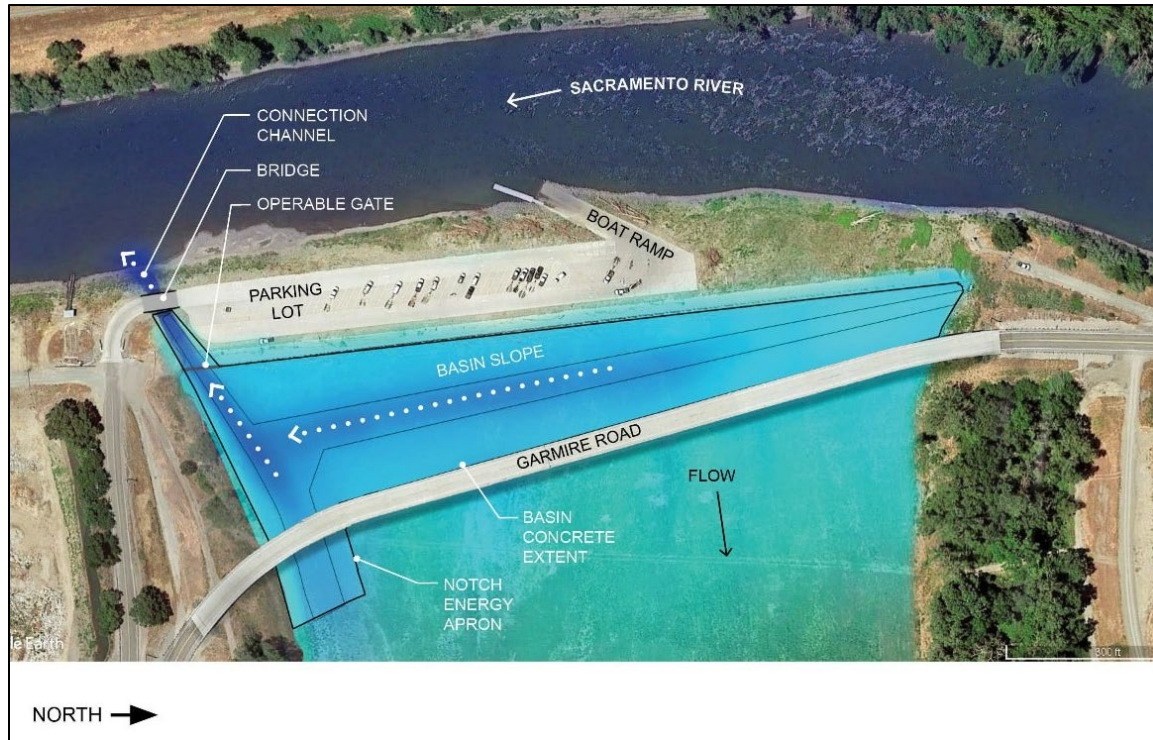
Figure 17
Illustration of Alternative 2 – South Notch

A single notch with an operable gate would be constructed at the southern end of the weir with a connection channel to the Sacramento River (**Figure 17**). An equipment pad would be constructed on the south abutment to place compressor and other mechanical and electrical equipment and to facilitate O&M of the gate. The energy dissipation basin would be extended farther east than the existing basin to accommodate energy dissipation and the basin would be reconstructed as a wide trapezoidal channel to provide fish passage past debris and sediment deposits. The basin would be sloped to the south to facilitate drainage to the notch opening and facilitate fish passage through the weir as Sacramento River elevations decrease.

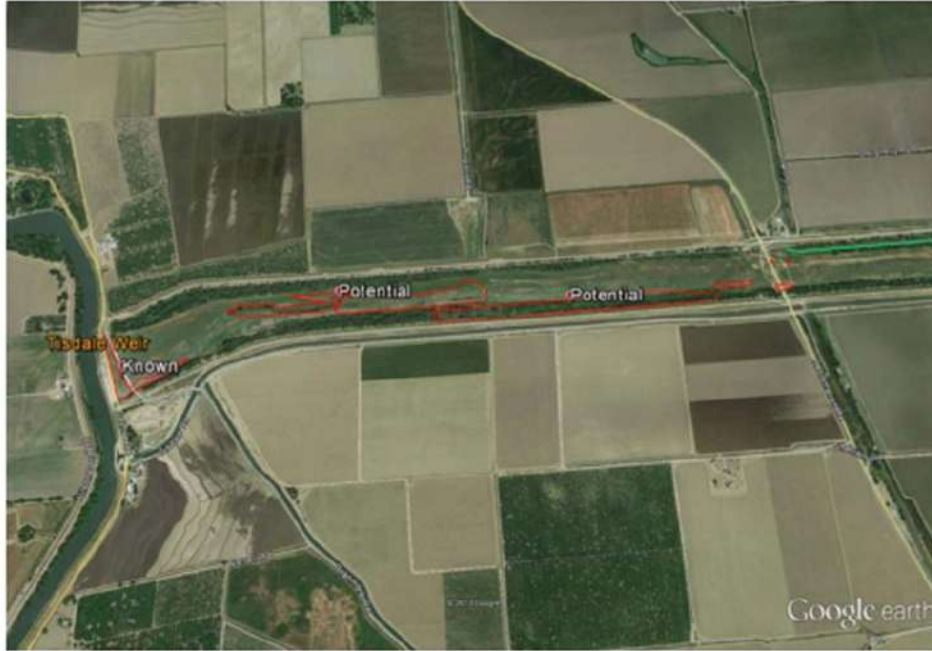
Notes: Screenshot is of the bypass between Tisdale Weir and the Reclamation Road Bridge. Imagery date is June 26, 2011.

Figure 1
Photo C1-28 in DWR (2014) of the energy dissipation basin below Tisdale Weir.

Adult Chinook salmon, Steelhead, Sturgeon and other fish may become isolated and subsequently stranded in the Tisdale Bypass when migrating up the Sutter Bypass from the Sacramento River during overtopping of the Tisdale Weir (Beccio 2017). When flows recede below the top of the Tisdale Weir, these and other fish species become stranded in the Tisdale Weir splash basin and in inundated areas downstream of the weir. The most common location that fish become trapped is in the energy dissipation basin just below the weir (**Figure 1**).

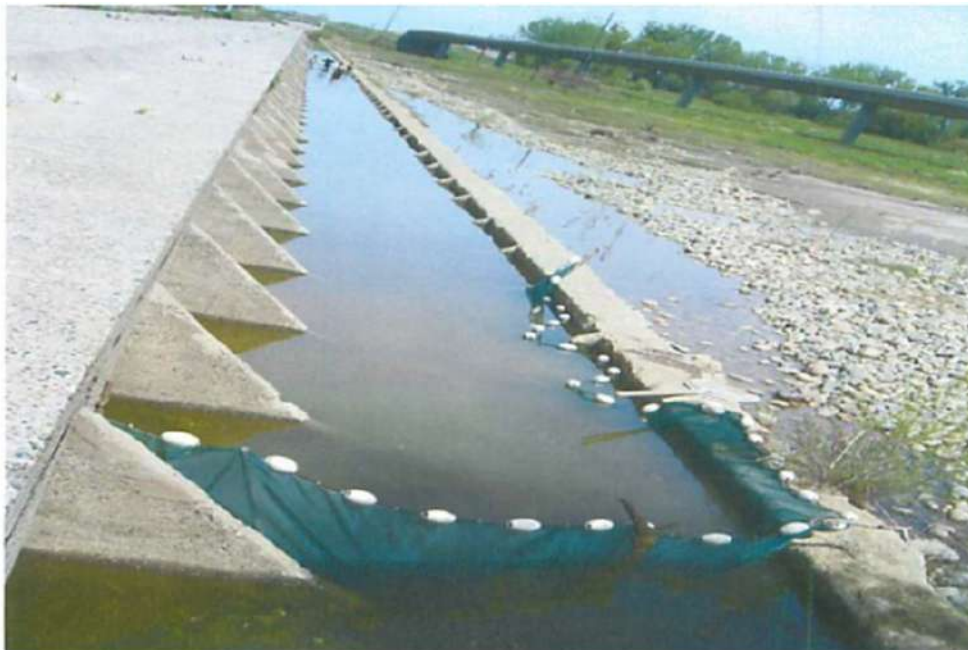
Note: Photo was taken on April 17, 2012 at 10:30 a.m. Source: California Department of Fish and Wildlife

Figure 2
Photo C1-30 in DWR (2014) of multiple isolated residual pools that may cause stranding when floodwaters recede. Note that other pools likely occur downstream of Reclamation road.

Stranding potential is the greatest between Tisdale Weir and the Reclamation Road Bridge (CVPIA 2017). The Tisdale Bypass between the Reclamation Road Bridge and the Sutter Bypass has a low-flow channel on each side of the Bypass that connects to the West Borrow Canal of the Sutter Bypass (CVPIA 2017). However, the potential stranding areas closest to the weir are not connected to these low-flow channels (CVPIA 2017). In addition to the energy dissipation basin, stranding may also occur in multiple isolated residual pools throughout the Tisdale Bypass when floodwaters recede (**Figure 2**).

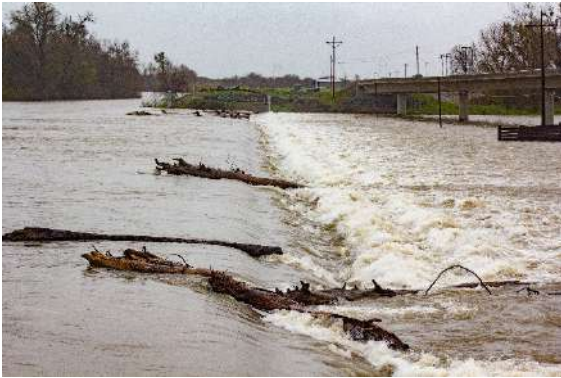
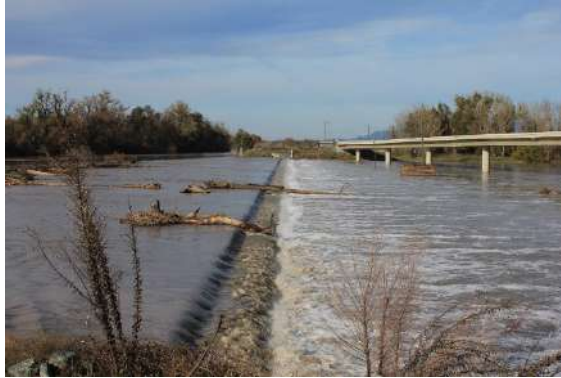
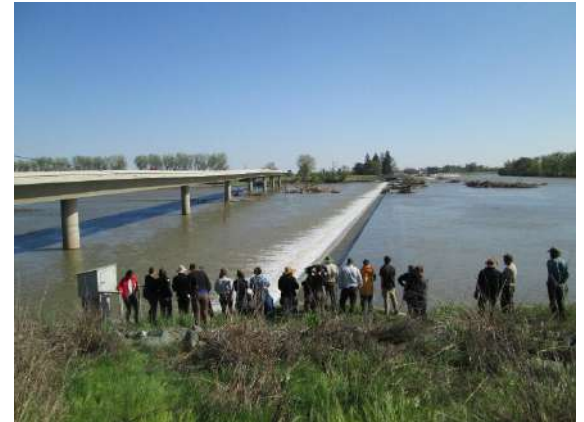
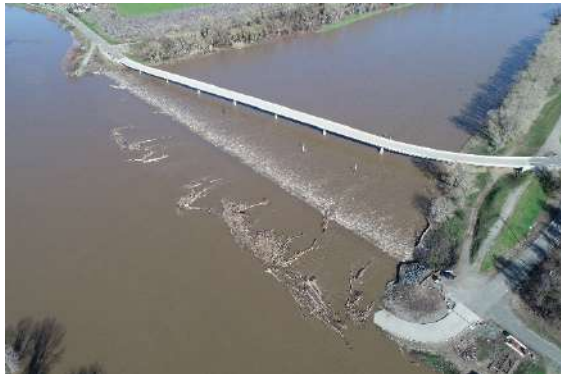
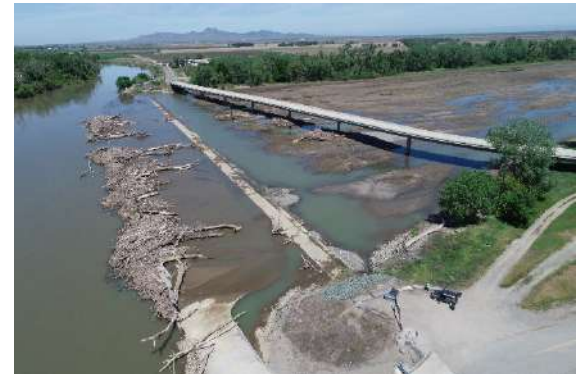
Figure 1

Table 1 lists the date of data acquisition, mapping method, weir overtopping condition, data source, and description of the data. **Figure 1** shows the photographs used for LWD mapping.

Date	Source	Description	Weir Spill	Method
4/23/2019	ESA ¹	Drone photos and videos	Yes	Locations estimated from photos and video
1/22/2019	ESA ²	Drone photos and videos	Yes	Locations estimated from photos and video
4/9/2018	UC Davis ³	Drone video	Yes	Georeferenced screen capture from video
4/8/2018	Sacramento Valley ⁴	Video taken from south bank	Yes	Locations estimated from video
3/30/2017	DWR ⁵	Photograph taken from north bank	Yes	Locations estimated from photo
1/9/2017	Sutter County ⁶	Drone video	Yes	Locations estimated from video
1/19/2016	Sutter County ⁷	Video taken from south bank	Yes	No LWD observed in video
12/4/2012	Sutter County ⁸	Video and photographs taken from south bank	Yes	Locations estimated from photos and video
3/30/2011	Google Earth ⁹	Google Earth imagery	Yes	Delineated from historical aerial in Google Earth
3/19/2011	DWR ¹⁰	Video and photographs taken from south bank	Yes	Locations estimated from photos and video

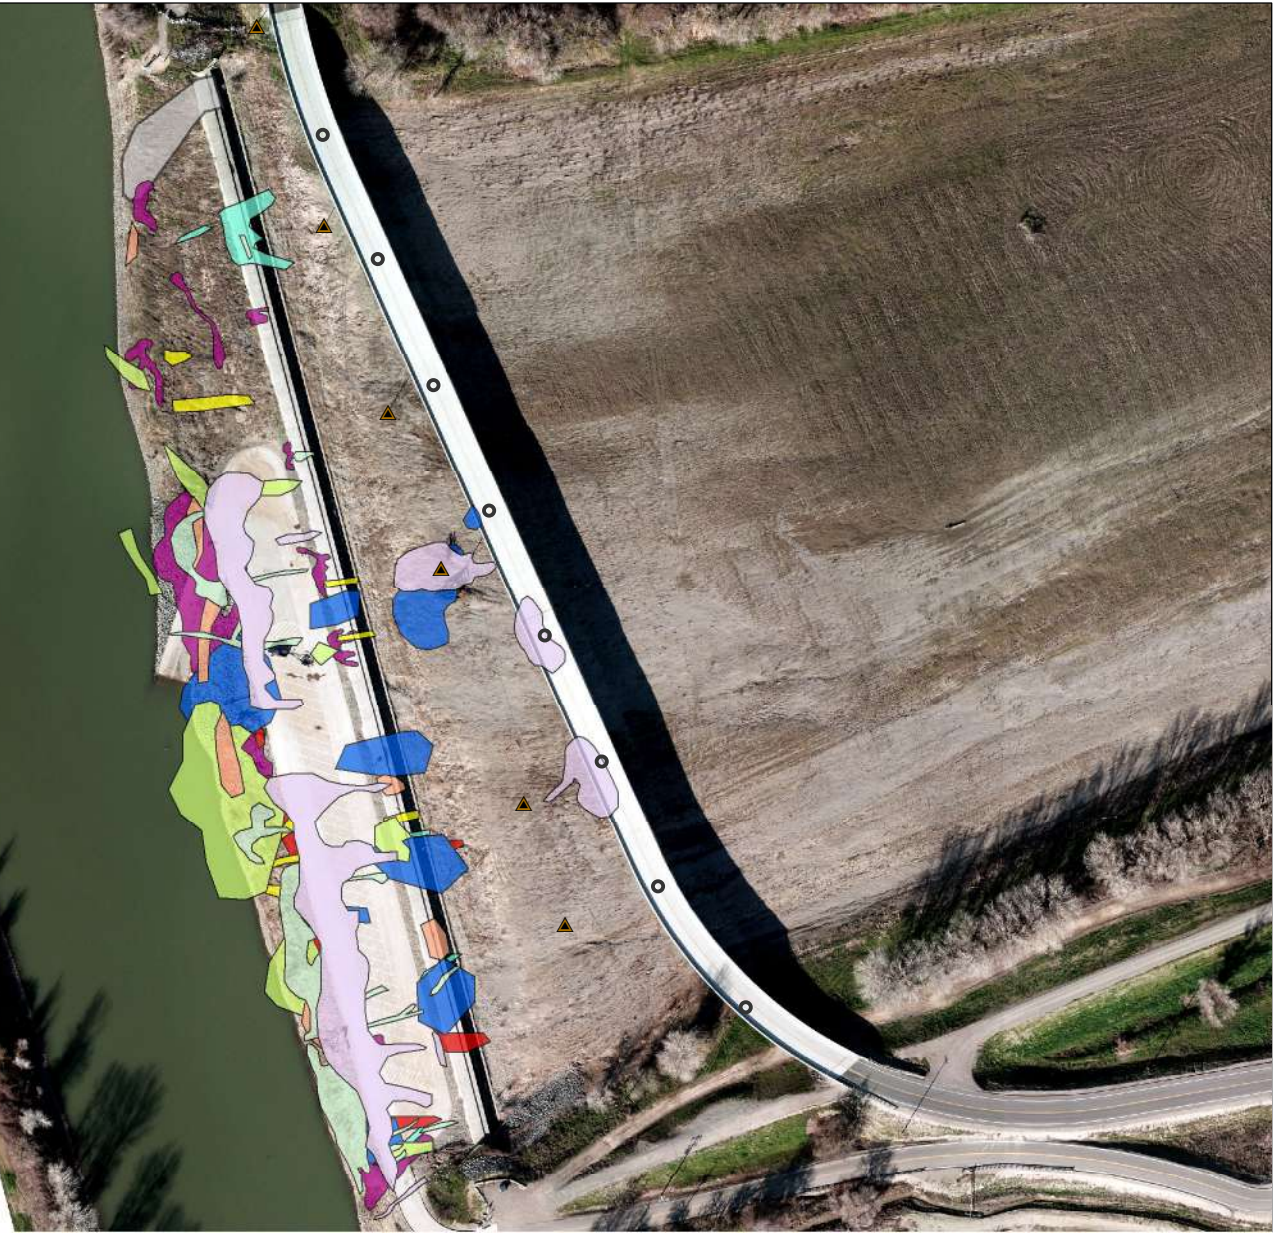
NOTES: Large wood debris locations digitized from images and video of spill events
