Dos Amigos Pumping Plant

Discharge Line Assessment and Repair

California Water Commission

April 17, 2013

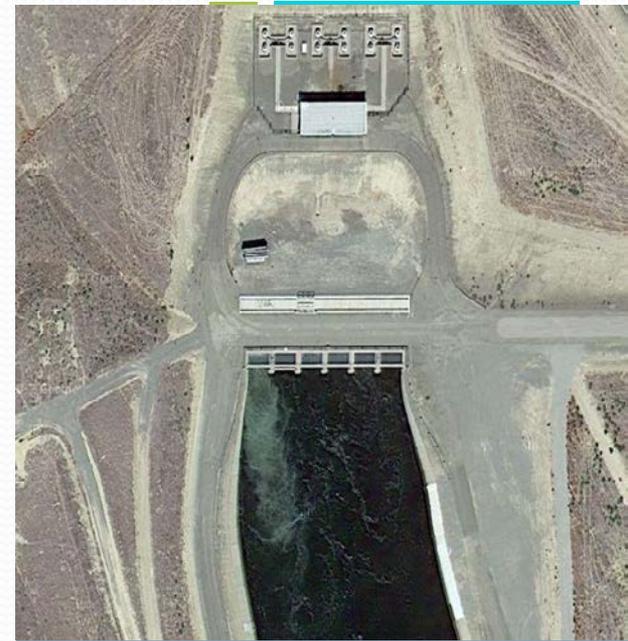
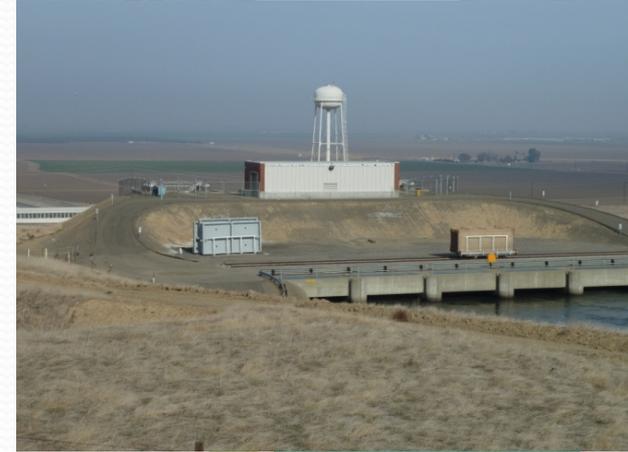
Dos Amigos

- A sinkhole was discovered on January 3rd, 2013, adjacent to the south wall of the DAPP Siphon Control House - when a heavy equipment truck broke through the pavement.
- The sinkhole is located ~20 ft above discharge lines No. 4 and No. 5, adjacent to the exterior of the Siphon Control House south wall, which is approximately 130-ft from outlet into the Aqueduct.

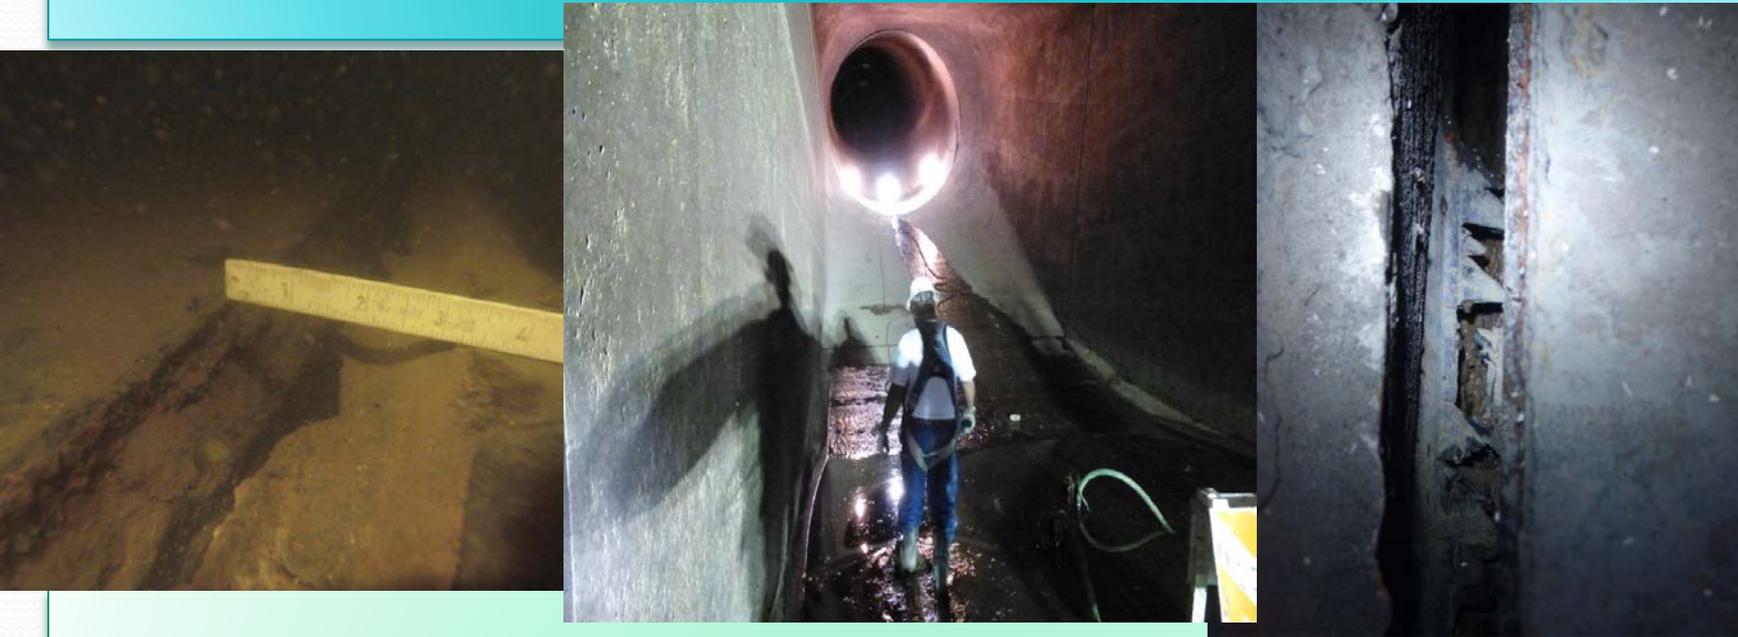
In Pipe Inspection – Line 5

- Inspections revealed joint separation at the invert of pipe joints between the encased steel pipe and reinforced concrete transition section in all discharge lines inspected.
- Divers found $\frac{3}{4}$ " up to 2 + " separations at the invert – but top tight.

- Missing joint sealant and tears in the Type 'A' rubber water stop.

Installing WEKO seals on all lines

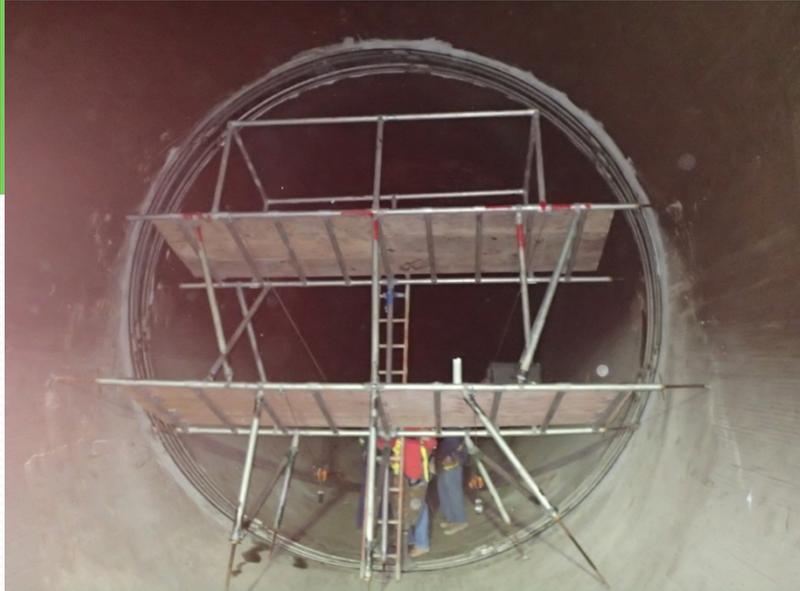
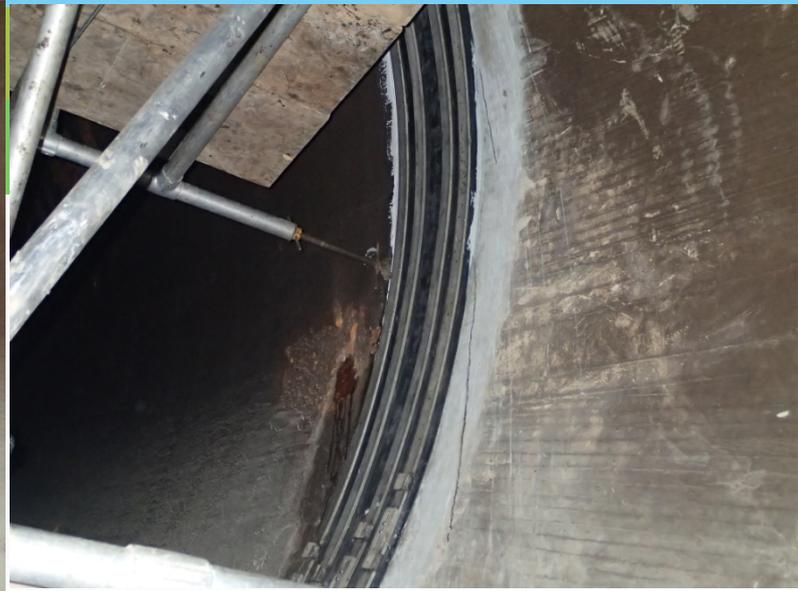
Seals installed on Discharge line # 5
