CALIFORNIA DEPARTMENT OF WATER RESOURCES

Assessment of the Vegetation Area on the Face of the Oroville Dam

August 30, 2017

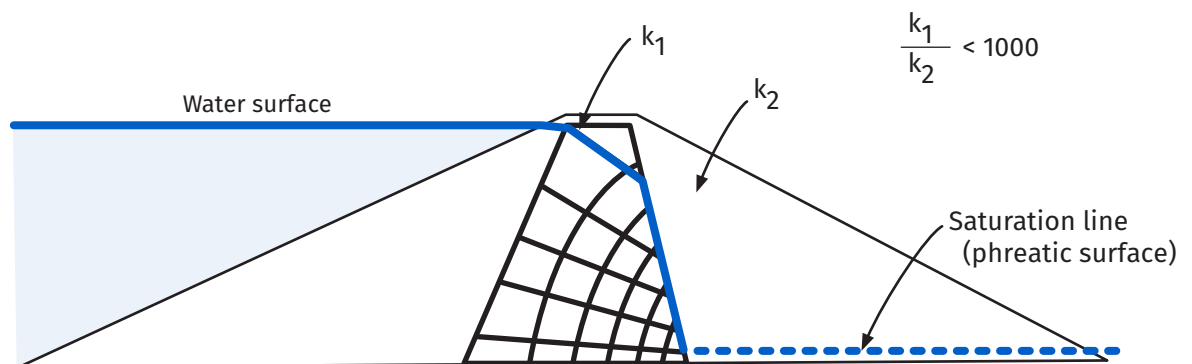
As shown in Figure 3, the top surface of the seepage level in the downstream portion of a dam (phreatic surface) is very low if the permeability (k) in the central core is at least 1,000 times less than that in the outer portion or shell of the dam.

FIGURE 3. Low Saturation/Seepage Line Resulting when an Embankment Dam has a Central Core that is 1,000 times or more Less Pervious than Outer Shell Material (adapted from Cedergren, 1997).

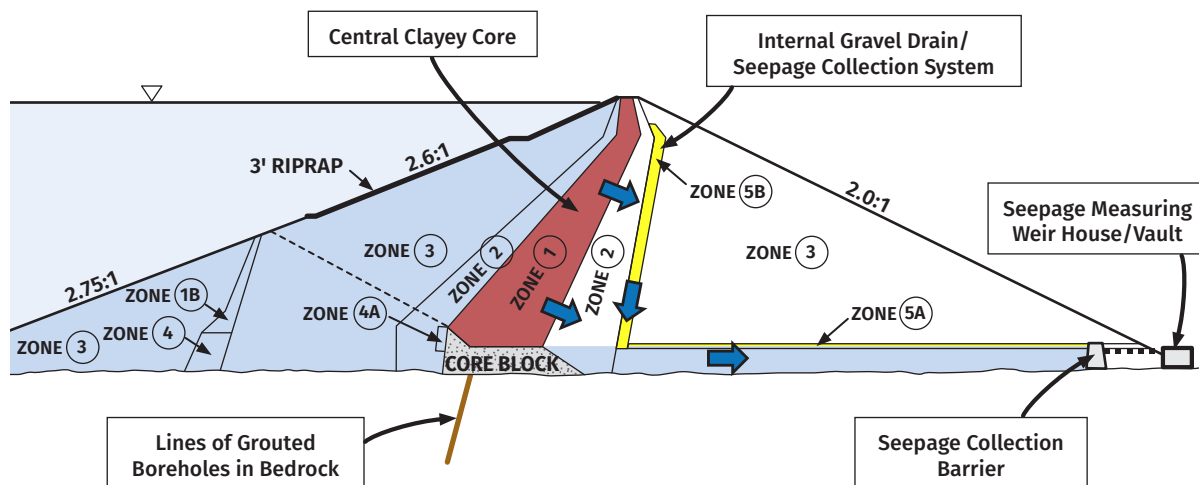
As shown in Figure 4, the design for seepage control in Oroville Dam follows this general principle and incorporates a central clayey core (Zone 1) that is about 2 million times more impervious than the outer shell zone (Zone 3) – a far higher ratio than the ratio of 1,000 needed to assure a very low phreatic surface and dry slope.

FIGURE 4. Cross Section of Oroville Dam illustrating Designed Seepage Barriers and Seepage Collection System.

As shown in Figure 4, the key barrier for seepage through the dam is the central clayey core within the dam (Zone 1). The key barrier for seepage through the foundation is grout injected into a line of boreholes in the bedrock beneath the core (red line below concrete core block). The clayey core is founded on a concrete block (core block) in the central section of the dam to prevent differential settlement of the core.

Figure 4 shows a near vertical gravel drain (Zone 5B) constructed downstream of the core (yellow zone) to collect seepage passing through the dam. Any seepage coming through the central clayey core is intercepted by this drain and then drops down to a low internal pool (blue-shaded zone in lower portion of embankment downstream of the core and core block).

Also shown in Figure 4, embankment seepage flows through a pipe from the low internal pool (dashed line) and out into a seepage measuring house (or vault) where it is measured by a weir as it discharges into the Feather River.
